TOOWOOMBA RANGE RAILWAY

SITE INVESTIGATION AND REMEDIAL SLOPE DESIGN – CH 144.500 TO 144.850 KM

Report Number. 137632080-012-R-Rev0

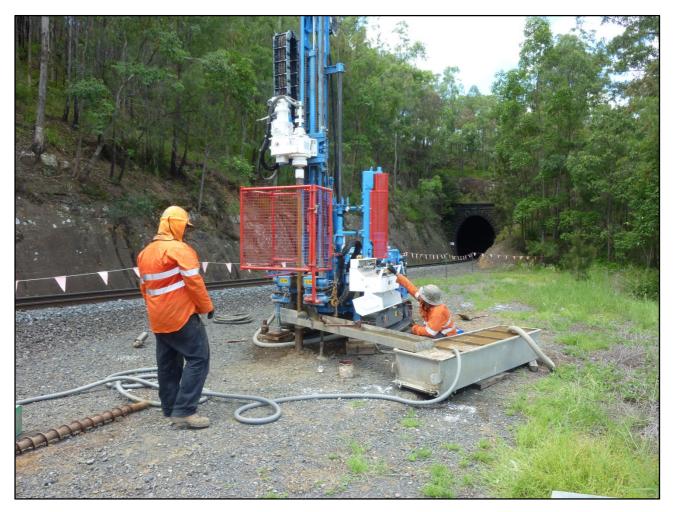
Photograph 1: View east showing drilling at Borehole BH07 on the upper access road at approximate Ch 144.57 km, with Tunnel 3 visible in the background. Note: *in situ* distinctly weathered sandstone exposed in the upslope cutting adjacent to the rail line.

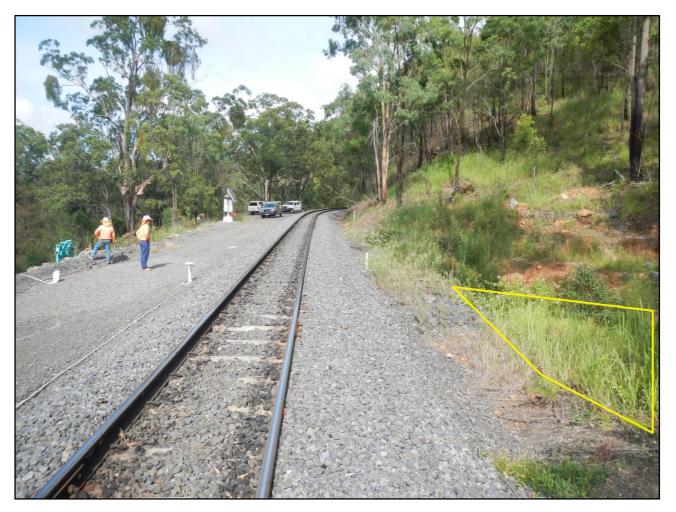
Photograph 2: View west along the railway corridor showing the upper access road and rail line at approximate Ch 144.7 km (near Borehole BH03). The inlet area for the under-rail culvert at Ch 144.73 km is visible in the right foreground of the image (marked in yellow).

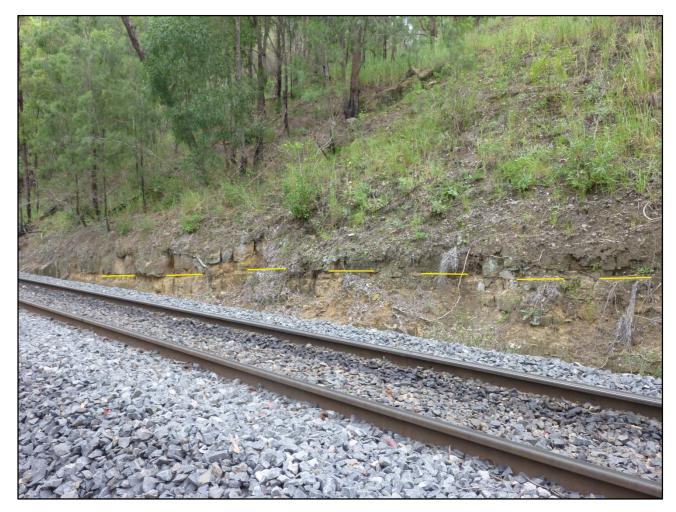
Photograph 3: View north from Borehole BH01 at approximate Ch 144.8 km showing *in situ* extremely weathered rock exposed in the upslope cutting adjacent to the rail line (sandstone above and mudstone below the yellow dashed line).

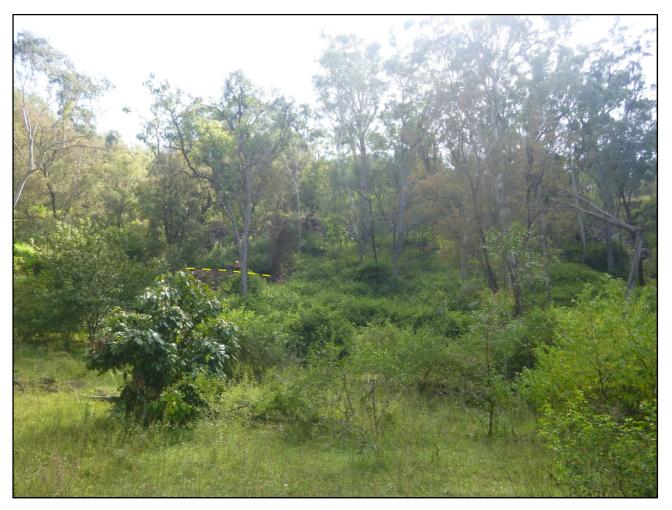
Photograph 4: View north showing the slope below the railway corridor at approximate Ch 144.8 km and the temporary work platform for Borehole BH02 (indicated by the yellow dashed line).

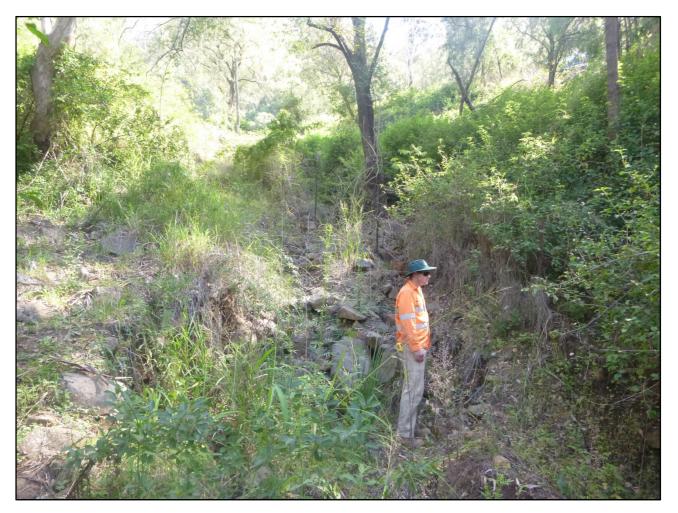
Photograph 5: View north-west at Geological Observation point G2 (located downslope of Borehole BH02) showing a gully filled with colluvium comprising predominantly basalt cobbles and boulders. This gully is the outflow channel for the under-rail culvert located at Ch 144.92 km.

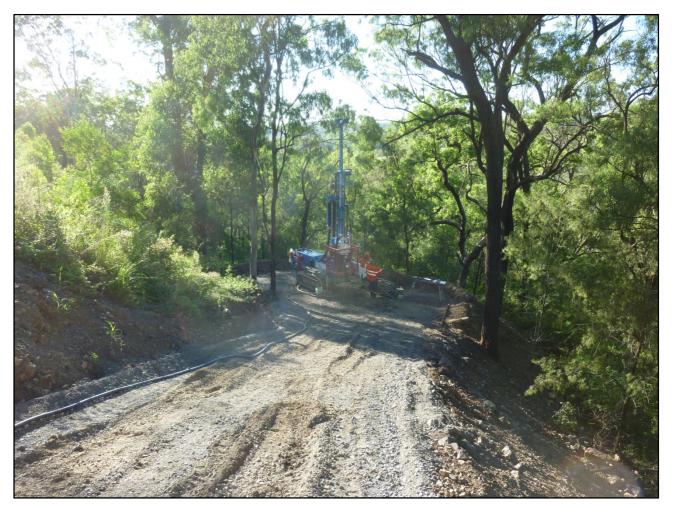
Photograph 6: View south-east showing drilling at Borehole BH04 (approximate Ch 144.7 km).

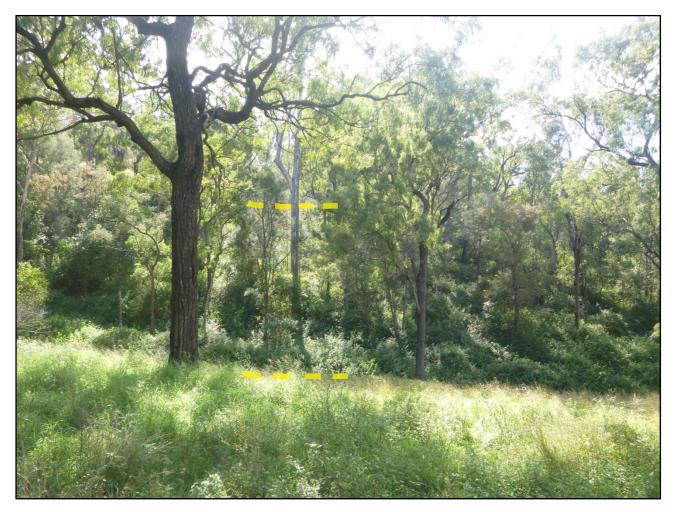
Photograph 7: View north showing the slope below the railway corridor at approximate Ch 144.7 km and the temporary work platform for Borehole BH04 (indicated by the top yellow dashed line). Note: the slope height between the two yellow dashed lines is approximately 20 m.

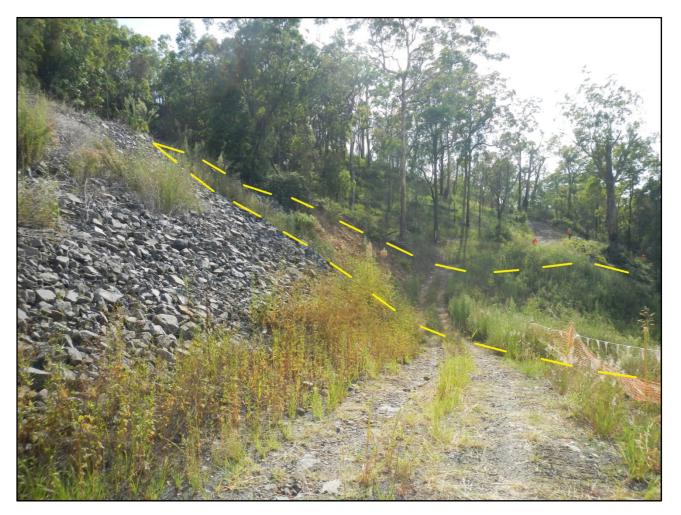
The back analysis results indicate that the analysed slopes are likely to be marginally stable in dry conditions with a Factor of Safety (FoS) of about 1.0. This suggests that any increase in driving forces (for example, due to development of pore water pressures or introduction of surcharge loads) could possibly lead to slope instability.

In wet conditions, with an Ru of 0.15 in the embankment fill and underlying colluvium and residual soil, a FoS of less than unity was obtained (typically 0.8). The critical failure surfaces were located within the embankment fill and the results support the hypothesis that slope failures were probably triggered by the infiltration of surface water into the embankment fill combined with poor drainage.

Photograph 8: View east along the lower access road from Borehole BH06 showing the location of the landslip centred on approximate Ch 144.55 km (yellow dashed lines). Note: some minor remedial works have been undertaken by QR to re-instate the lower access road within the landslip zone, however the slopes immediately above and below the road remain untouched since the time of the failure in February 2013.

Reconstruction of the slope to a 1V:1.5H batter is proposed using select coarse rock fill (< 500 mm size) and assuming that the existing slope crest position and lower access road elevation is to be maintained. This proposed solution has the benefit of being relatively easy to construct with conventional earth moving equipment, and results in a free-draining slope which reduces the risk of pore water pressure build up and the potential instability associated with this condition.

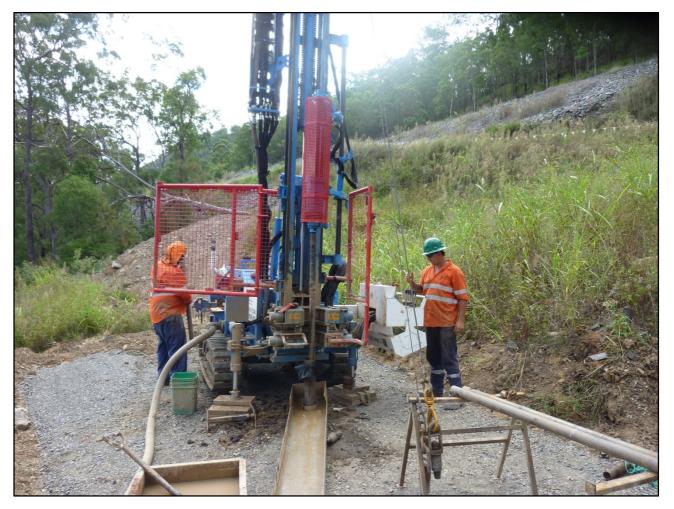
In Borehole BH08 landslide debris comprising displaced clayey sand embankment fill was encountered between 0.6 m and 3.8 m depth. SPT N values of 0 and 4 were recorded in this material indicating very loose to loose conditions. The material was found to be moist to wet.

Photograph 9: View west showing drilling at Borehole BH08 within the landslip zone at approximate Ch 144.55 km.
