TOOWOOMBA RANGE RAILWAY

SITE INVESTIGATION AND REMEDIAL SLOPE DESIGN – CH 142.630 TO 142.810 KM

Report Number. 137632080-011-R-Rev0

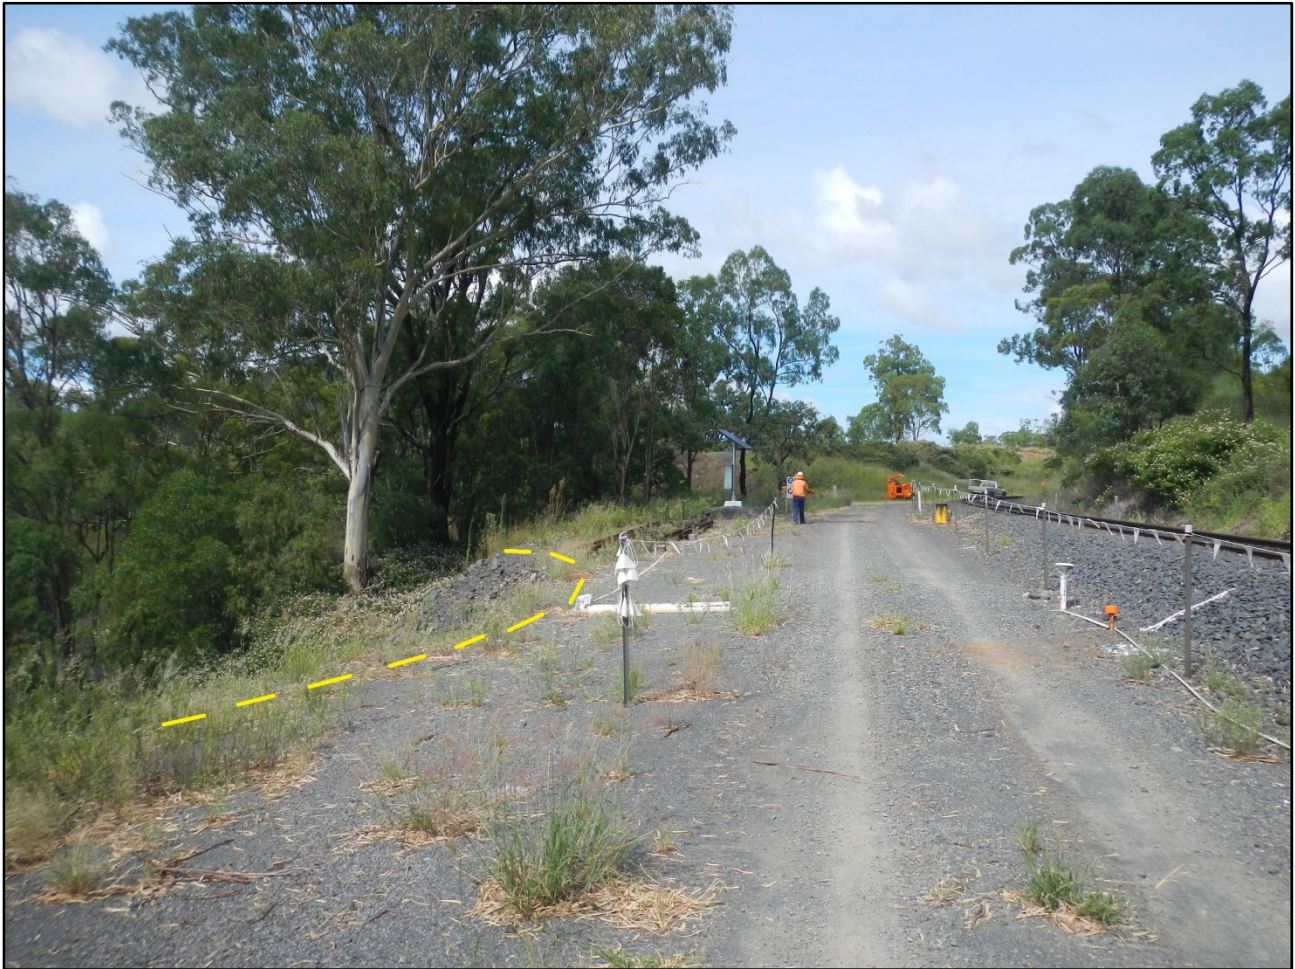
Photograph 1: View south-west along the railway corridor at Ch 142.7 km showing the landslip failure scarp (dashed yellow line), access road and rail line.

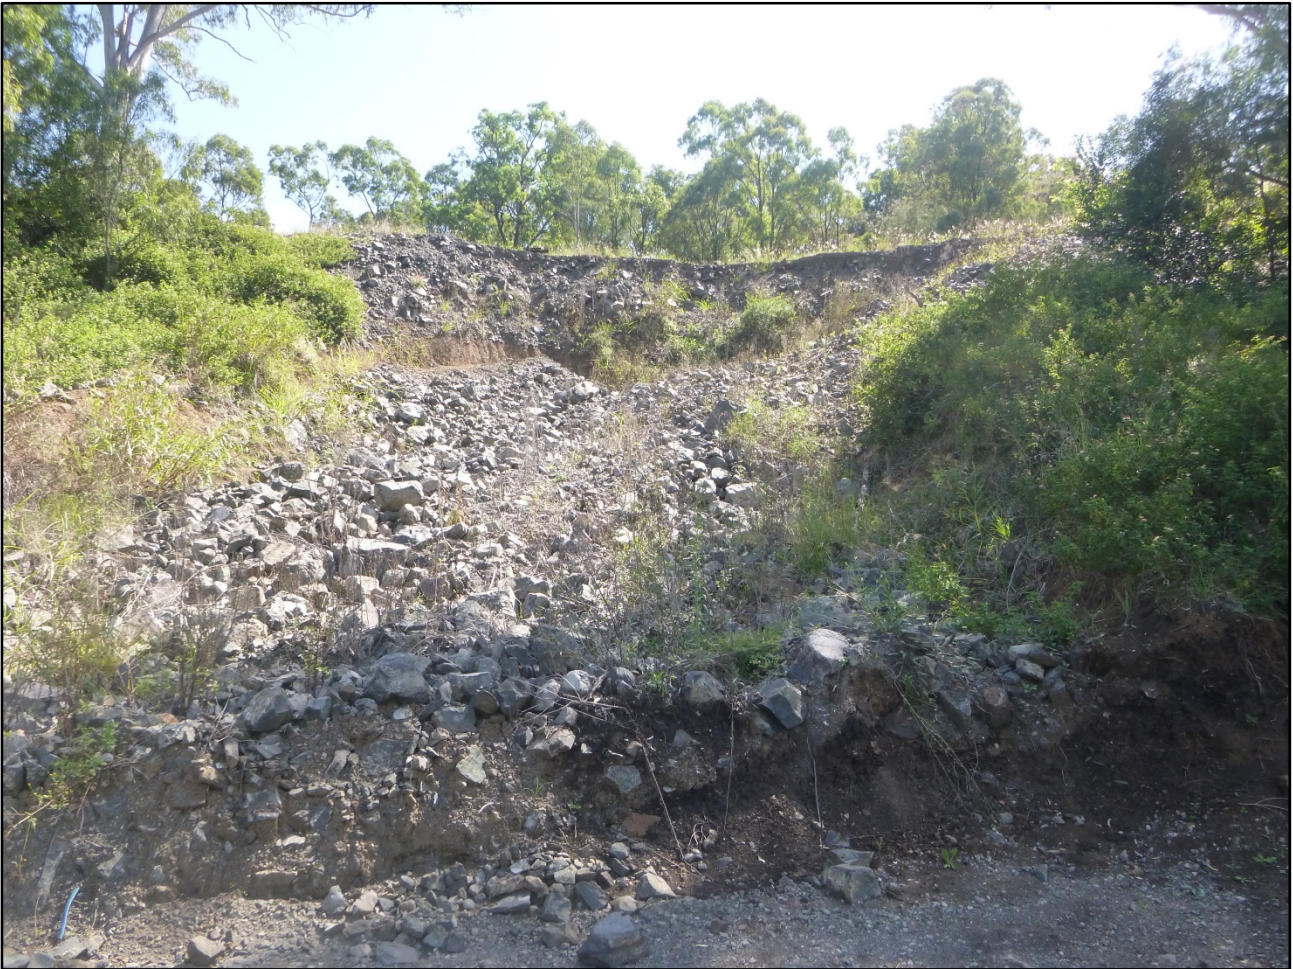
In Borehole BH01 at 1.4 m depth within the embankment fill, a 2.4 m thick very loose, ash gravel layer was encountered. Complete drill fluid loss was encountered in this material at a depth of 2.5 m. In the vertical failure scarp at the slope crest adjacent to Borehole BH01, observations indicate the presence of a gravelly clay and ash fill layer between 5.0 m and 6.5 m depth. The difference in depth to the top of the ash fill layer at these two locations (separated by a distance of approximately 15 m) highlights the discontinuous nature and random distribution of the ash fill material throughout the embankment fill.

The back analysis results indicate that the slope was likely to be marginally stable in dry conditions with a Factor of Safety (FoS) of 1.1 obtained. In wet conditions, with an R_u of 0.2 in the embankment fill and underlying colluvium and residual soil, a FoS of less than unity was obtained (0.9). This critical failure surface is located within the embankment fill and the results support the hypothesis that slope failure was probably triggered by the infiltration of surface water into the embankment fill combined with poor drainage.

Photograph 2: View north (from location of Borehole BH02) showing landslide between approximate Ch 142.700 km and Ch 142.725 km with 7 m vertical failure scarp visible at slope crest adjacent to the access road.

- Excavation and removal of fill, colluvium and residual soil to expose the underlying *in situ* weathered rock at the slope toe and across the slope.
- Excavation of a shear key trench in the *in situ* weathered rock at the slope toe to provide the foundation and lateral restraint for the new construction.
- Preparation of a temporary benched cut in the *in situ* weathered rock across the slope to provide the base for the new construction.
- Reconstruction of the slope to a 1V:1.5H batter using select rock fill and assuming that the existing slope crest position is to be maintained. This proposed solution has the benefit of being relatively easy to construct with conventional earth moving equipment, and results in a free-draining slope which reduces the risk of pore water pressure build up and the potential instability associated with this condition.

Reconstruction of the slope to a 1V:1.5H batter is proposed using select coarse rock fill (< 500 mm size) and assuming that the existing slope crest position is to be maintained. This proposed solution has the benefit of being relatively easy to construct with conventional earth moving equipment, and results in a free-draining slope which reduces the risk of pore water pressure build up and the potential instability associated with this condition.

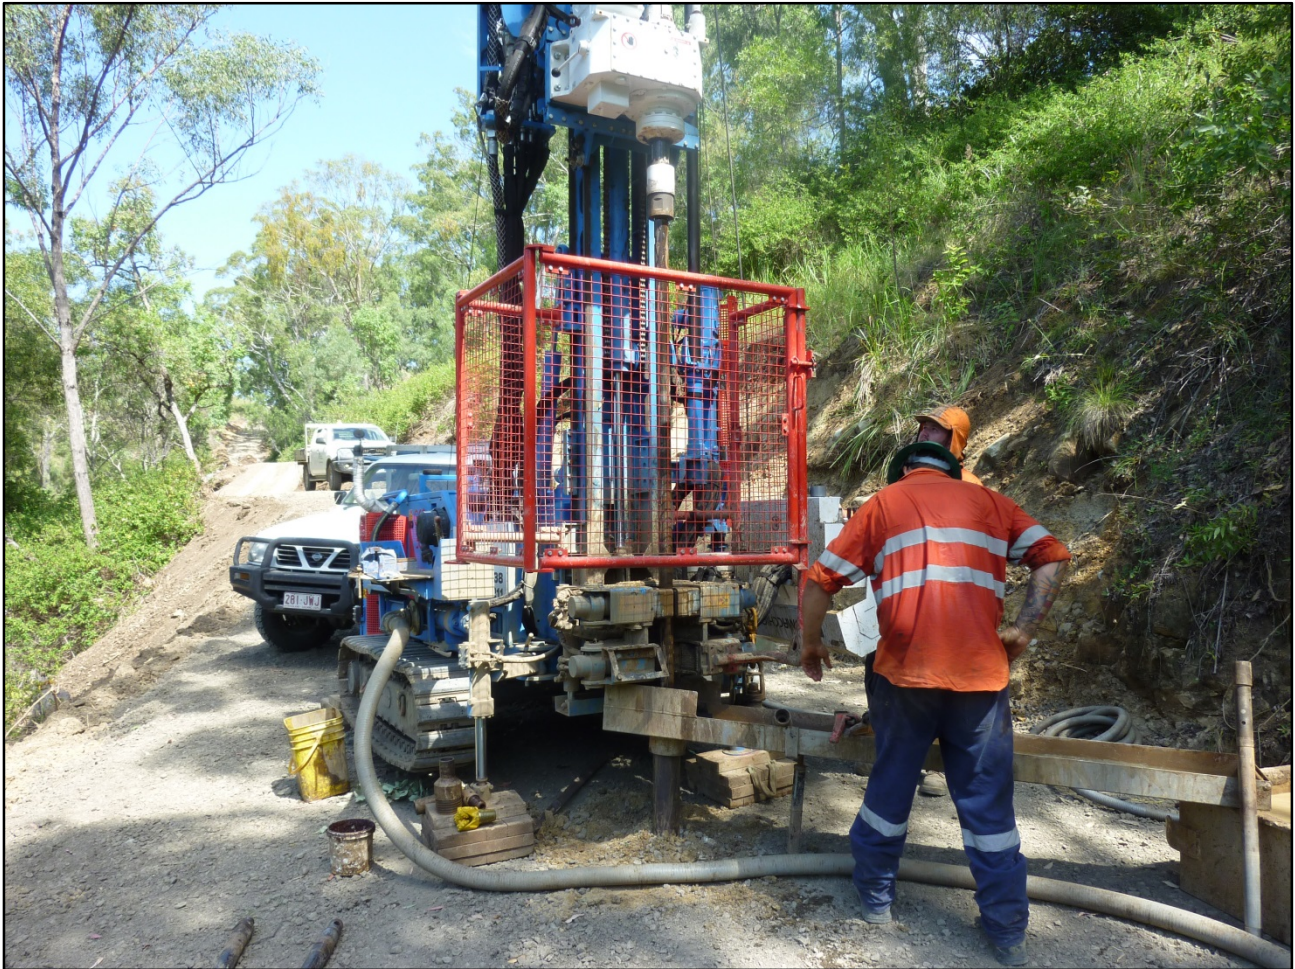
Photograph 3: View south-west showing the slope toe area, temporary access track and drilling at Borehole BH04.

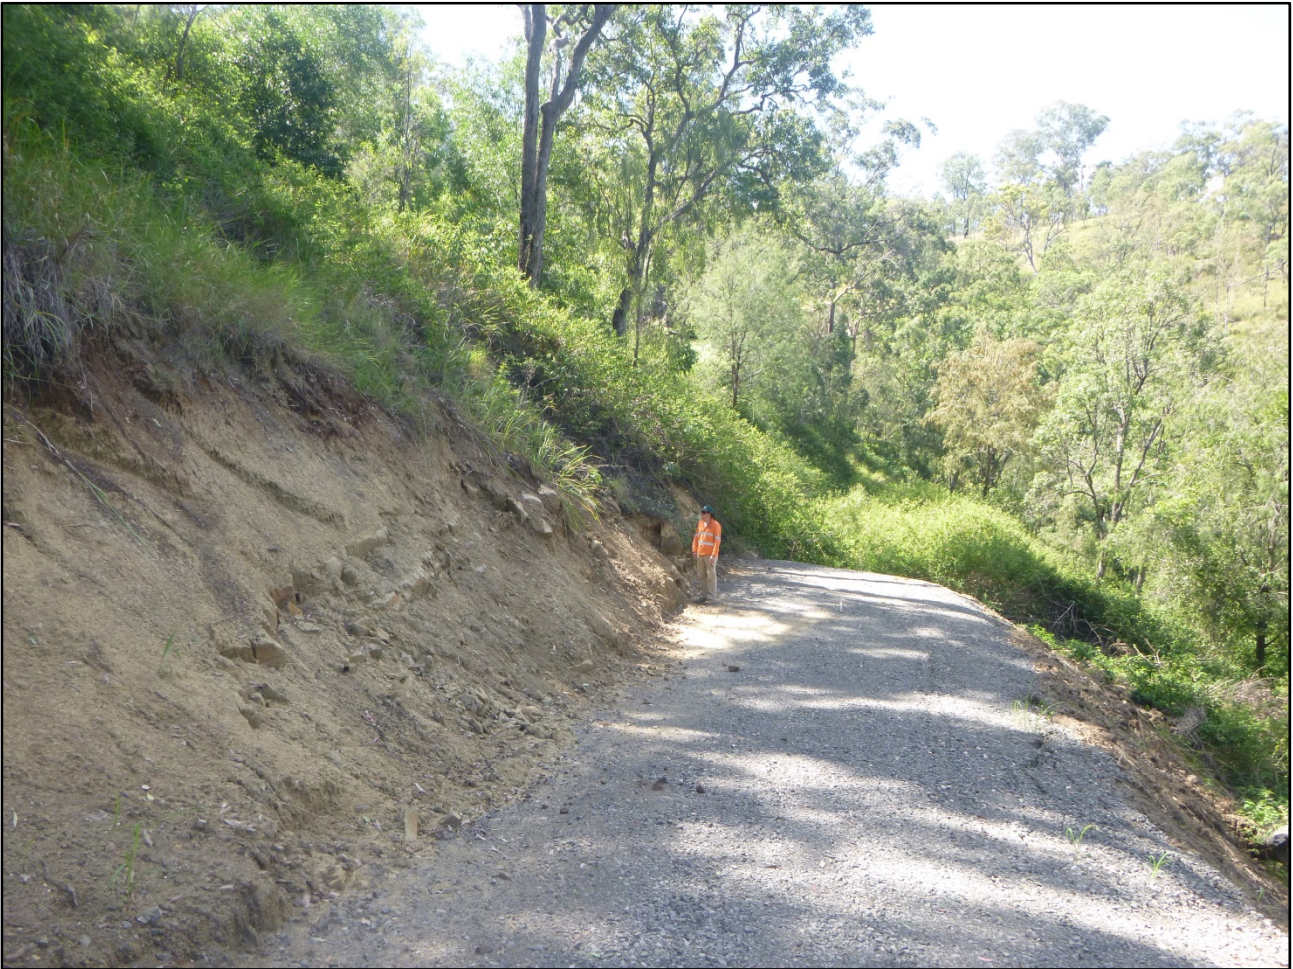
Construction of a temporary fill platform was required for drill rig access to progress Borehole BH04 and this required excavation of a 3 m high cut batter. The batter exposed *in situ*, extremely to distinctly weathered mudstone, with some interbedded sandstone layers up to 0.3 m thick. The rock bedding was measured as dipping less than or equal to 5° below horizontal in a general westerly direction. Two sets of sub-vertical jointing were observed, both dipping greater than or equal to 80° below horizontal in approximate north-north-westerly and north-easterly directions.

Photograph 4: View north-east showing the temporary access track at the location of Borehole BH04 and *in situ* extremely to distinctly weathered mudstone with interbedded sandstone layers exposed in the upslope cutting.

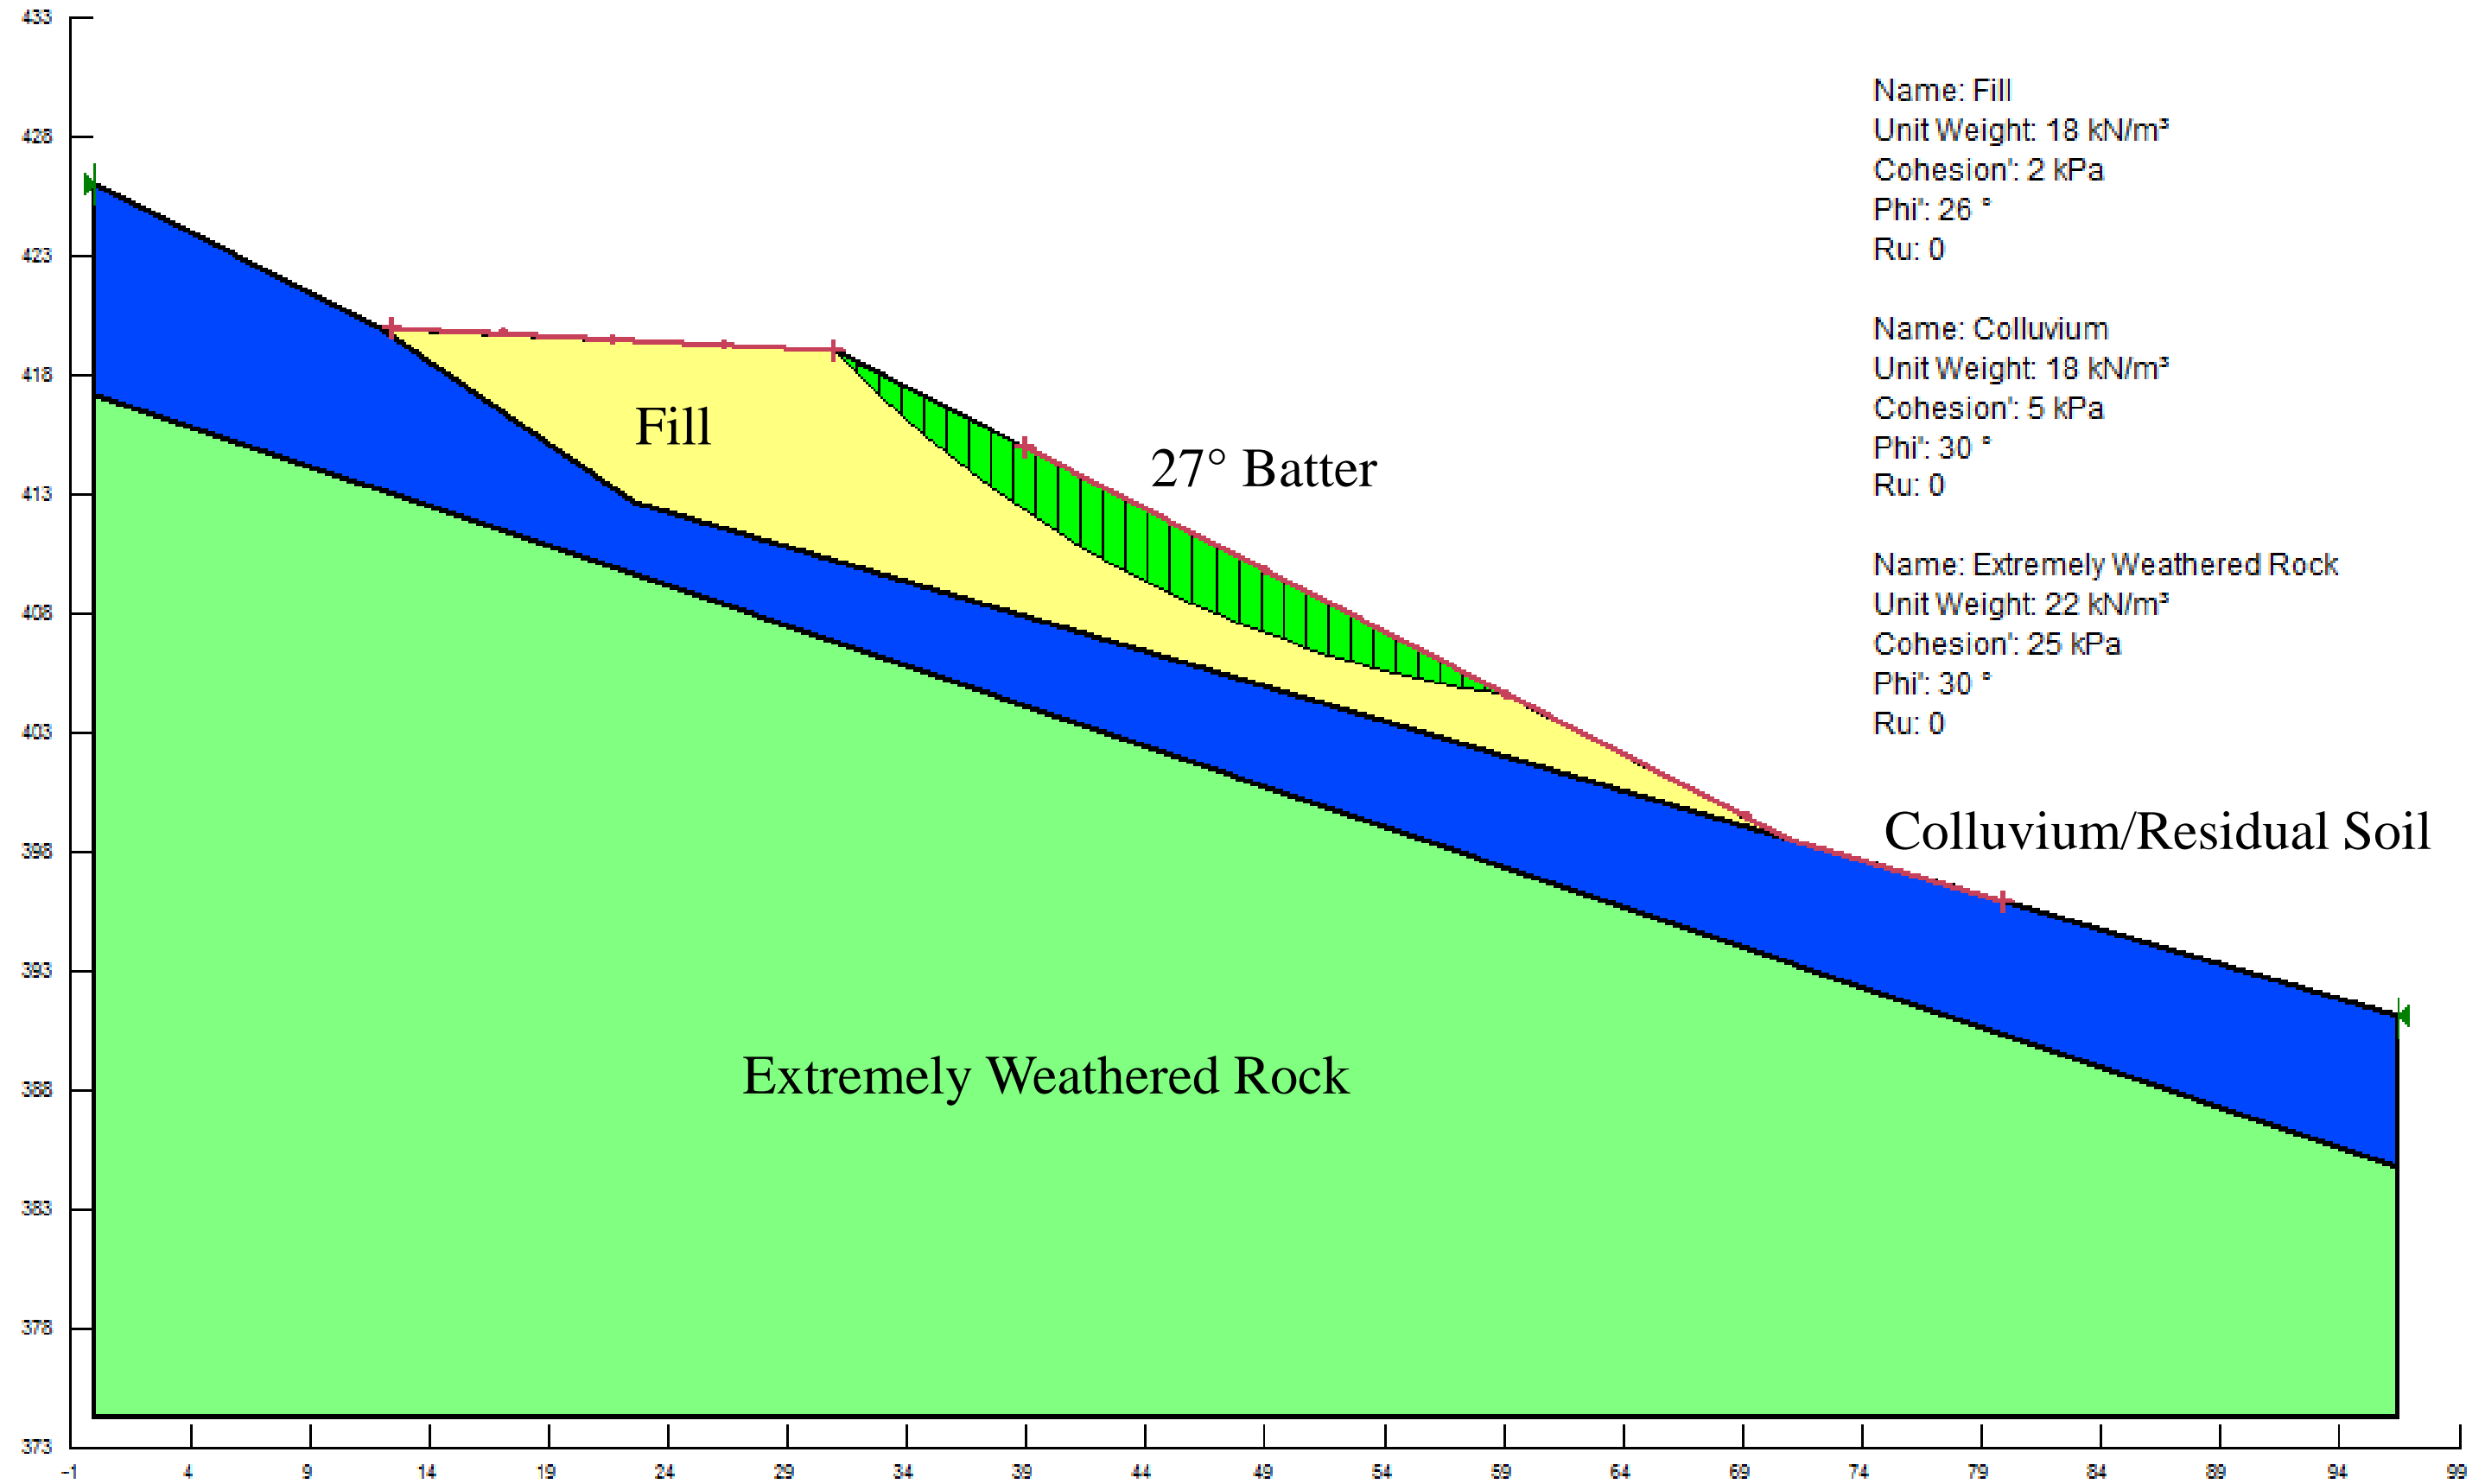
CLIENT Queensland Rail		PROJECT Toowoomba Range Railway – Ch 142.7 km		
	DRAWN SCF	DATE 29/04/2015	TITLE Slope Stability Analysis		
	CHECKED GR	DATE 29/04/2015	Inferred Initial Conditions, Dry		
	SCALE As Shown		PROJECT No 137632080-011	FIGURE No C-1	REV No 0

The results of the slope stability analysis including the adopted geological model and critical failure surface are presented on Figures C-1 and C-2 in **Appendix C**.

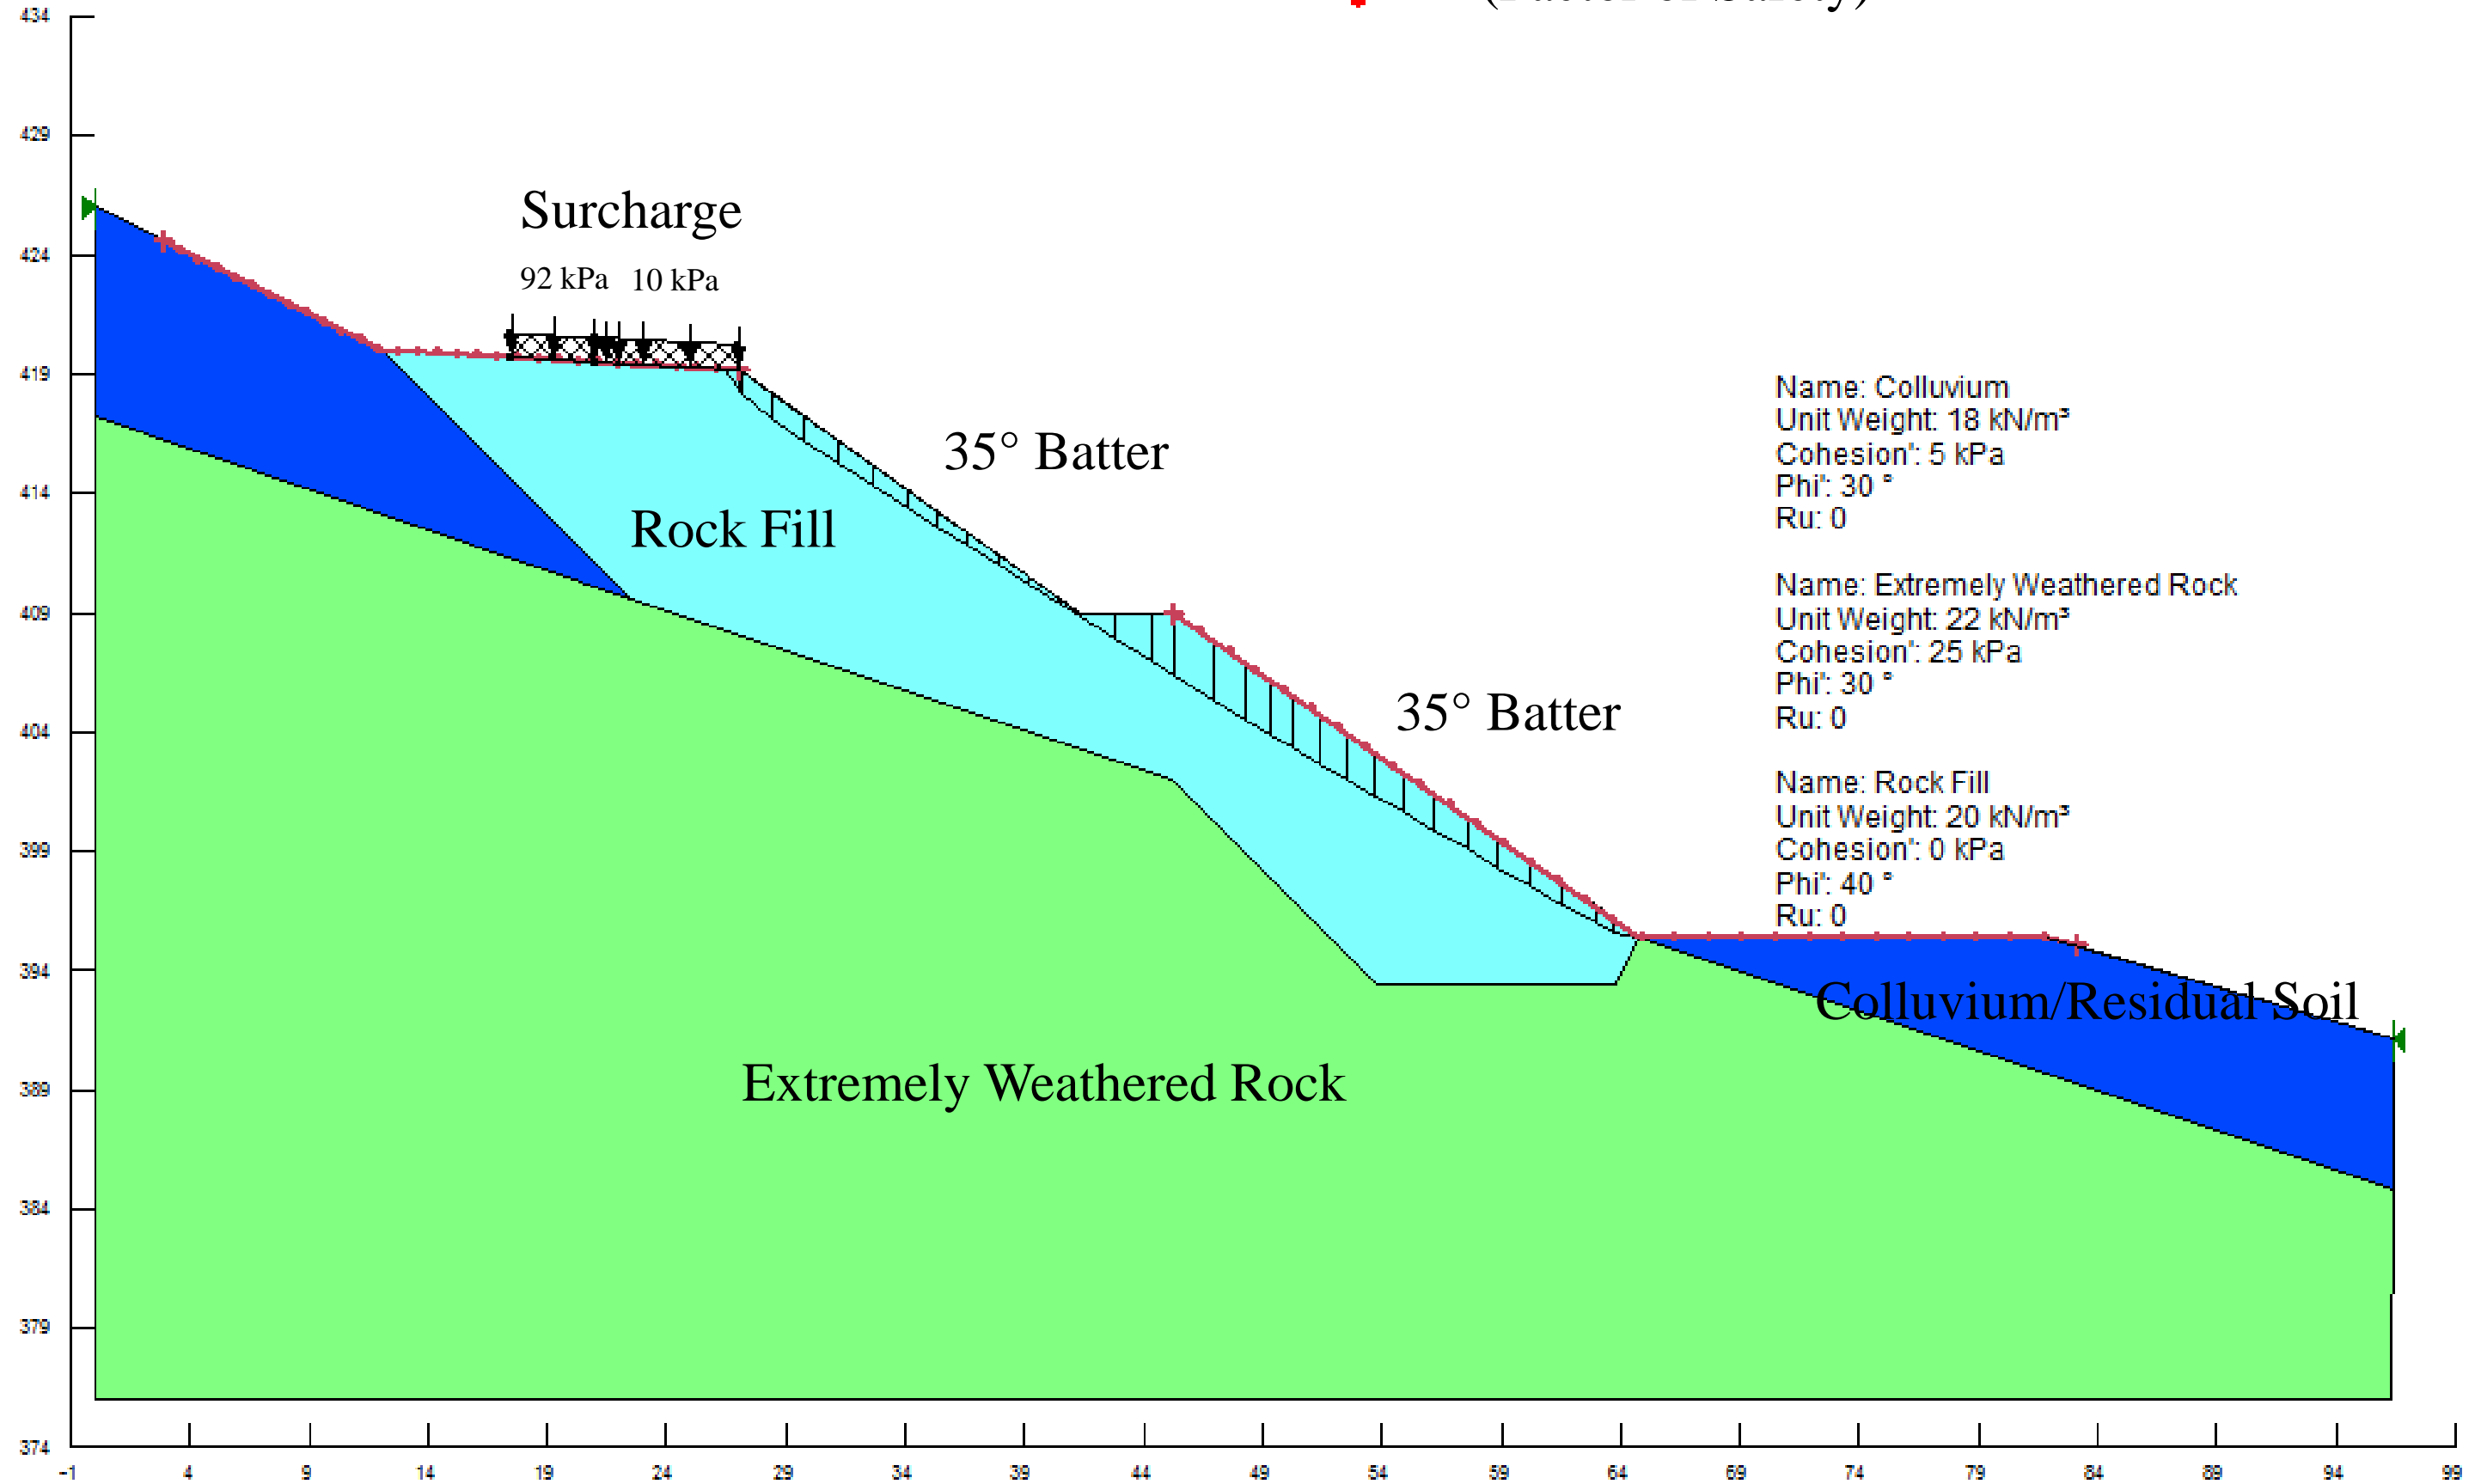
CLIENT Queensland Rail		PROJECT Toowoomba Range Railway – Ch 142.7 km		
	DRAWN SCF	DATE 29/04/2015	TITLE Slope Stability Analysis		
	CHECKED GR	DATE 29/04/2015	Rock Fill Remediation, c'=0, φ'=40		
	SCALE As Shown		PROJECT No 137632080-011	FIGURE No C-3	REV No 0

Further details of the slope stability analysis including the adopted geological model and critical failure surface are presented on Figures C-3 and C-4 in **Appendix C**.

With the introduction of a 4 m wide mid-slope bench the results indicate that a FoS of 1.36 could be achieved for a dry condition by modelling the rockfill with zero cohesion and a friction angle of 40°. Subsequently by modelling the rockfill with a small cohesion value of 2 kPa to simulate the interlocking and self-supporting nature of coarse rockfill, a FoS of 1.48 was obtained. This is considered to be a realistic simulation of what could be achieved using coarse rockfill to re-construct the slope utilising a mid-slope bench.

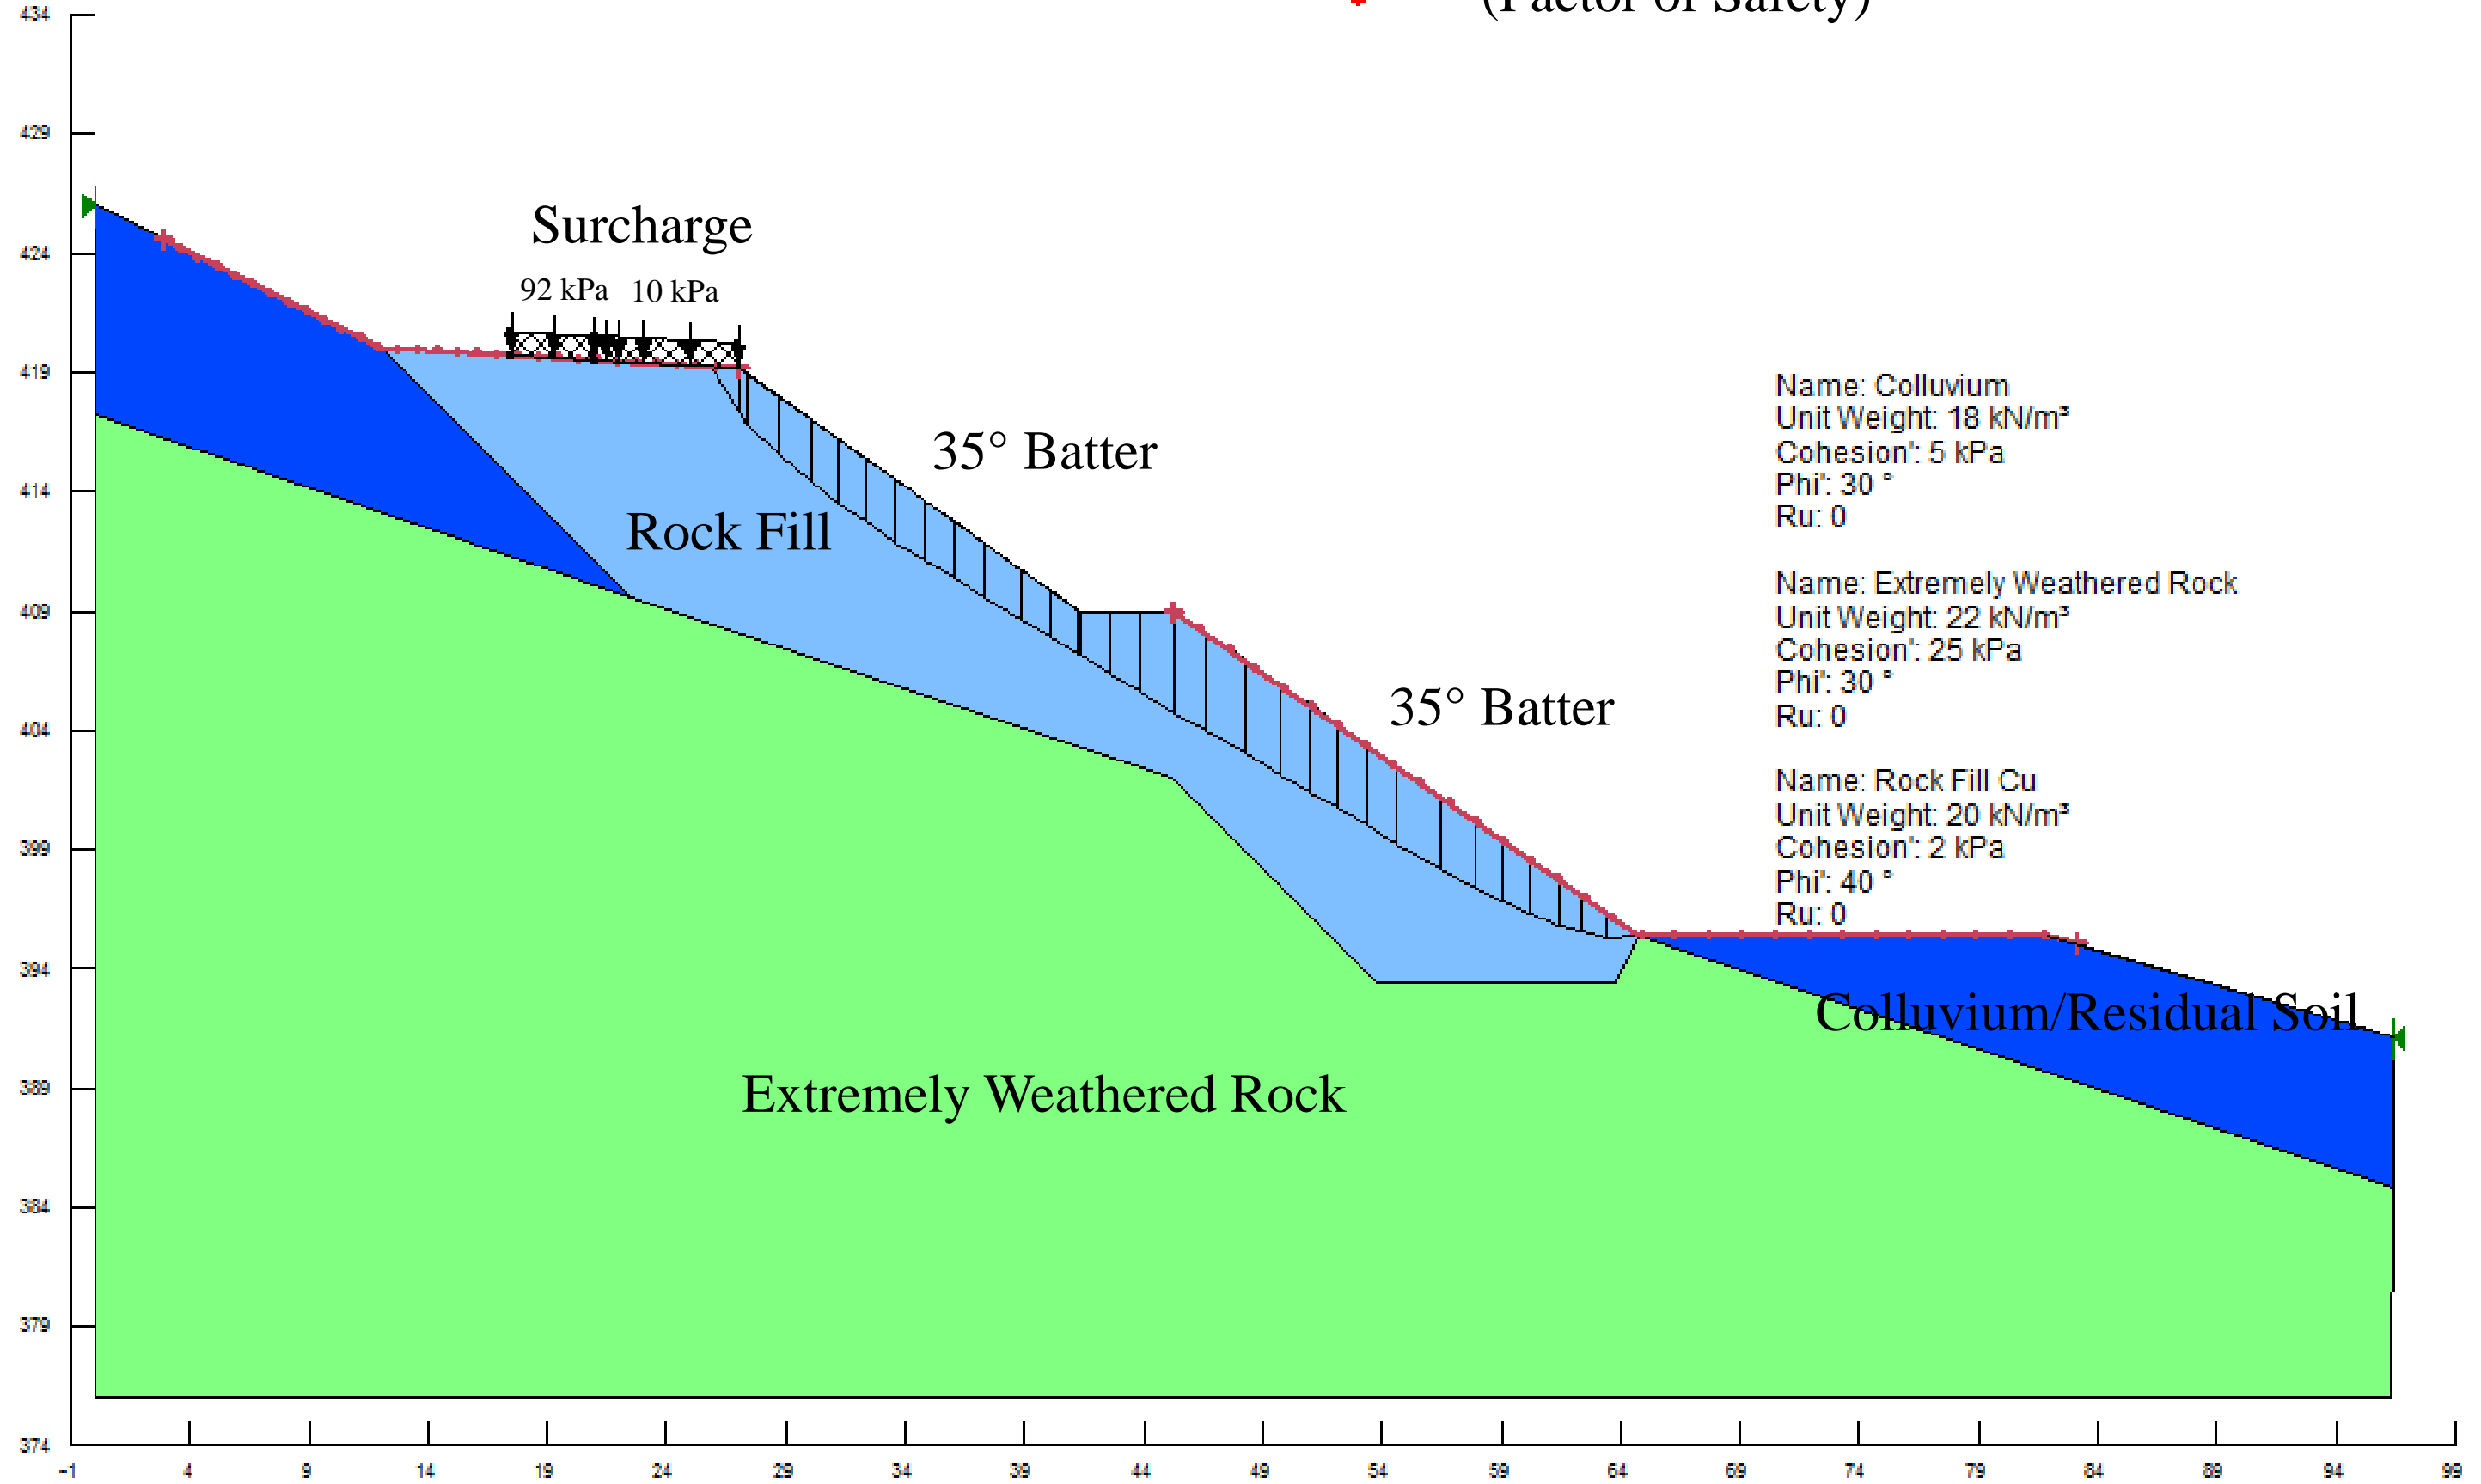
CLIENT Queensland Rail		PROJECT Toowoomba Range Railway – Ch 142.7 km		
	DRAWN SCF	DATE 29/04/2015	TITLE Slope Stability Analysis		
	CHECKED GR	DATE 29/04/2015	Rock Fill Remediation, c'=2, φ'=40		
	SCALE As Shown		PROJECT No 137632080-011	FIGURE No C-4	REV No 0

In the circumstances (existing earthworks on steep ground) a safety factor of 1.48 for dry conditions is considered satisfactory.
