**ATTACHMENT 5 – WorleyParsons Review of the West Moreton Reference Tariff
Capital and Maintenance Costs – Redacted**

West Moreton Reference Tariff Submission Review

WEST MORETON REFERENCE TARIFF SUBMISSION REVIEW

PROJECT 301001-01731 - AU1

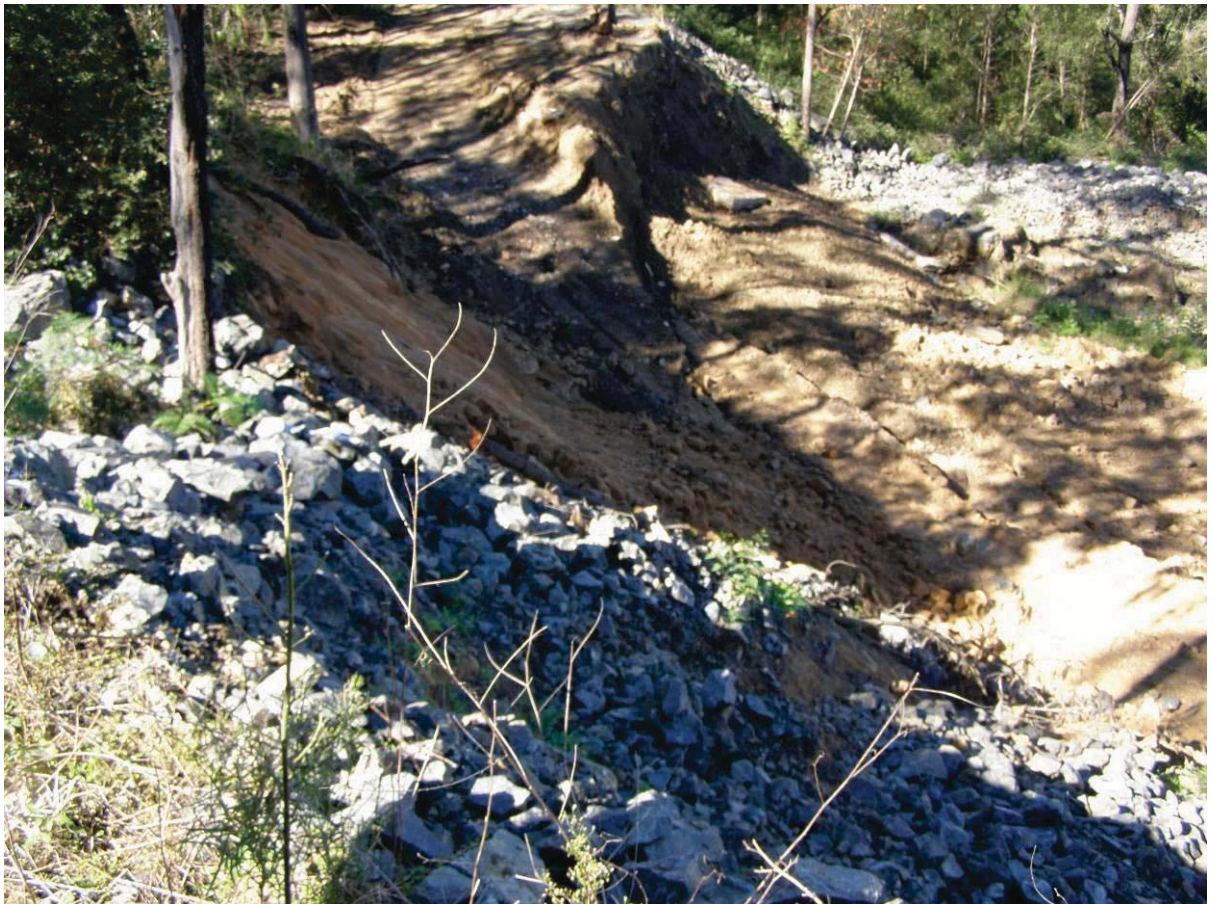
With increases in traffic and modern track maintenance practices, it was necessary to widen the formation some 20 years ago to provide road access for maintenance and emergencies. It appears that this widening may not have been installed and compacted to modern earthworks, hydrological and hydraulic standards (for example the effects of climate change and increased inclement weather events experienced in the last decade may not have been forecasted or considered) and hence during the recent extreme rainfall events in December 2011 and January 2013, water cascading from higher reaches has caused major slippages in several locations. Subsidence of the access road and cracking indicating face movement of embankments has also occurred.

Figure 2 - Slip of face of access road embankment at 142.5 km ML

Queensland Rail have made known the cost of the repair works that have been carried out to date, and it is evident that major sites have been repaired for between \$1M and \$2.5M. Also spreadsheets have been seen which define much work still to be done. Priorities are listed as 2 and 3, but locations such as the major cracking at 144.6 km ML are a concern that they may fail at any time.

Golders are at present reviewing the defects on the range, and it is expected that these studies will define a number of works which should be attended to soon.

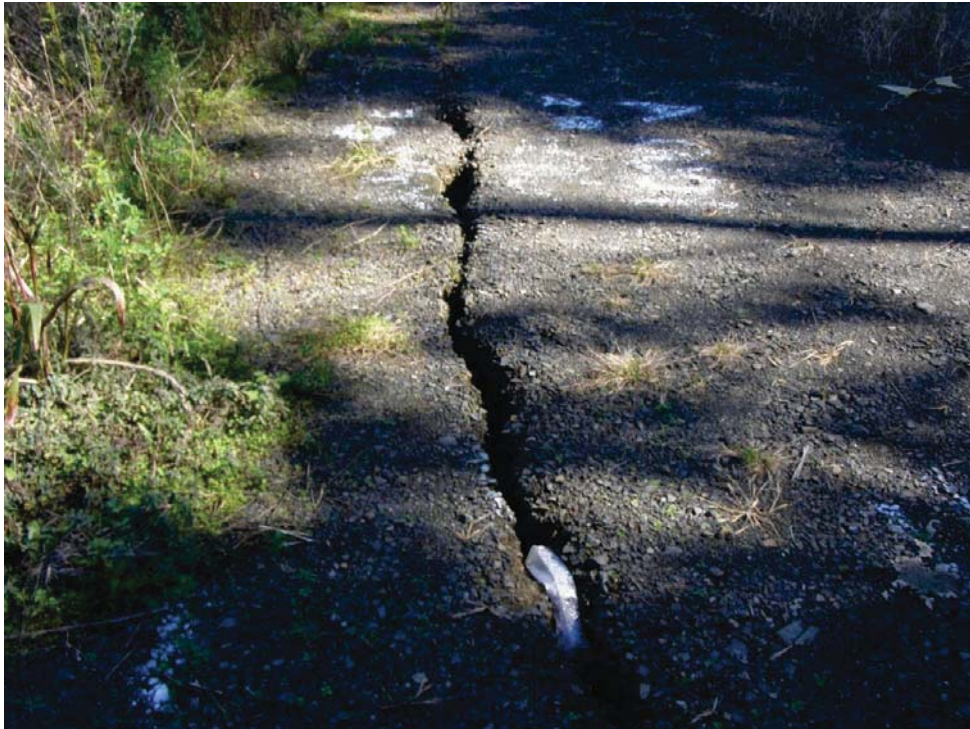
Figure 3 - Cracking on edge of access road at 144.6 km ML

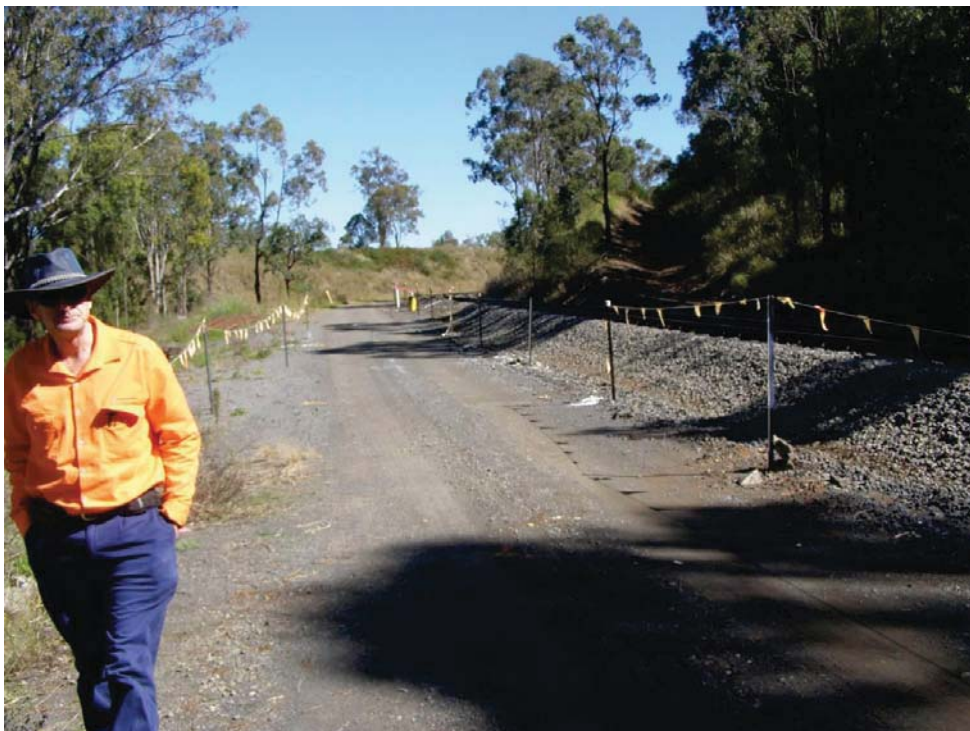
Figure 4 - Slump in access road from white post to foreground 142.5 km ML

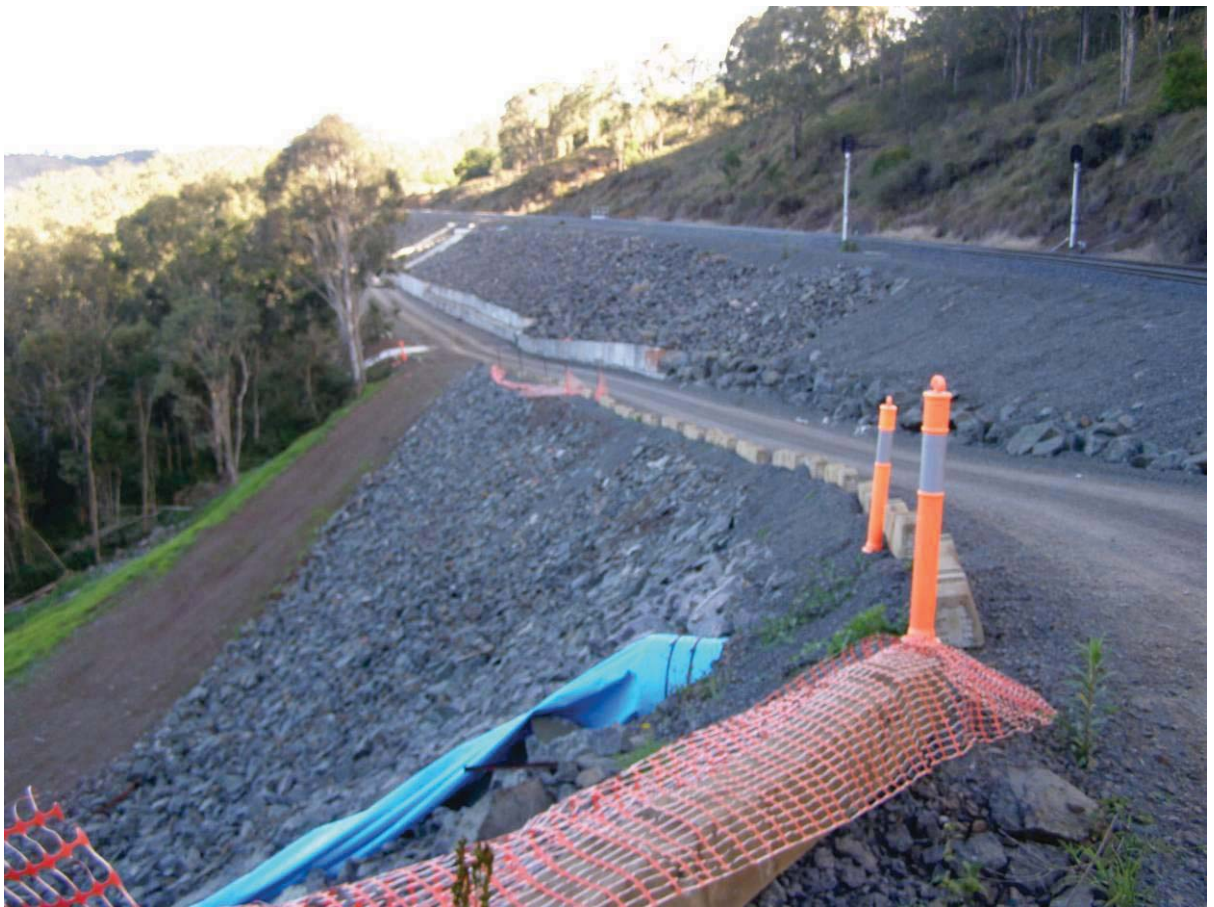
Following the 2011 events, Queensland Rail have been receiving advice from Golders, a reputable geotechnical consultant, and major repair works have been completed, particularly at Rangeview and Ballard. This damage required closure of the track for a period of about three months.

Figure 5 - Washout rectification at Rangeview 155 km ML

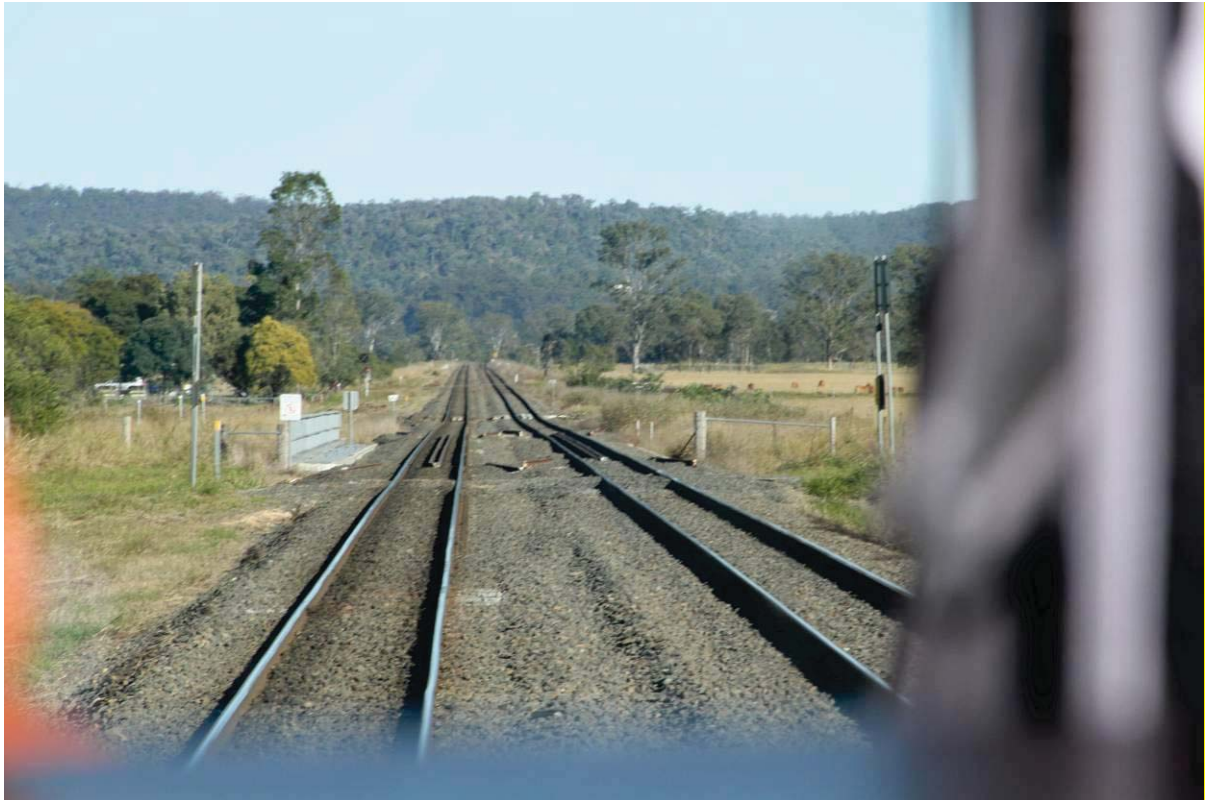
The flood opening at 111.380 km WL was not inspected, but the opening at 113.190 km which was examined is understood to be similar. This consists of two concrete piers to formation level with a short steel span of the order of a metre in length. The dip in the track top was quite evident.

Figure 6 - Dip in Rail Track

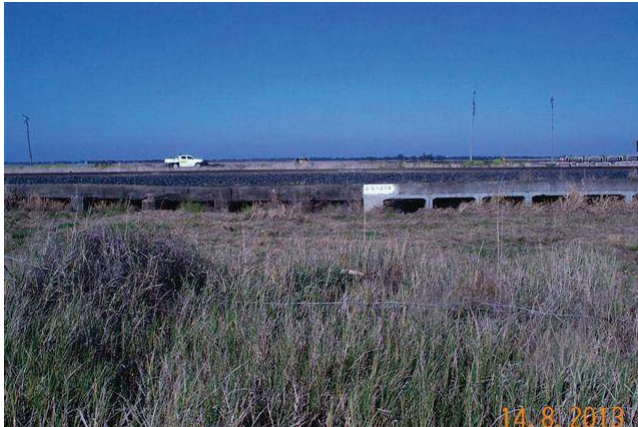
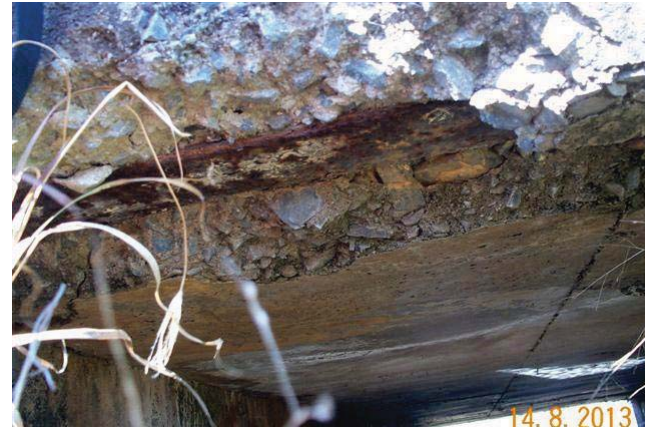
Figure 7 - Culvert at 55.270 km WL

This item proposes the replacement of badly deteriorated and/or life expired existing reinforced concrete box culvert drains because of reported calcium chloride attack.

A selection of nine (in total) culverts were submitted for review, some with suspected calcium chloride attack. WorleyParsons inspected two of the culverts (60.140 km ML and 63.901 km WL) during the site inspection and were provided with photographs of the extent of damage on the other seven culverts. One of the culverts at 55.270 WL (see Figure 7 & 8) is significantly deteriorated and although this damage would not be specifically due to calcium chloride attack the damage is similar, with large sections of the culvert spalling and a significant area of reinforcement being exposed.

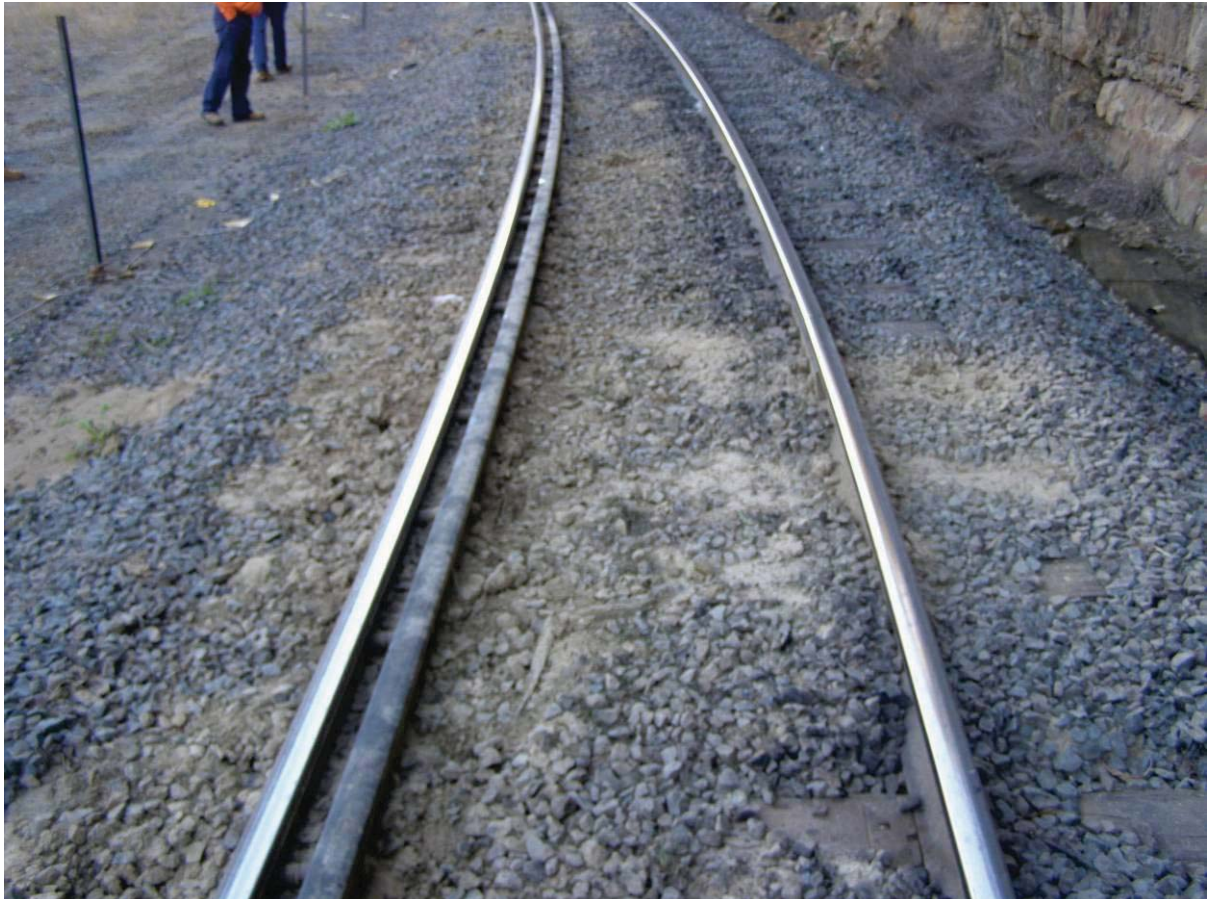
These curves were examined during the inspection, and after three months of the trial, no maintenance attention has been required. Assuming this continues to the end of the six months, Queensland Rail proposes to progressively expand the application over the next five years.

Figure 9 - Existing curve with check rail (and mudhole)

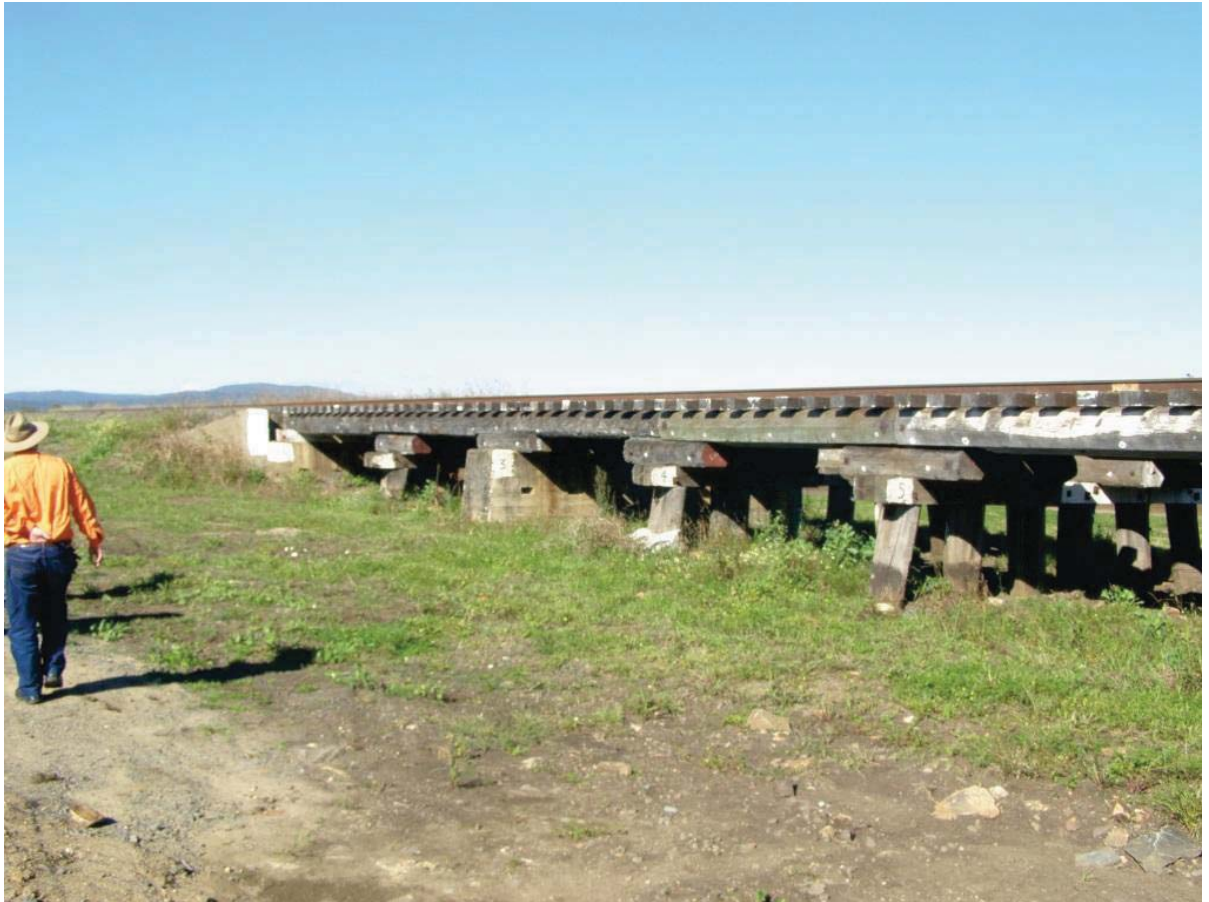
Figure 10 - Typical timber bridge (83.190 km ML)

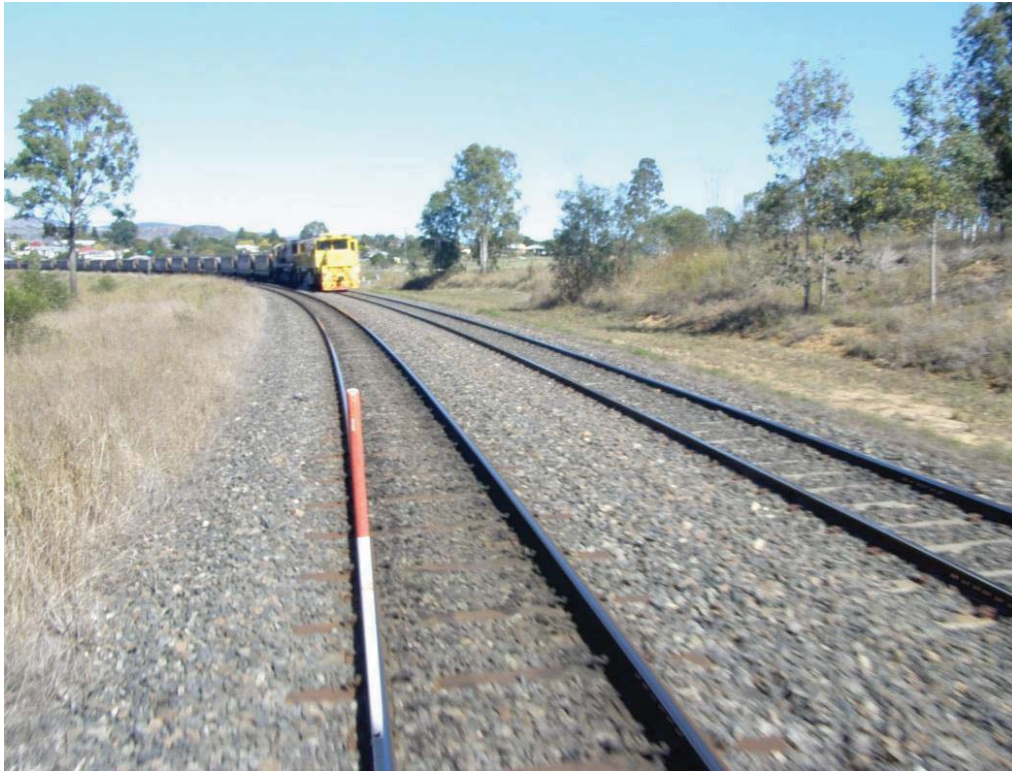
Figure 11 - Typ. 41 rail, steel & timber sleepers, plated joint, pumping

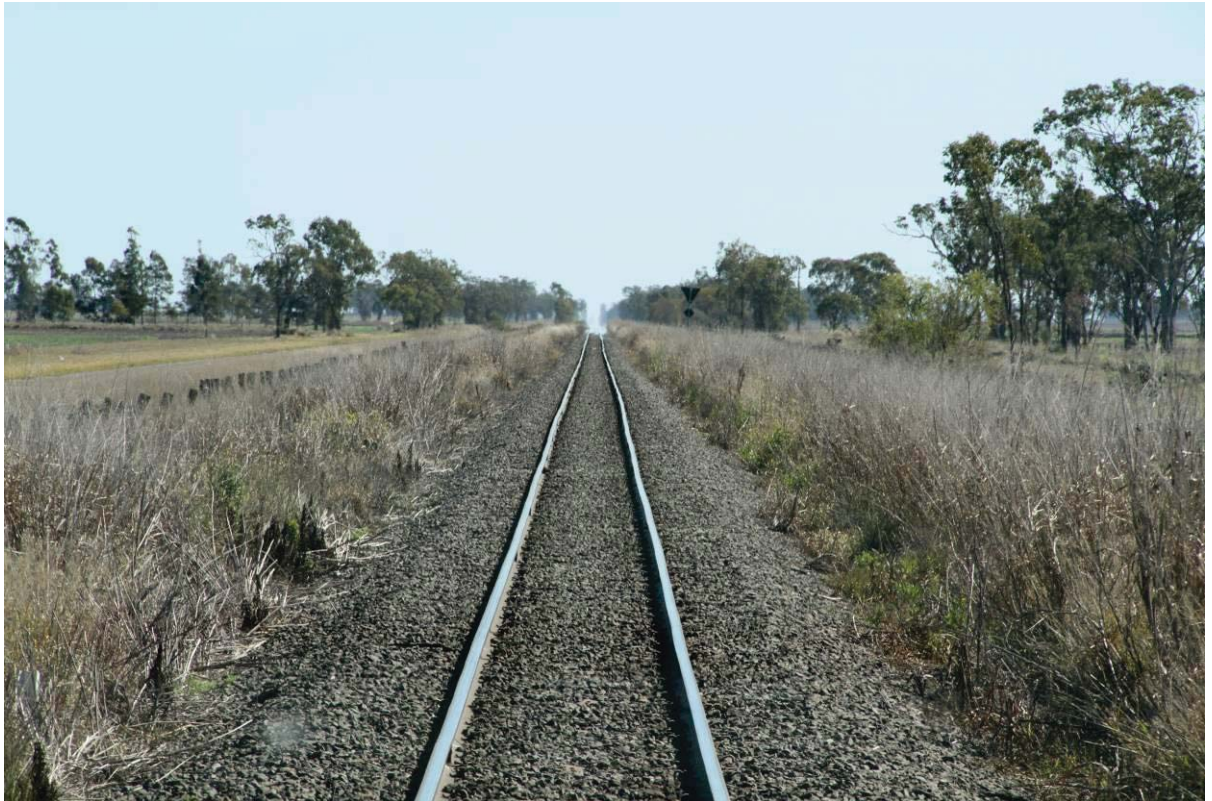
Figure 13 - Typical Top & Line problems west of Toowoomba

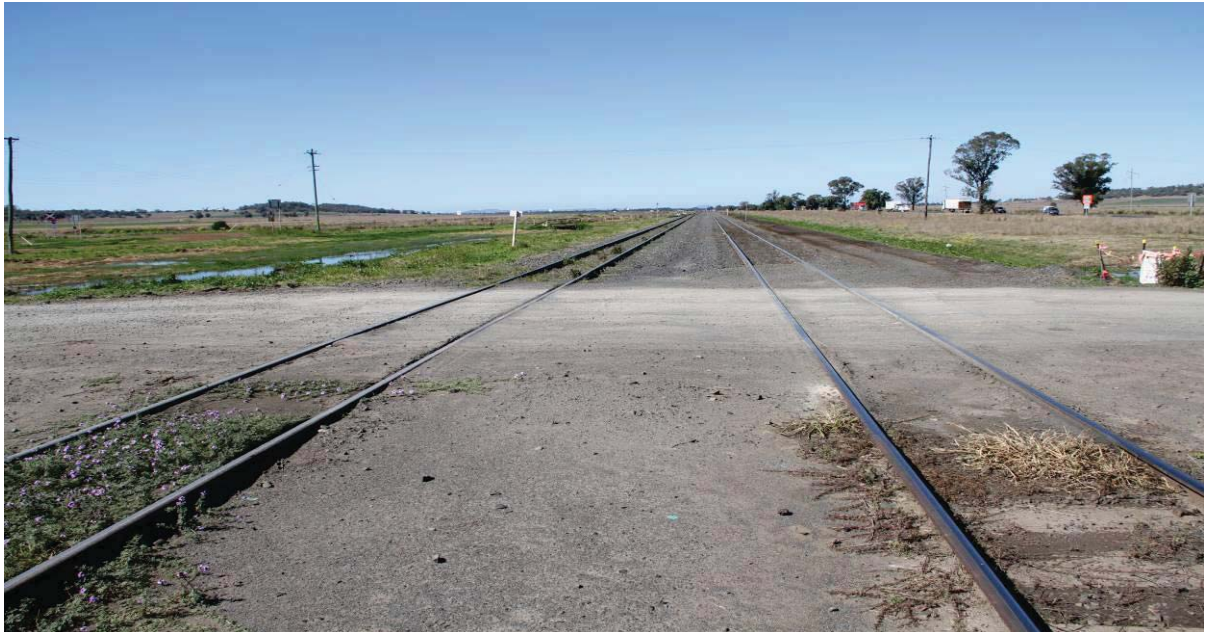
Figure 14 - Open level crossing Malu 48.760 km WL

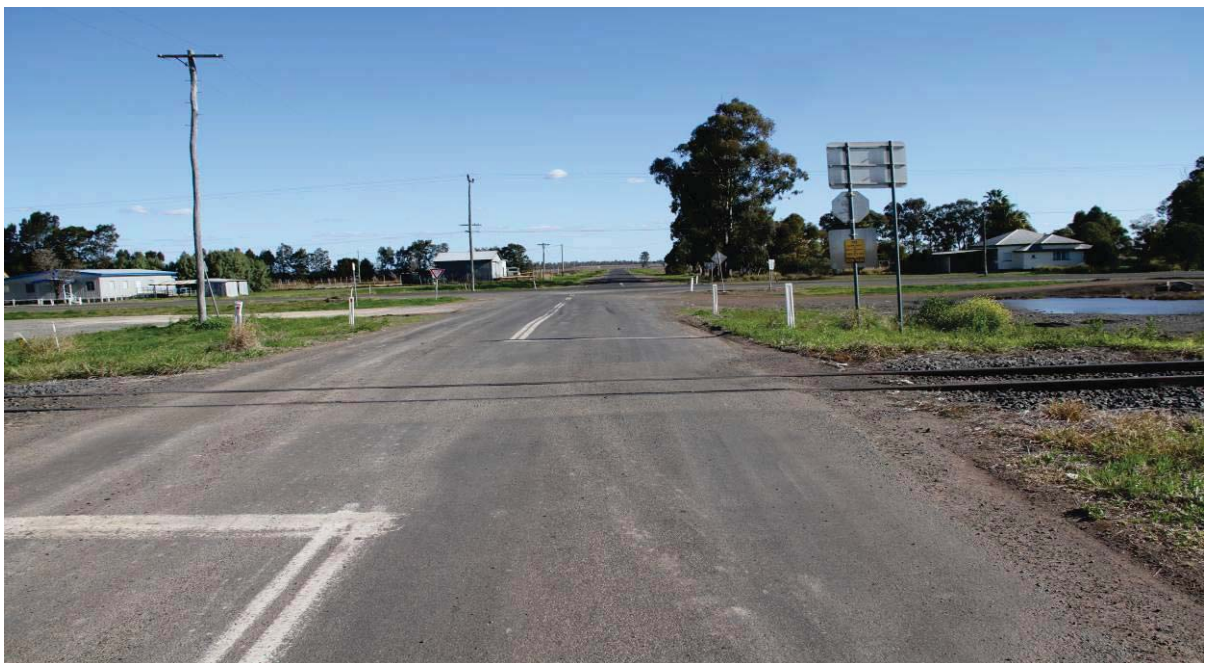
Figure 15 - Open level crossing Macalister 107.700 km WL

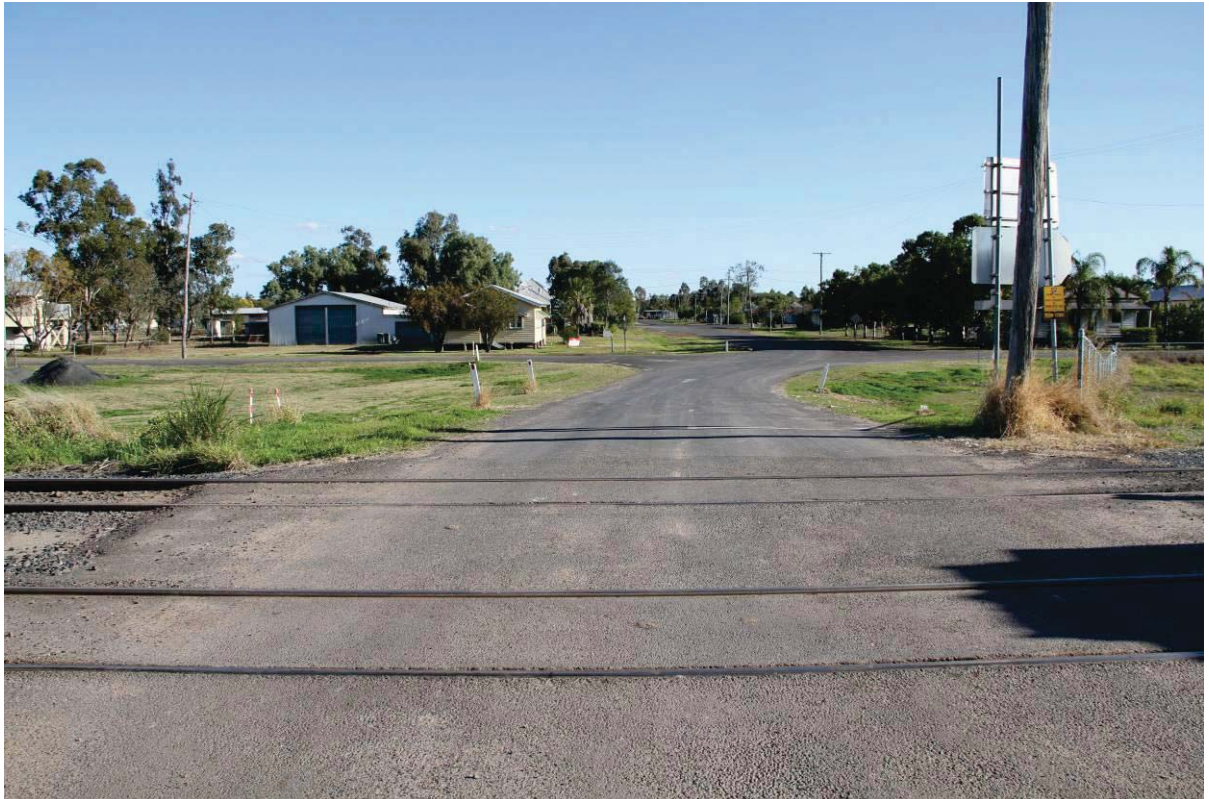
Figure 16 - Open level crossing Warra 127.741 WL

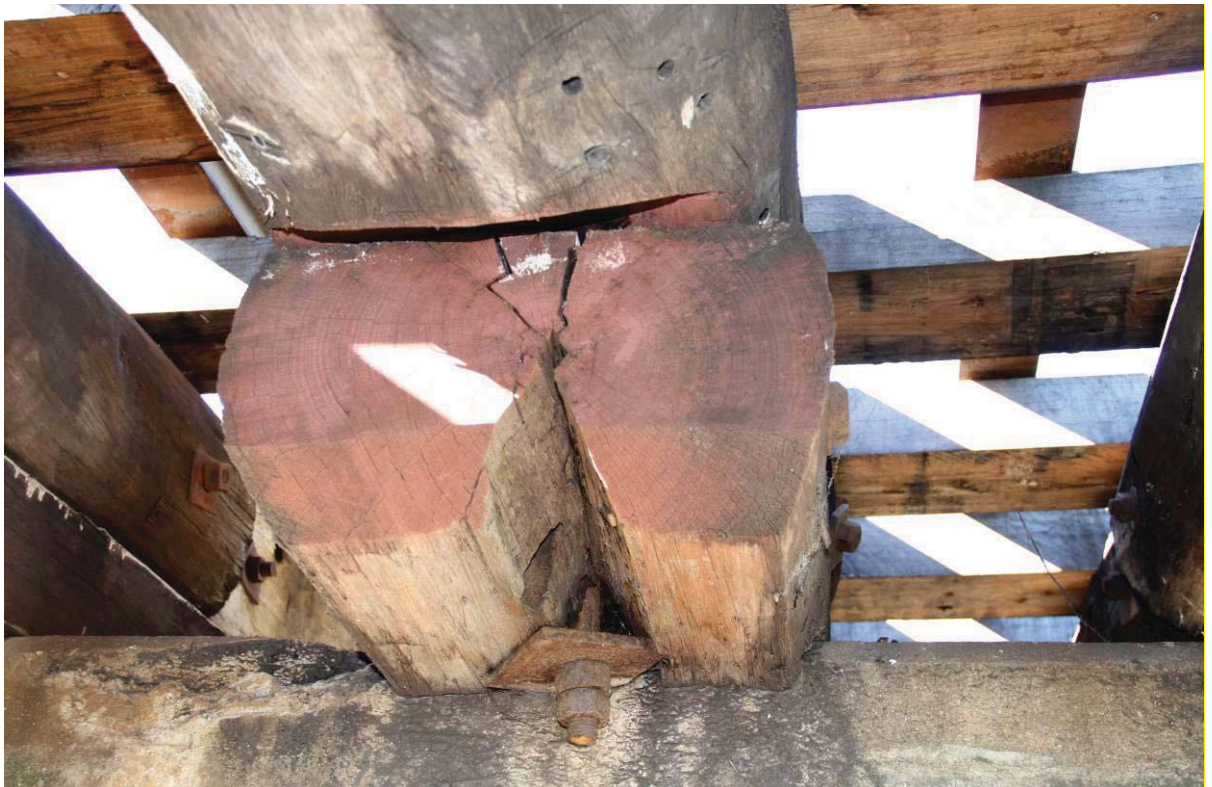
Figure 19 - Defective timbers marked for reparation

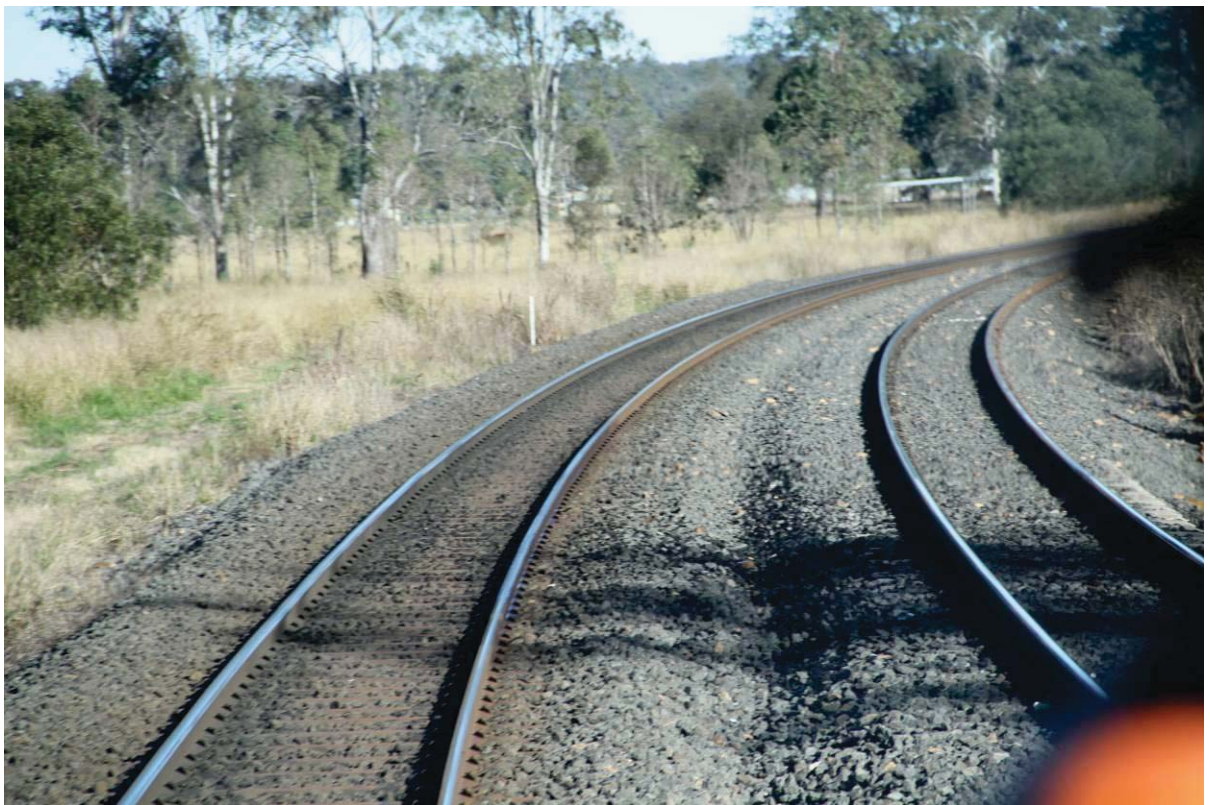
Apart from a 10 metre length of severe track wear at the level crossing adjacent to Rosewood station, the Down track from Helidon was in reasonable condition. The Up track with 110 metre length LWR and fishplated joints evidenced many dipped and battered fishplate joints and welds.

Figure 20 - Typical track structure Rosewood to Helidon

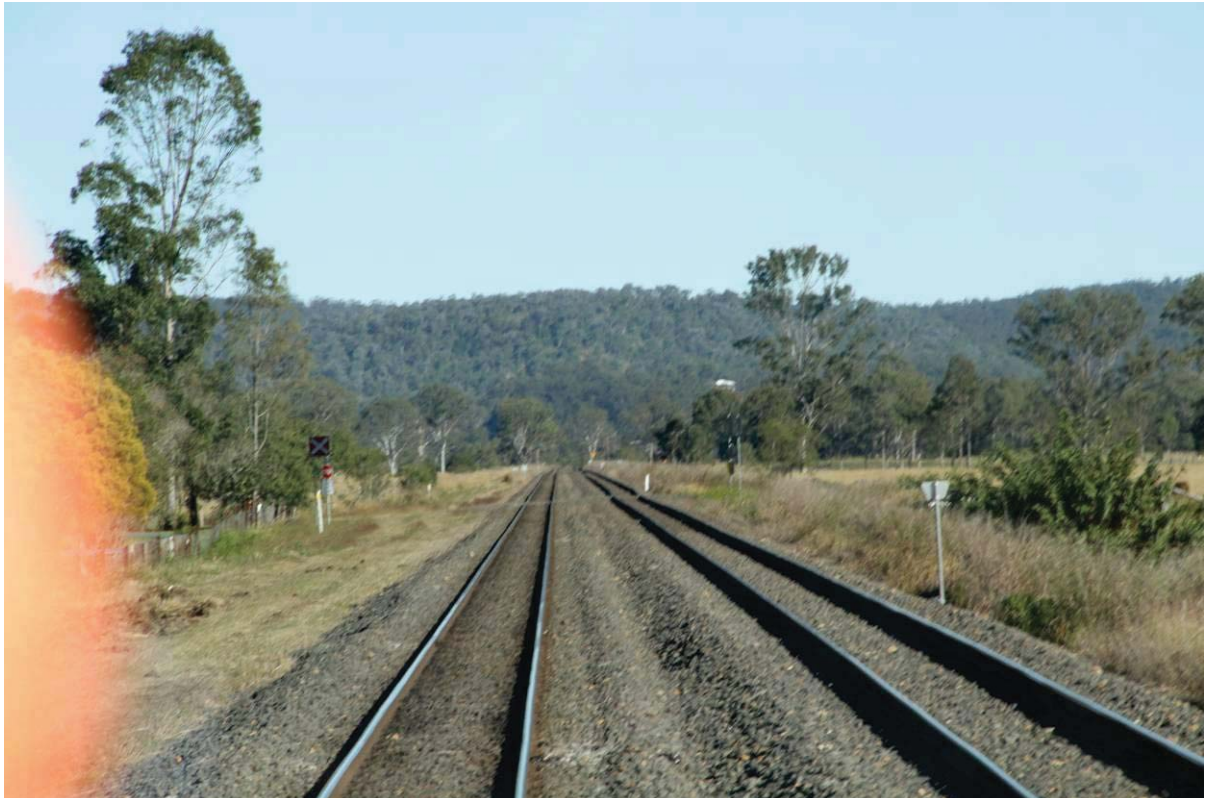
Rail on the Up line mainly consisted of 41kg/m rail on steel interspersed with timber sleepers and generally appeared to be in reasonable condition.

Figure 21 - Top and line fair

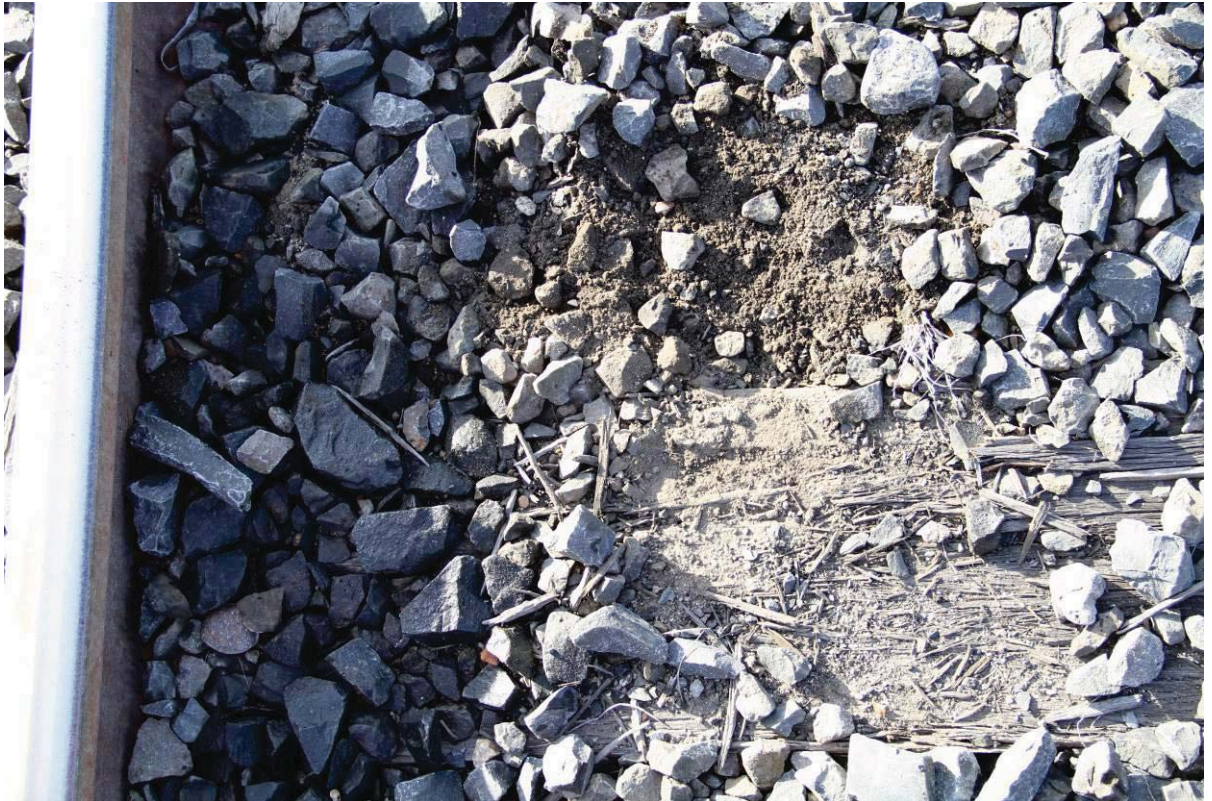
Some deterioration was noted in timber sleepers; however sleepers were generally in fair condition for the level of service required.

Figure 23 - Deterioration of Timber Sleepers and ballast contamination

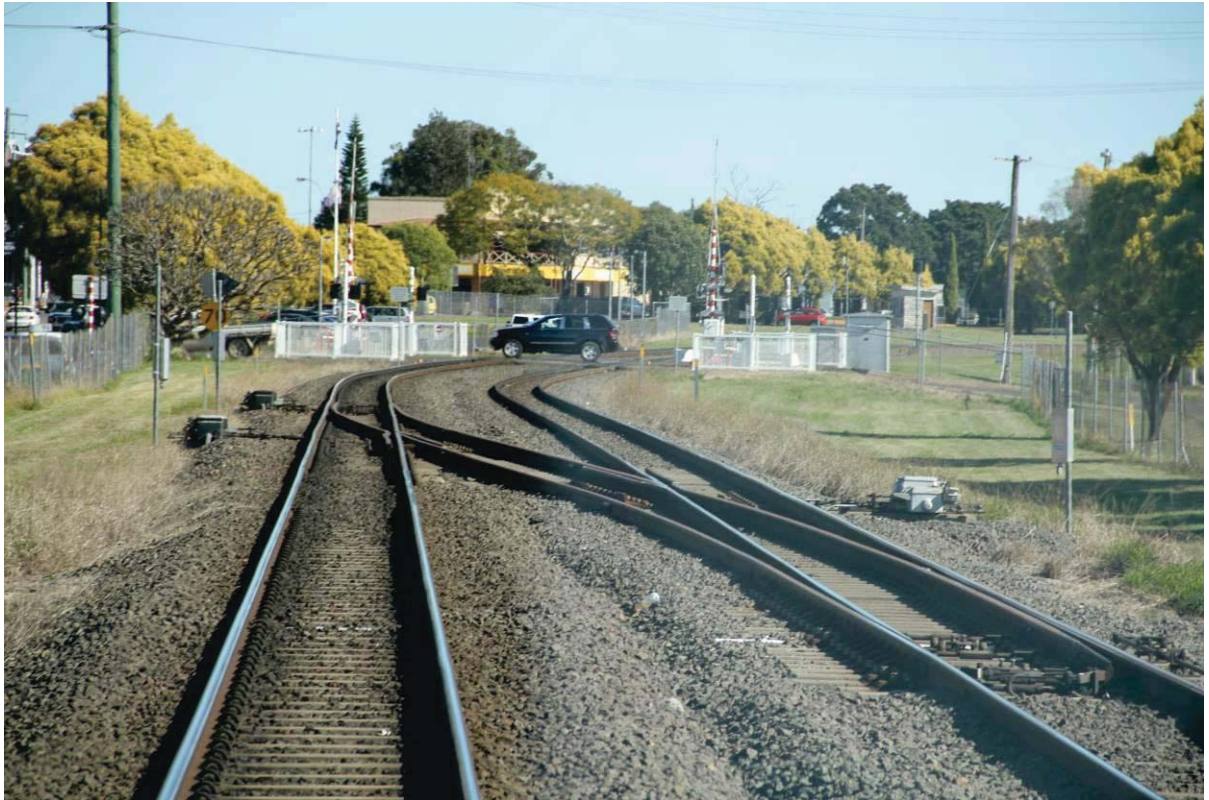
Figure 24 - Typical Turnout Conditions

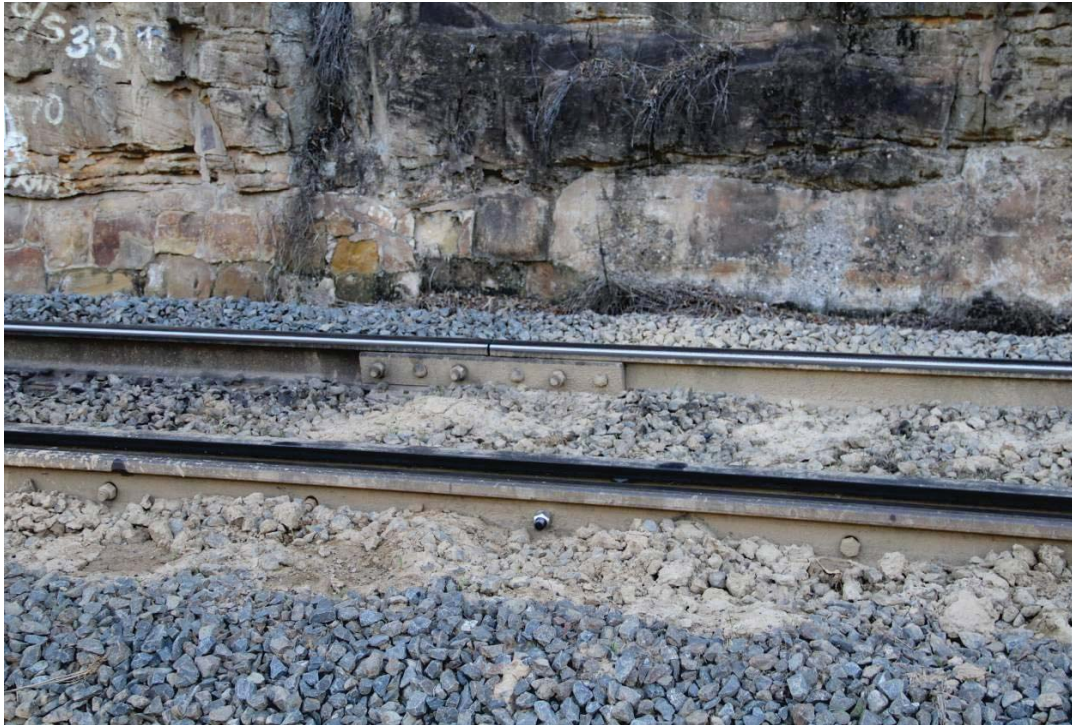
Figure 27 - Typical mudhole and evidence of bolts snapping at checkrail

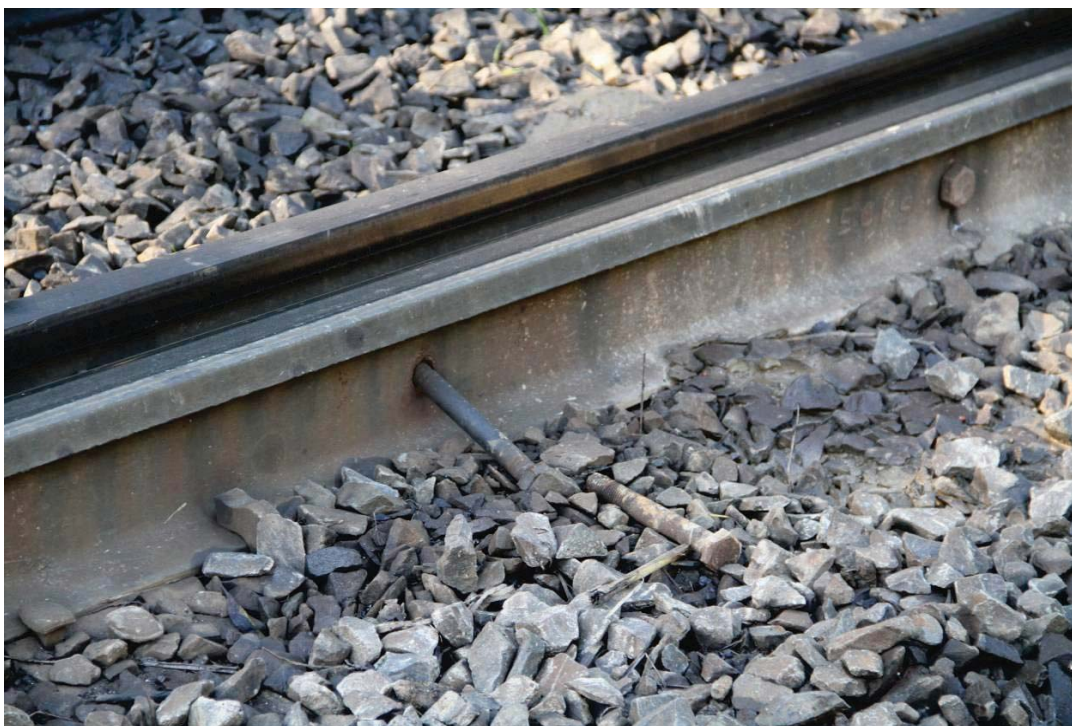
Figure 28 - Bolts protruding/snapping at checkrails

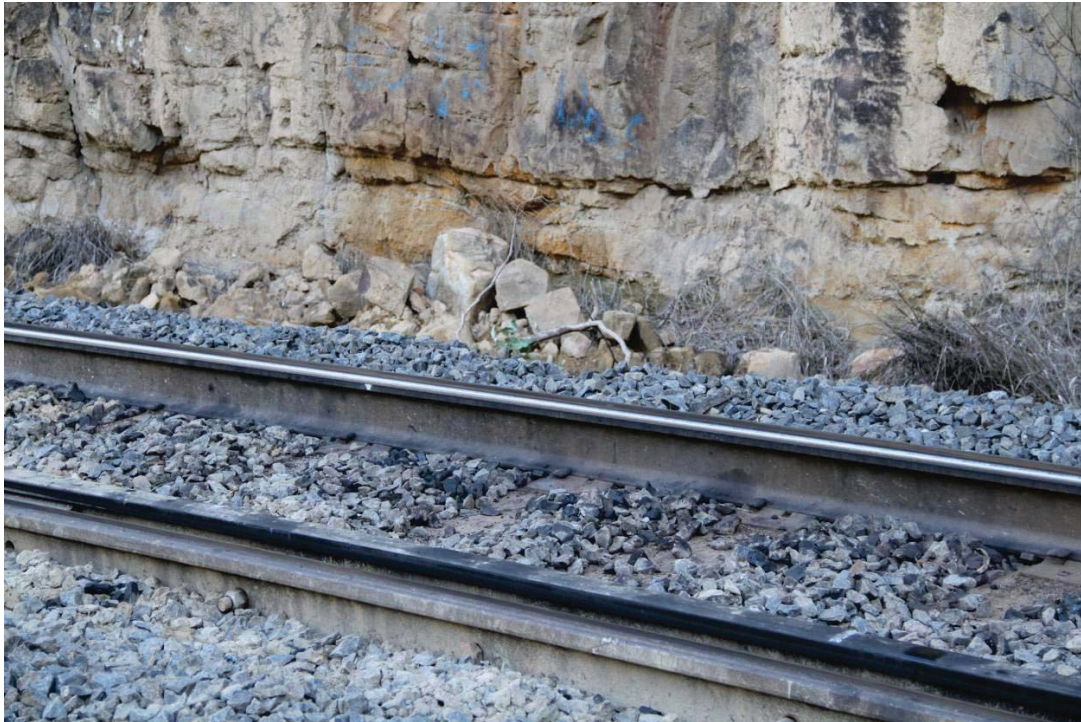
Figure 29 - Contaminated ballast

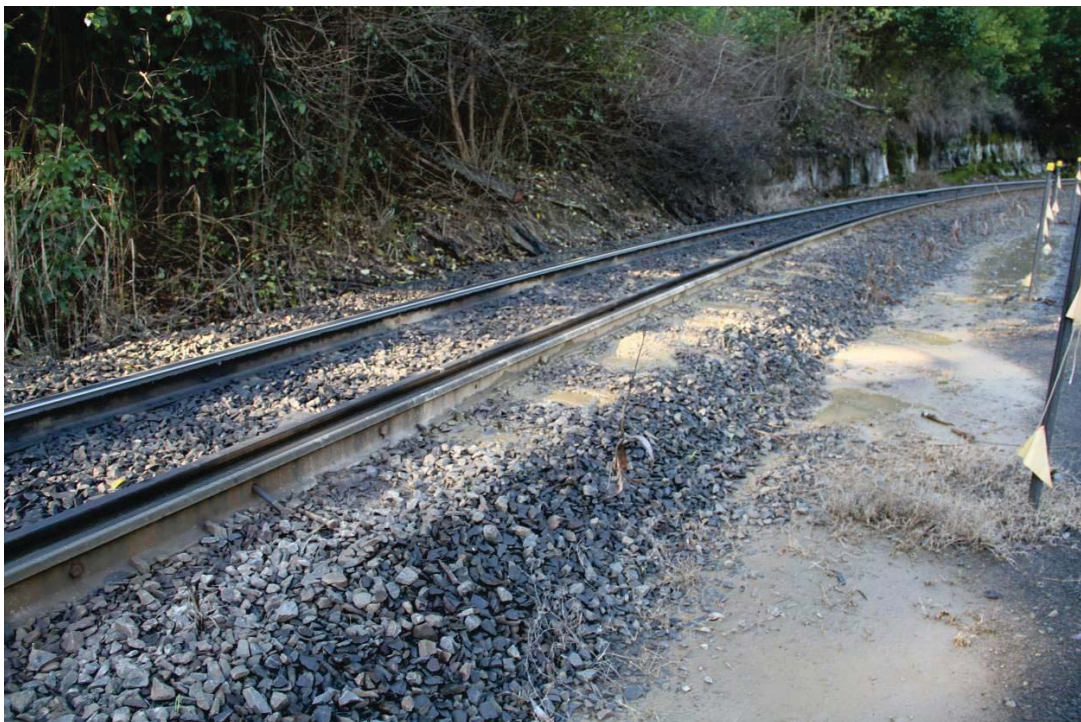
Figure 30 - Contaminated ballast and poor drainage causing pooling adjacent to track

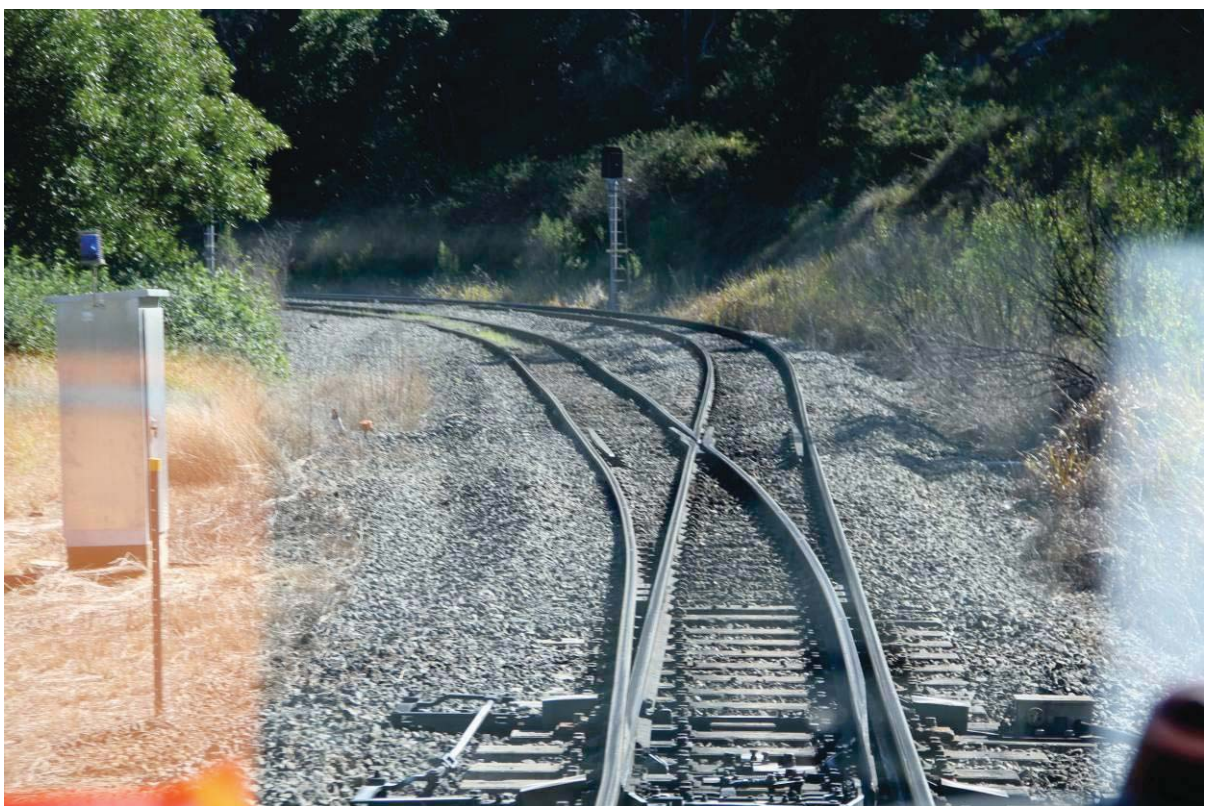
Turnouts at the six stations in the range territory are all modern designs with RBM frogs and all were observed to be in reasonable condition.

Figure 31 - Typical turnout

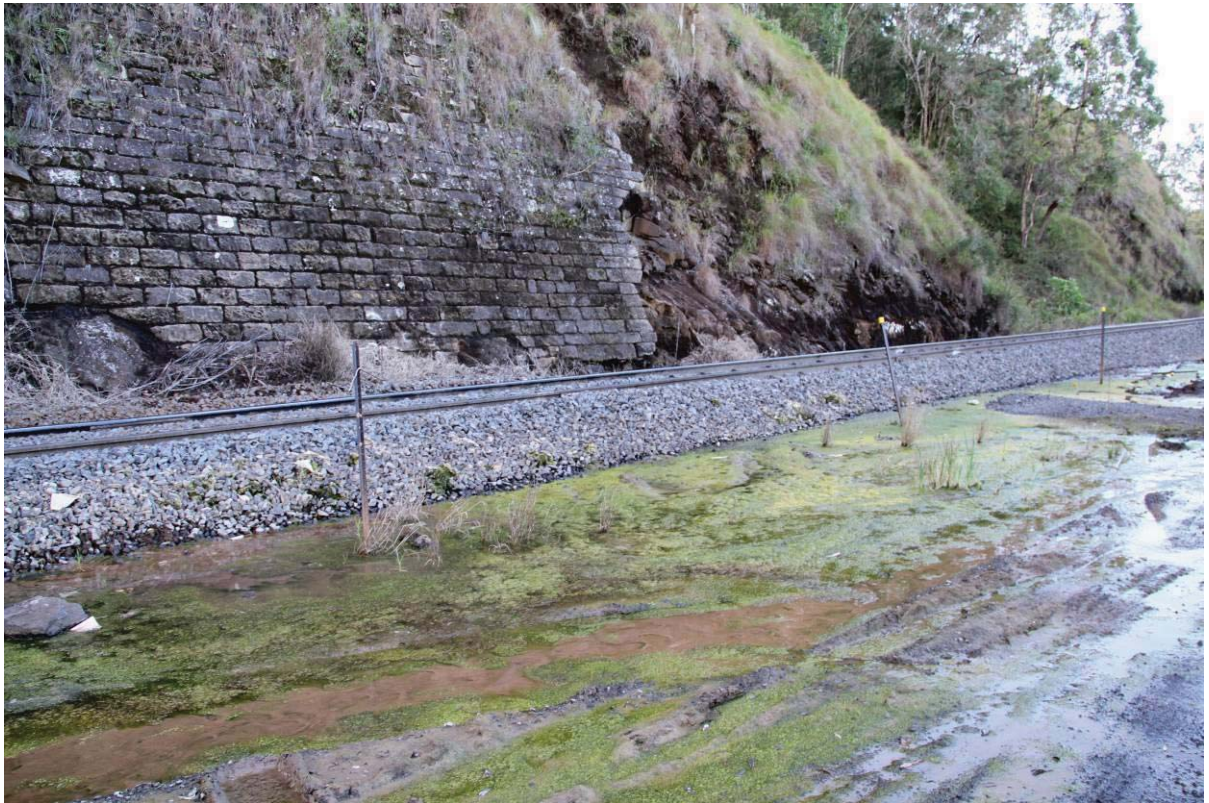
Figure 32 - An example of pooling adjacent to track
