**ATTACHMENT 5 – WorleyParsons Review of the West Moreton Reference Tariff
Capital and Maintenance Costs – Redacted**

West Moreton Reference Tariff Submission Review

WEST MORETON REFERENCE TARIFF SUBMISSION REVIEW

PROJECT 301001-01731 - AU1

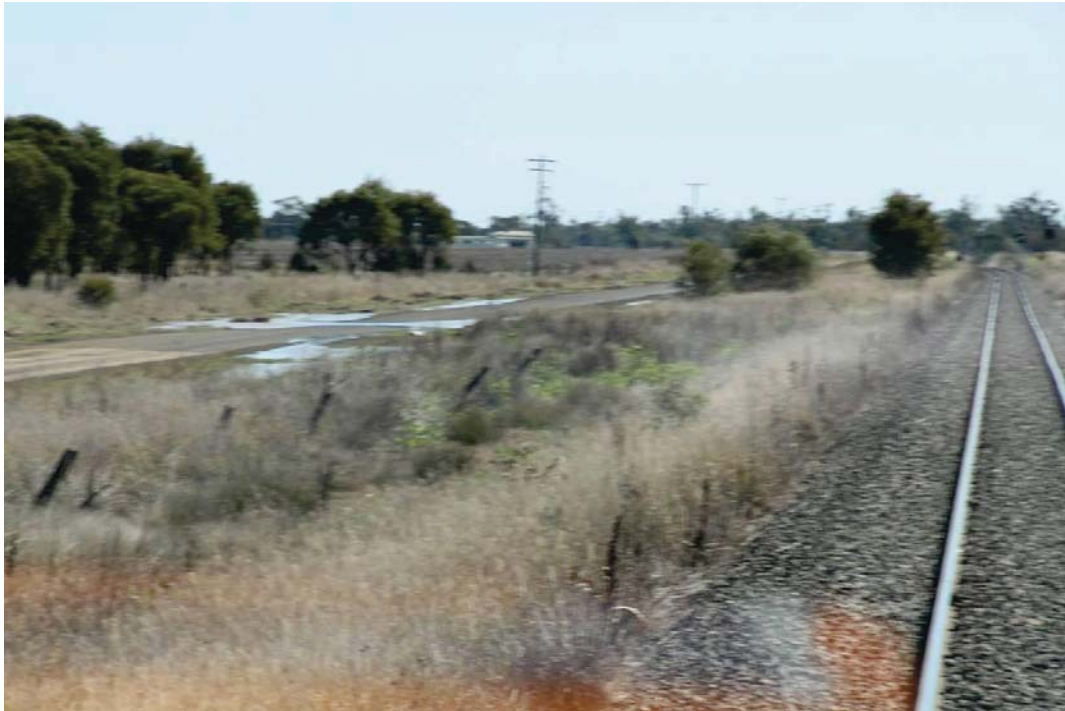
Figure 33 - Much of the adjacent highway was still flooded despite rains having stopped over 24 hours previously

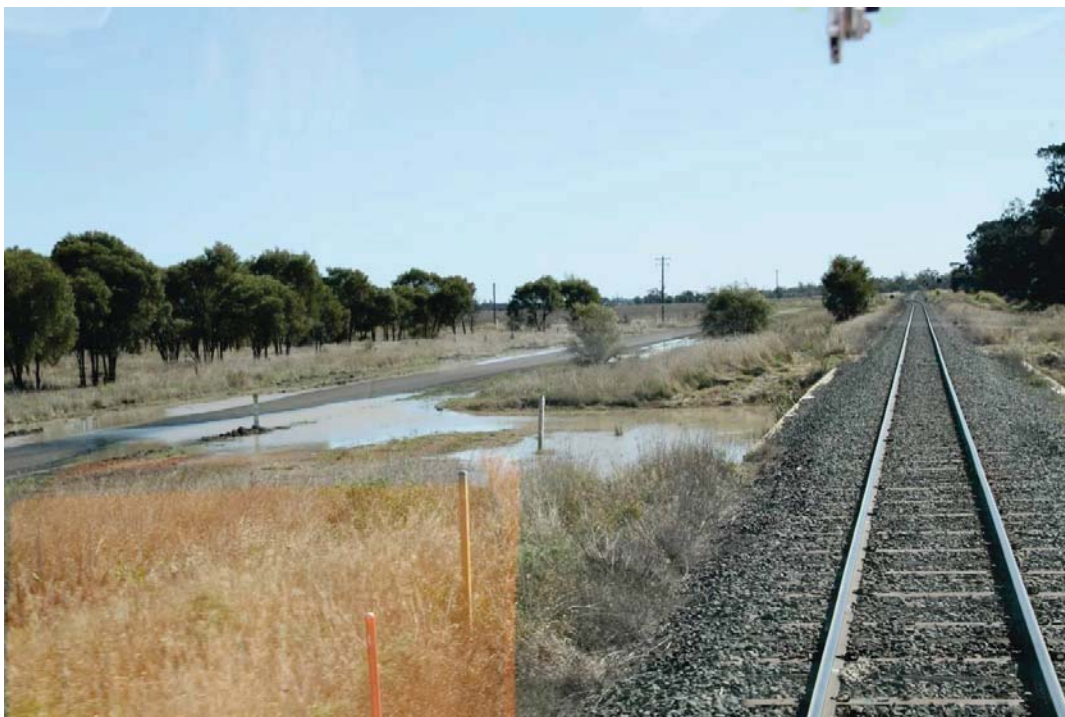
Figure 34 - Flooding and pooling of highway adjacent to culvert opening

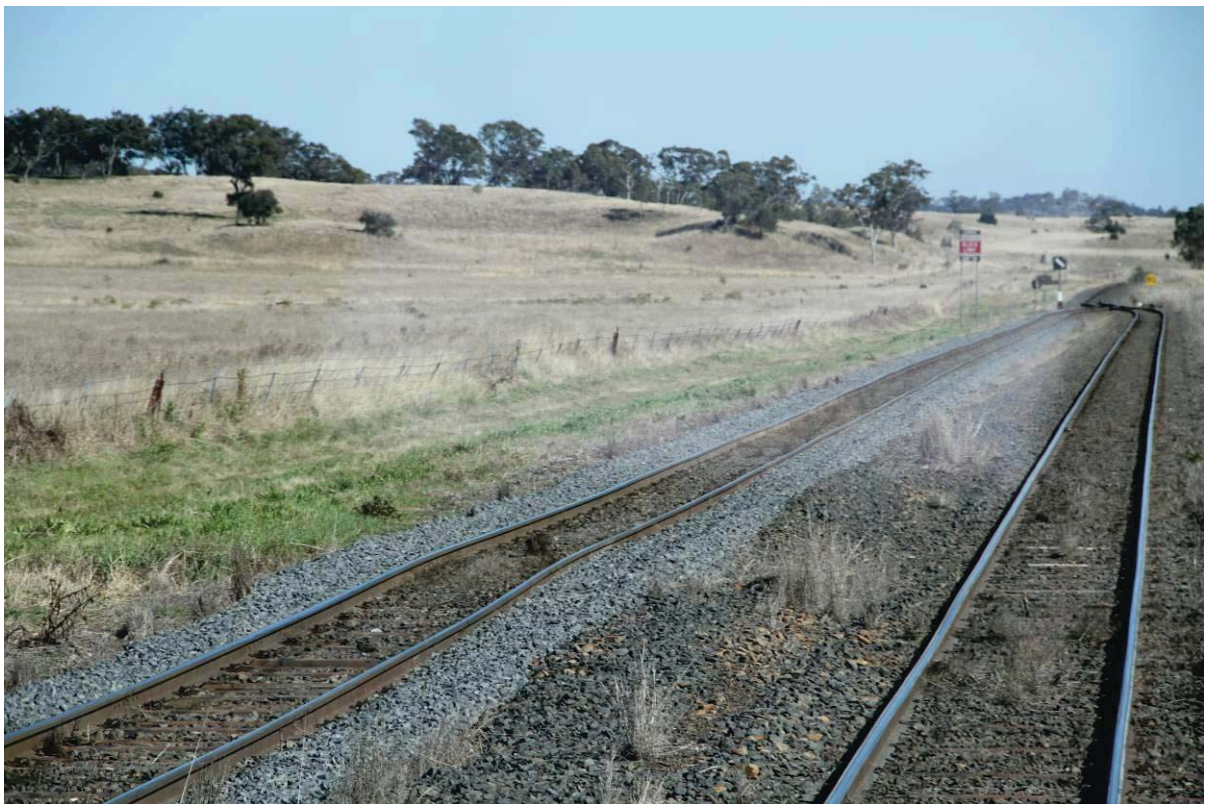
Considering the poor soil conditions and age and type of the infrastructure the rail was generally in fair condition with some sections in poor condition due to recent rains which has caused significant pooling adjacent to the track and aggravated mudholes. Dips in top and line (some significant) along the section were also experienced (see figure 35).

Figure 35 - Dip in top and line due to loss of structure integrity

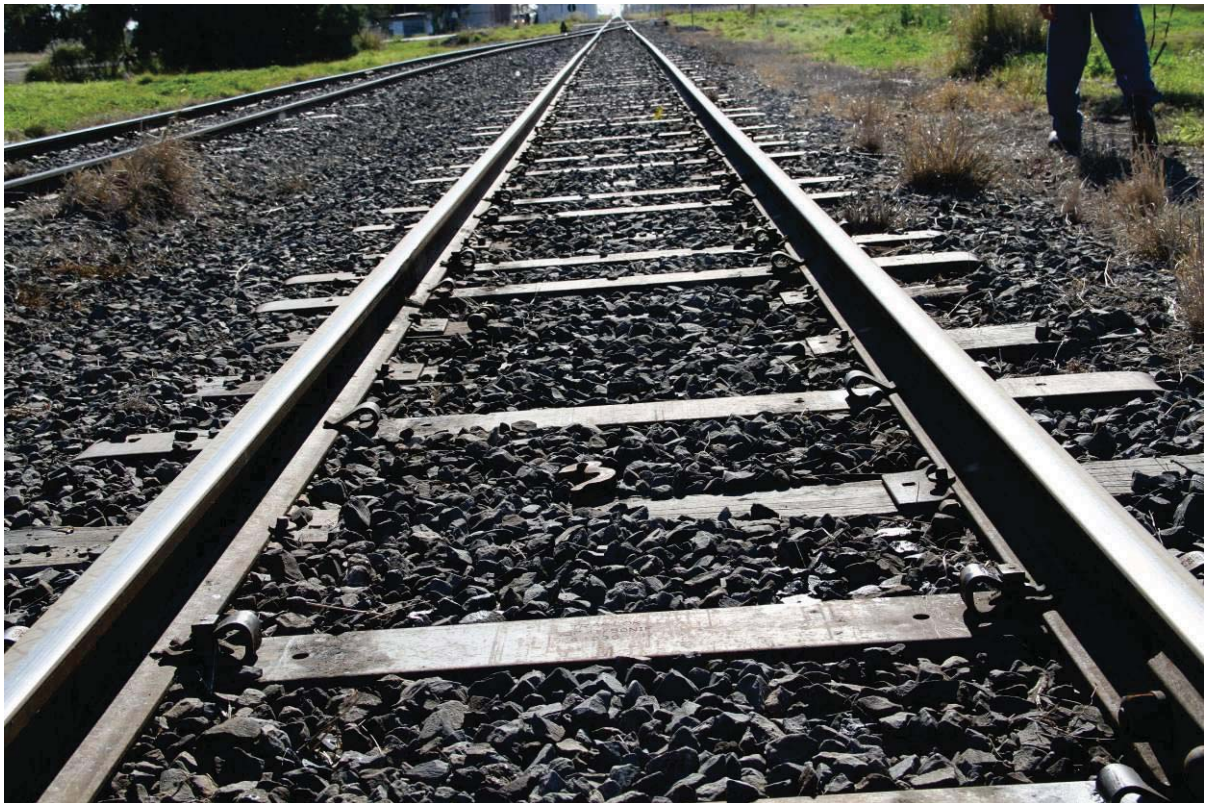
Although no detailed inspection of sleepers was carried out, it was noted that some deterioration was evident. However, overall the condition was considered fair in view of the age of the asset and the environmental conditions.

Figure 36 - Typical track section

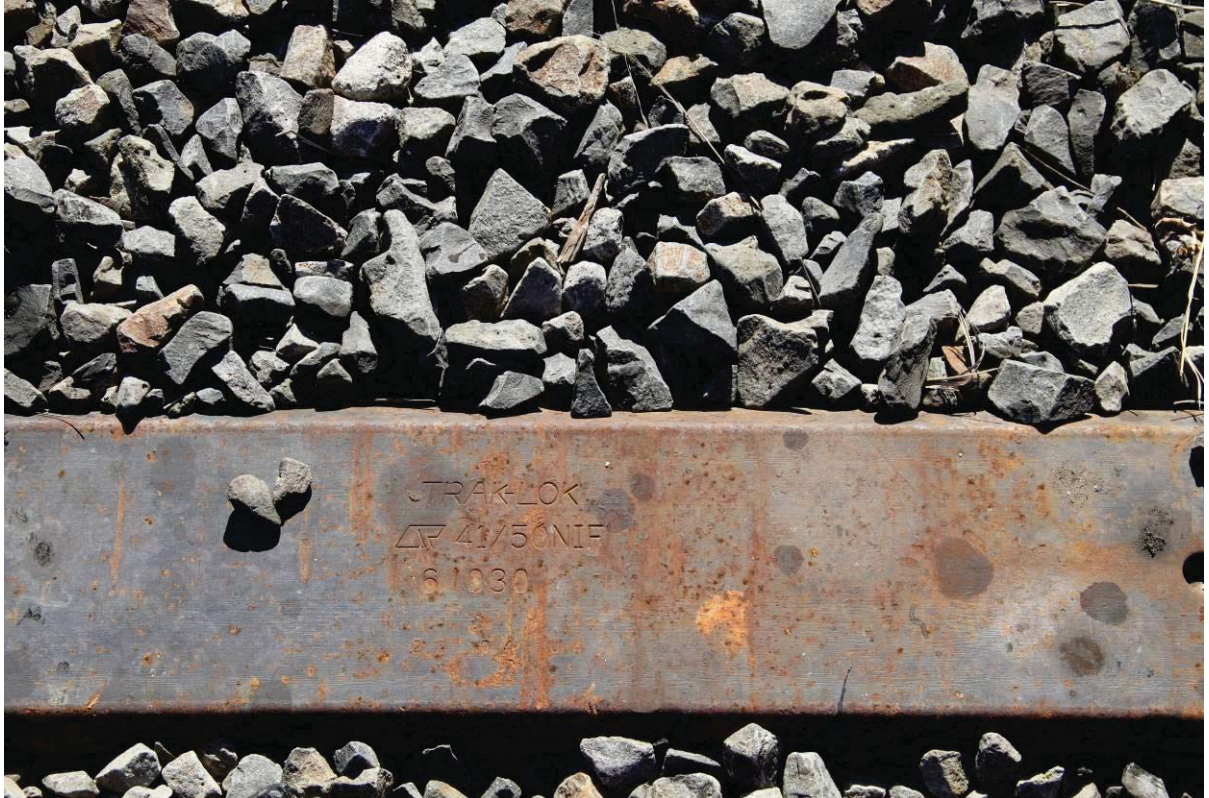
Figure 37 - Steel sleepers were generally in fair condition although some signs of corrosion and aging generally evident

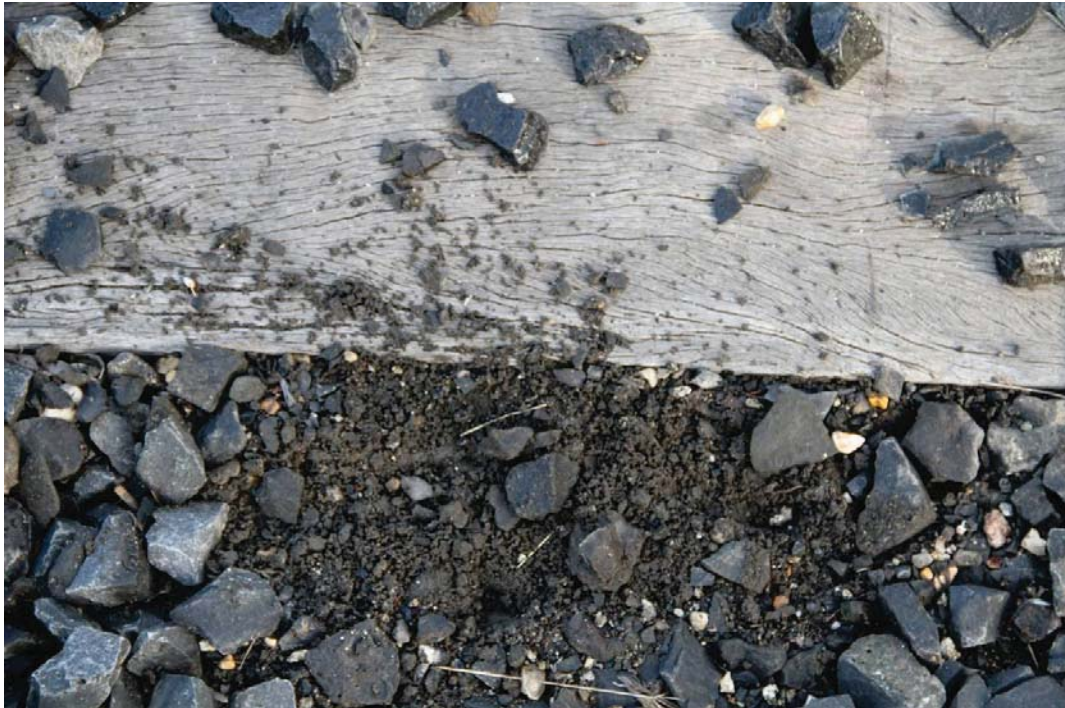
Figure 38 - Removal of top thin layer of ballast often revealed level of contamination underneath

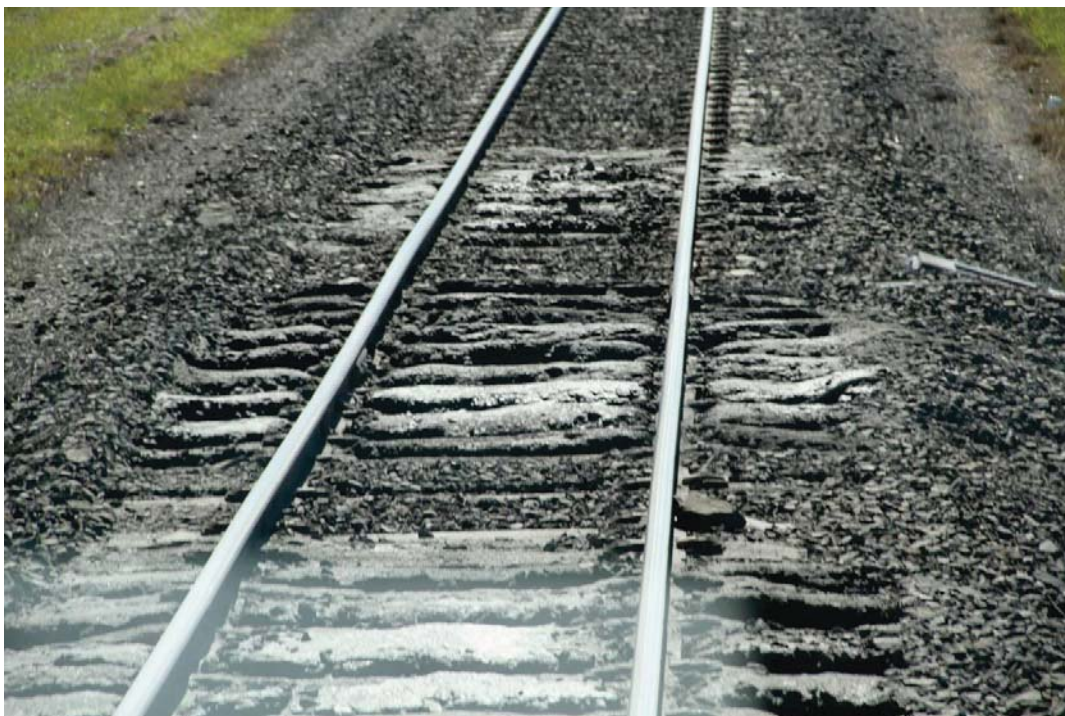
Figure 39 - Typical mudholed section

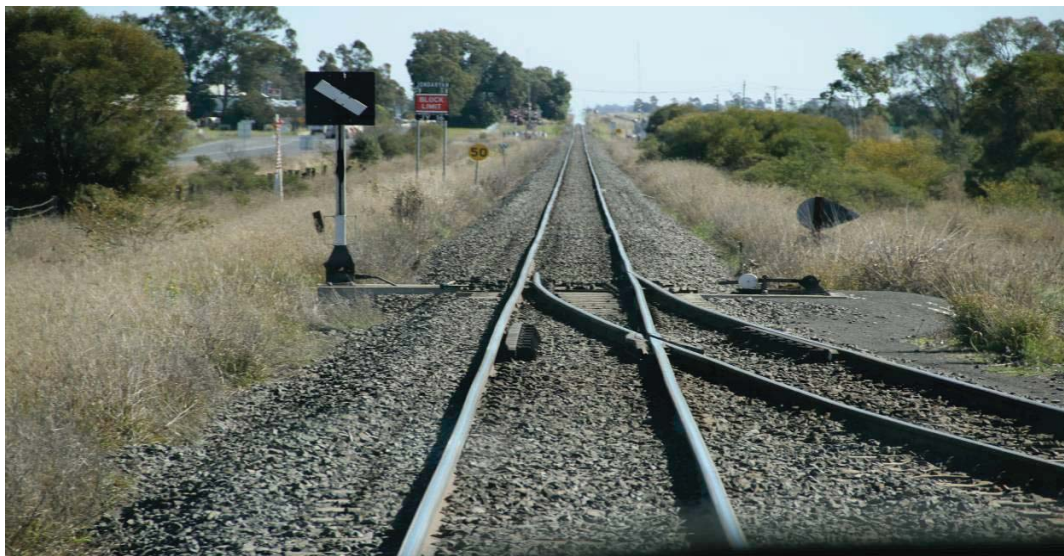
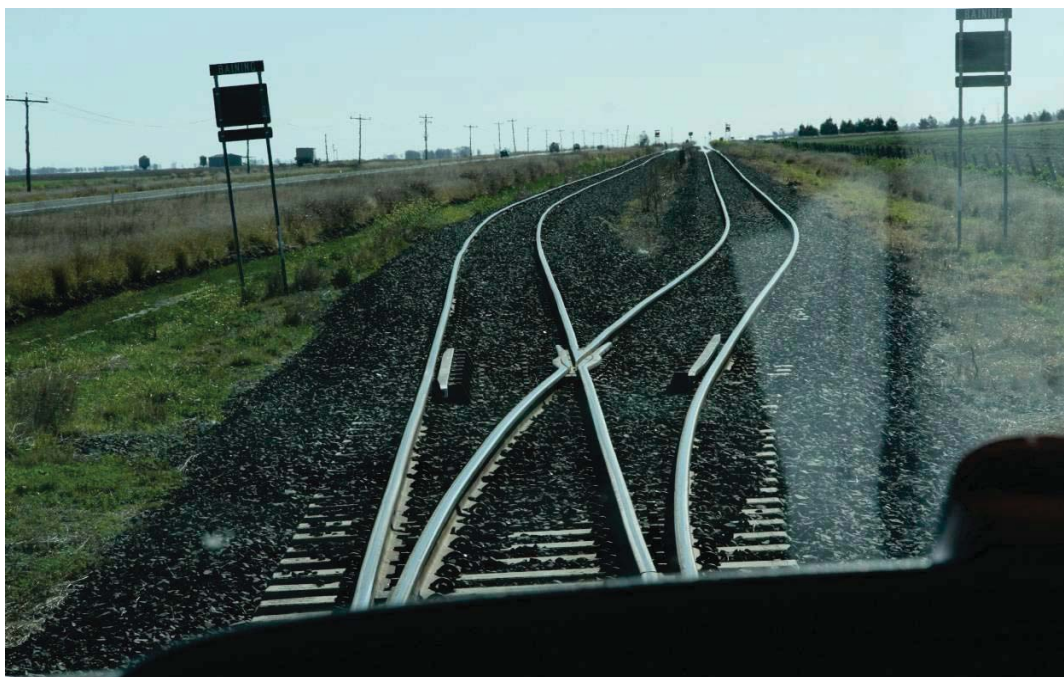
Some turnouts were found to be in relatively poor condition (i.e. Oakey 30.25km), however these were listed to be replaced or for significant reparatory works. Exclusive of these, turnouts overall were found to be in fair condition.

Figure 40 - Typical turnouts condition

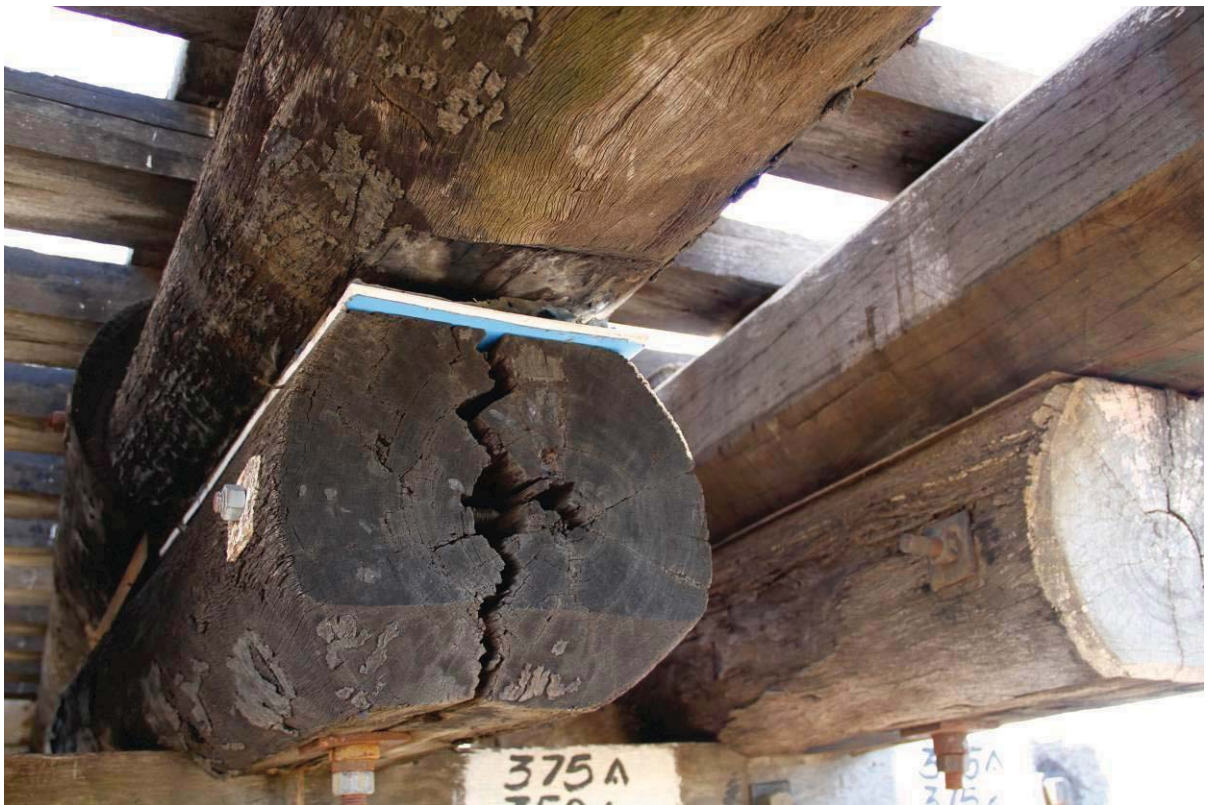
Some deterioration was observed at the timber bridges inspected, with indications of rot and deterioration on several of the girders, piles and headstocks.

Figure 41 - Damaged Timbers
