TOOWOOMBA RANGE RAILWAY

SITE INVESTIGATION AND REMEDIAL SLOPE DESIGN – CH 144.500 TO 144.850 KM

Report Number. 137632080-012-R-Rev0

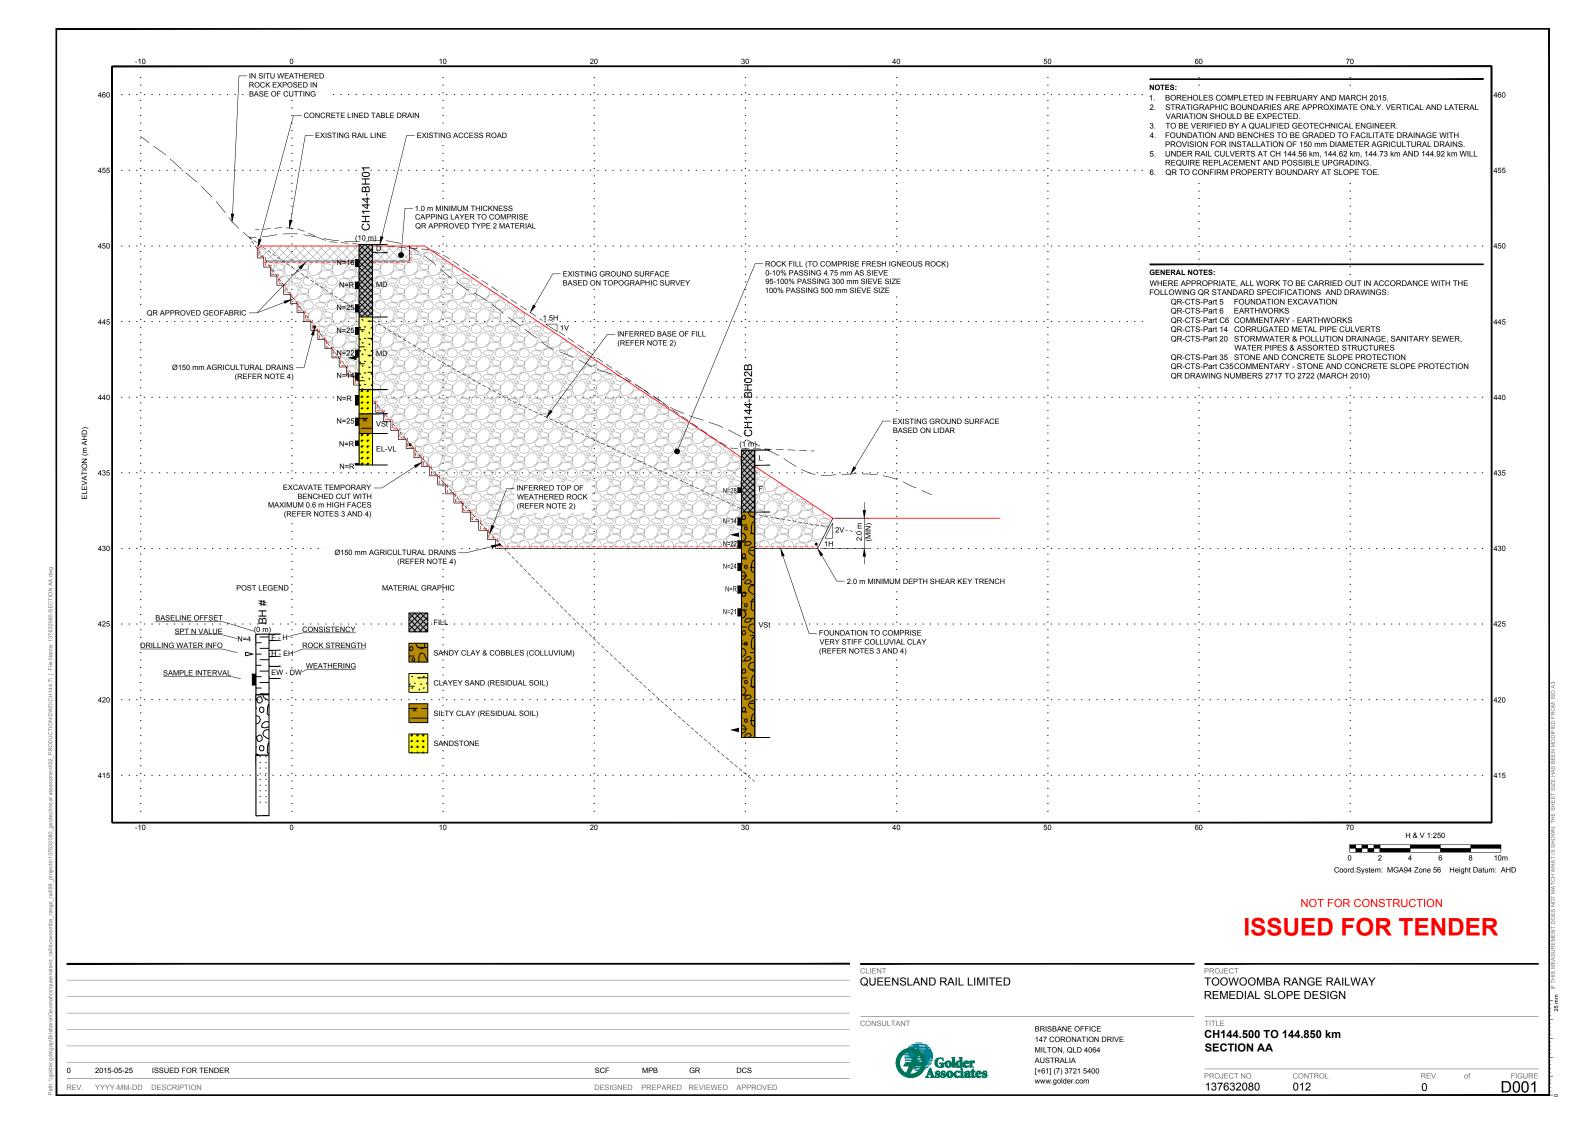
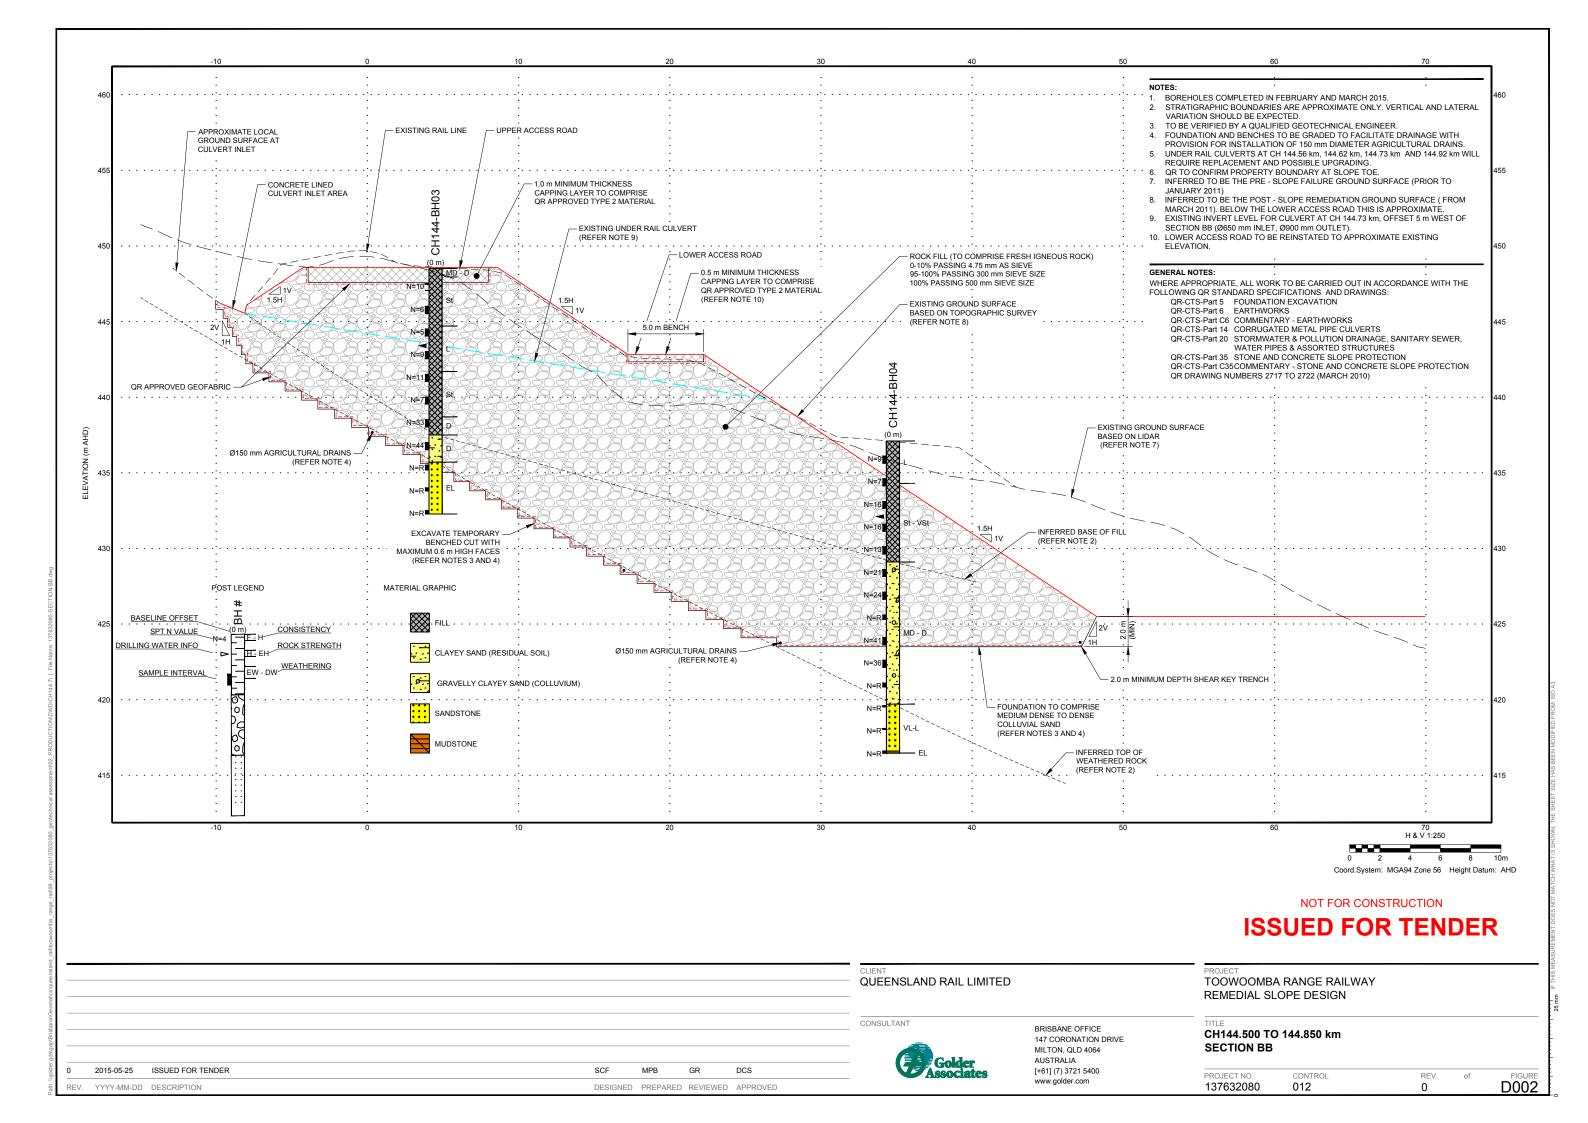
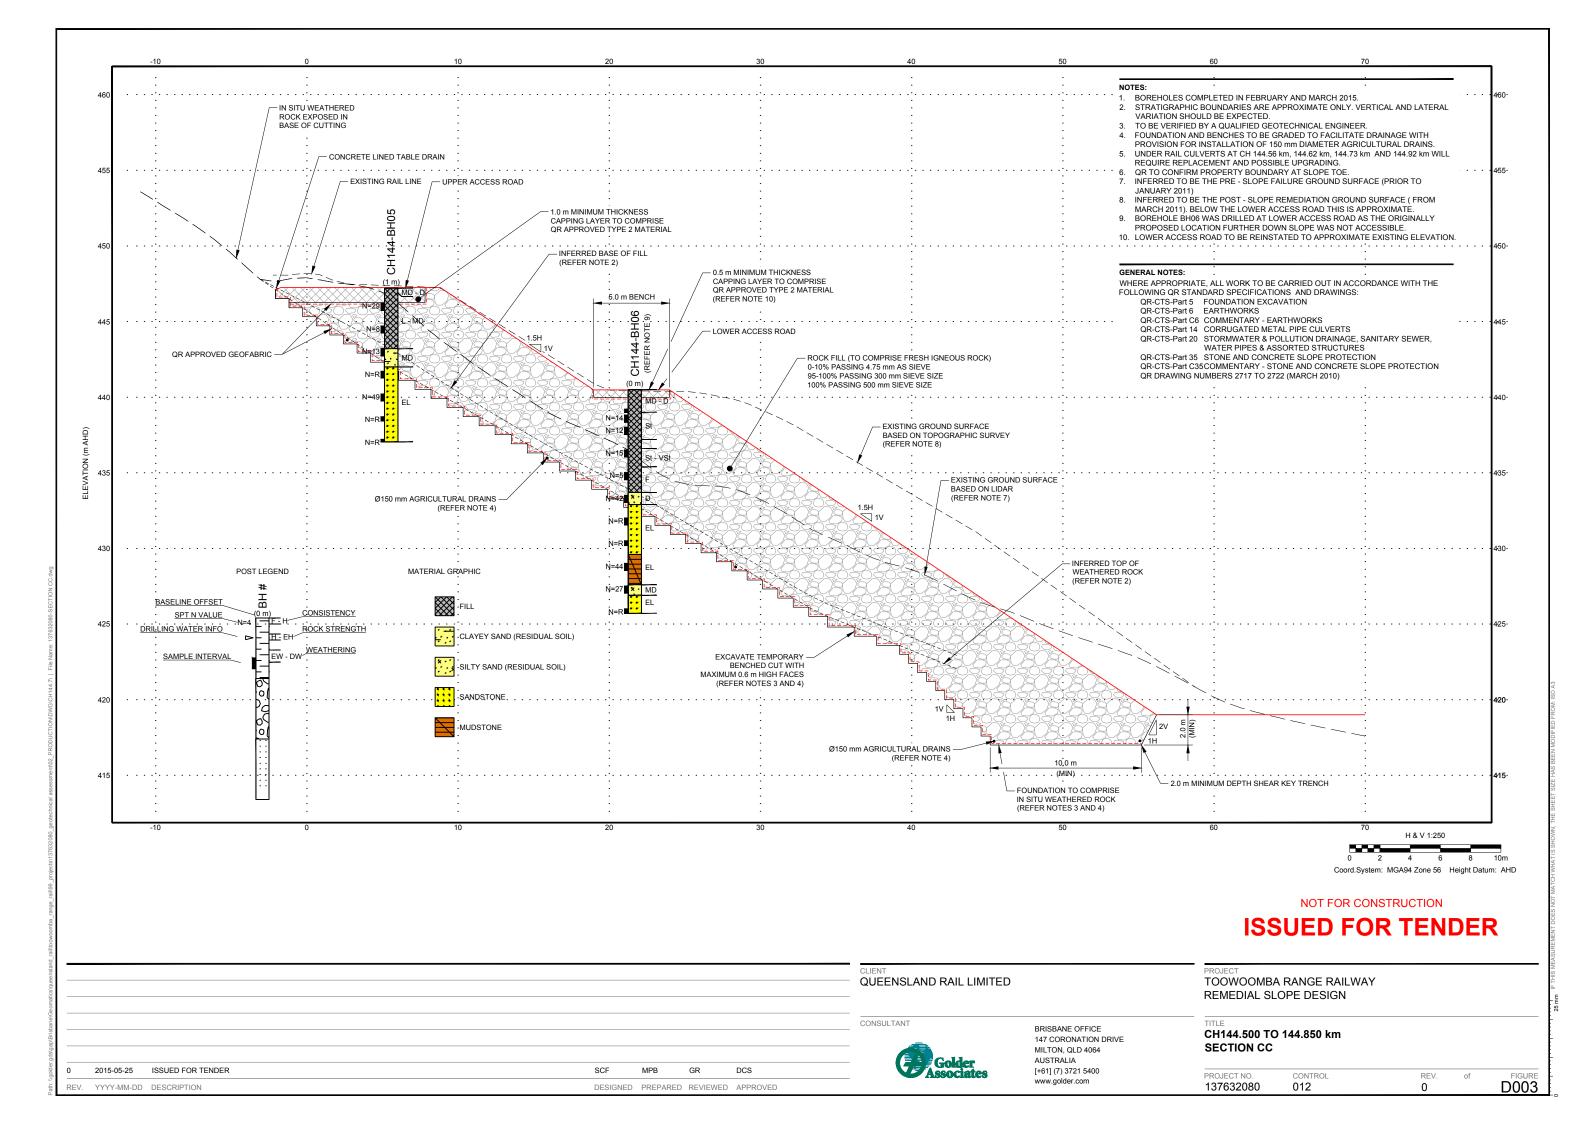
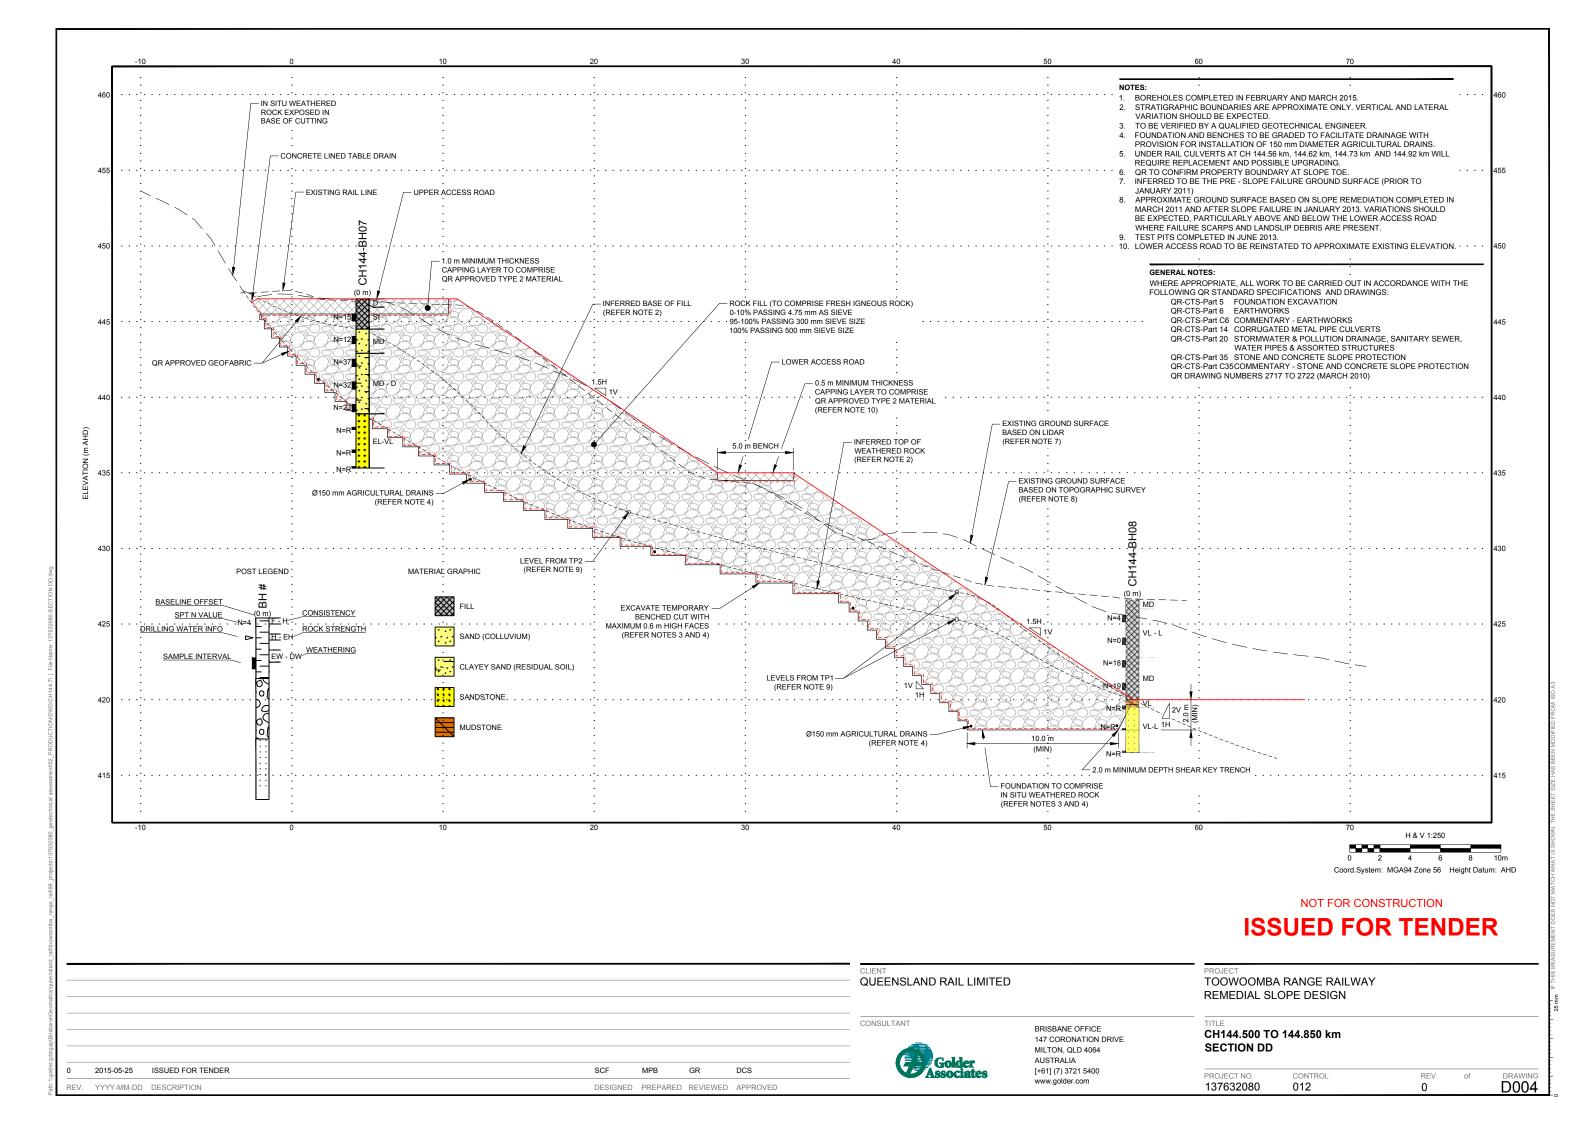
Cross-sections showing topography, relevant surface features and ground conditions based on borehole drilling are presented in Drawings D001 to D004.
