TOOWOOMBA RANGE RAILWAY

SITE INVESTIGATION AND REMEDIAL SLOPE DESIGN – CH 142.630 TO 142.810 KM

Report Number. 137632080-011-R-Rev0

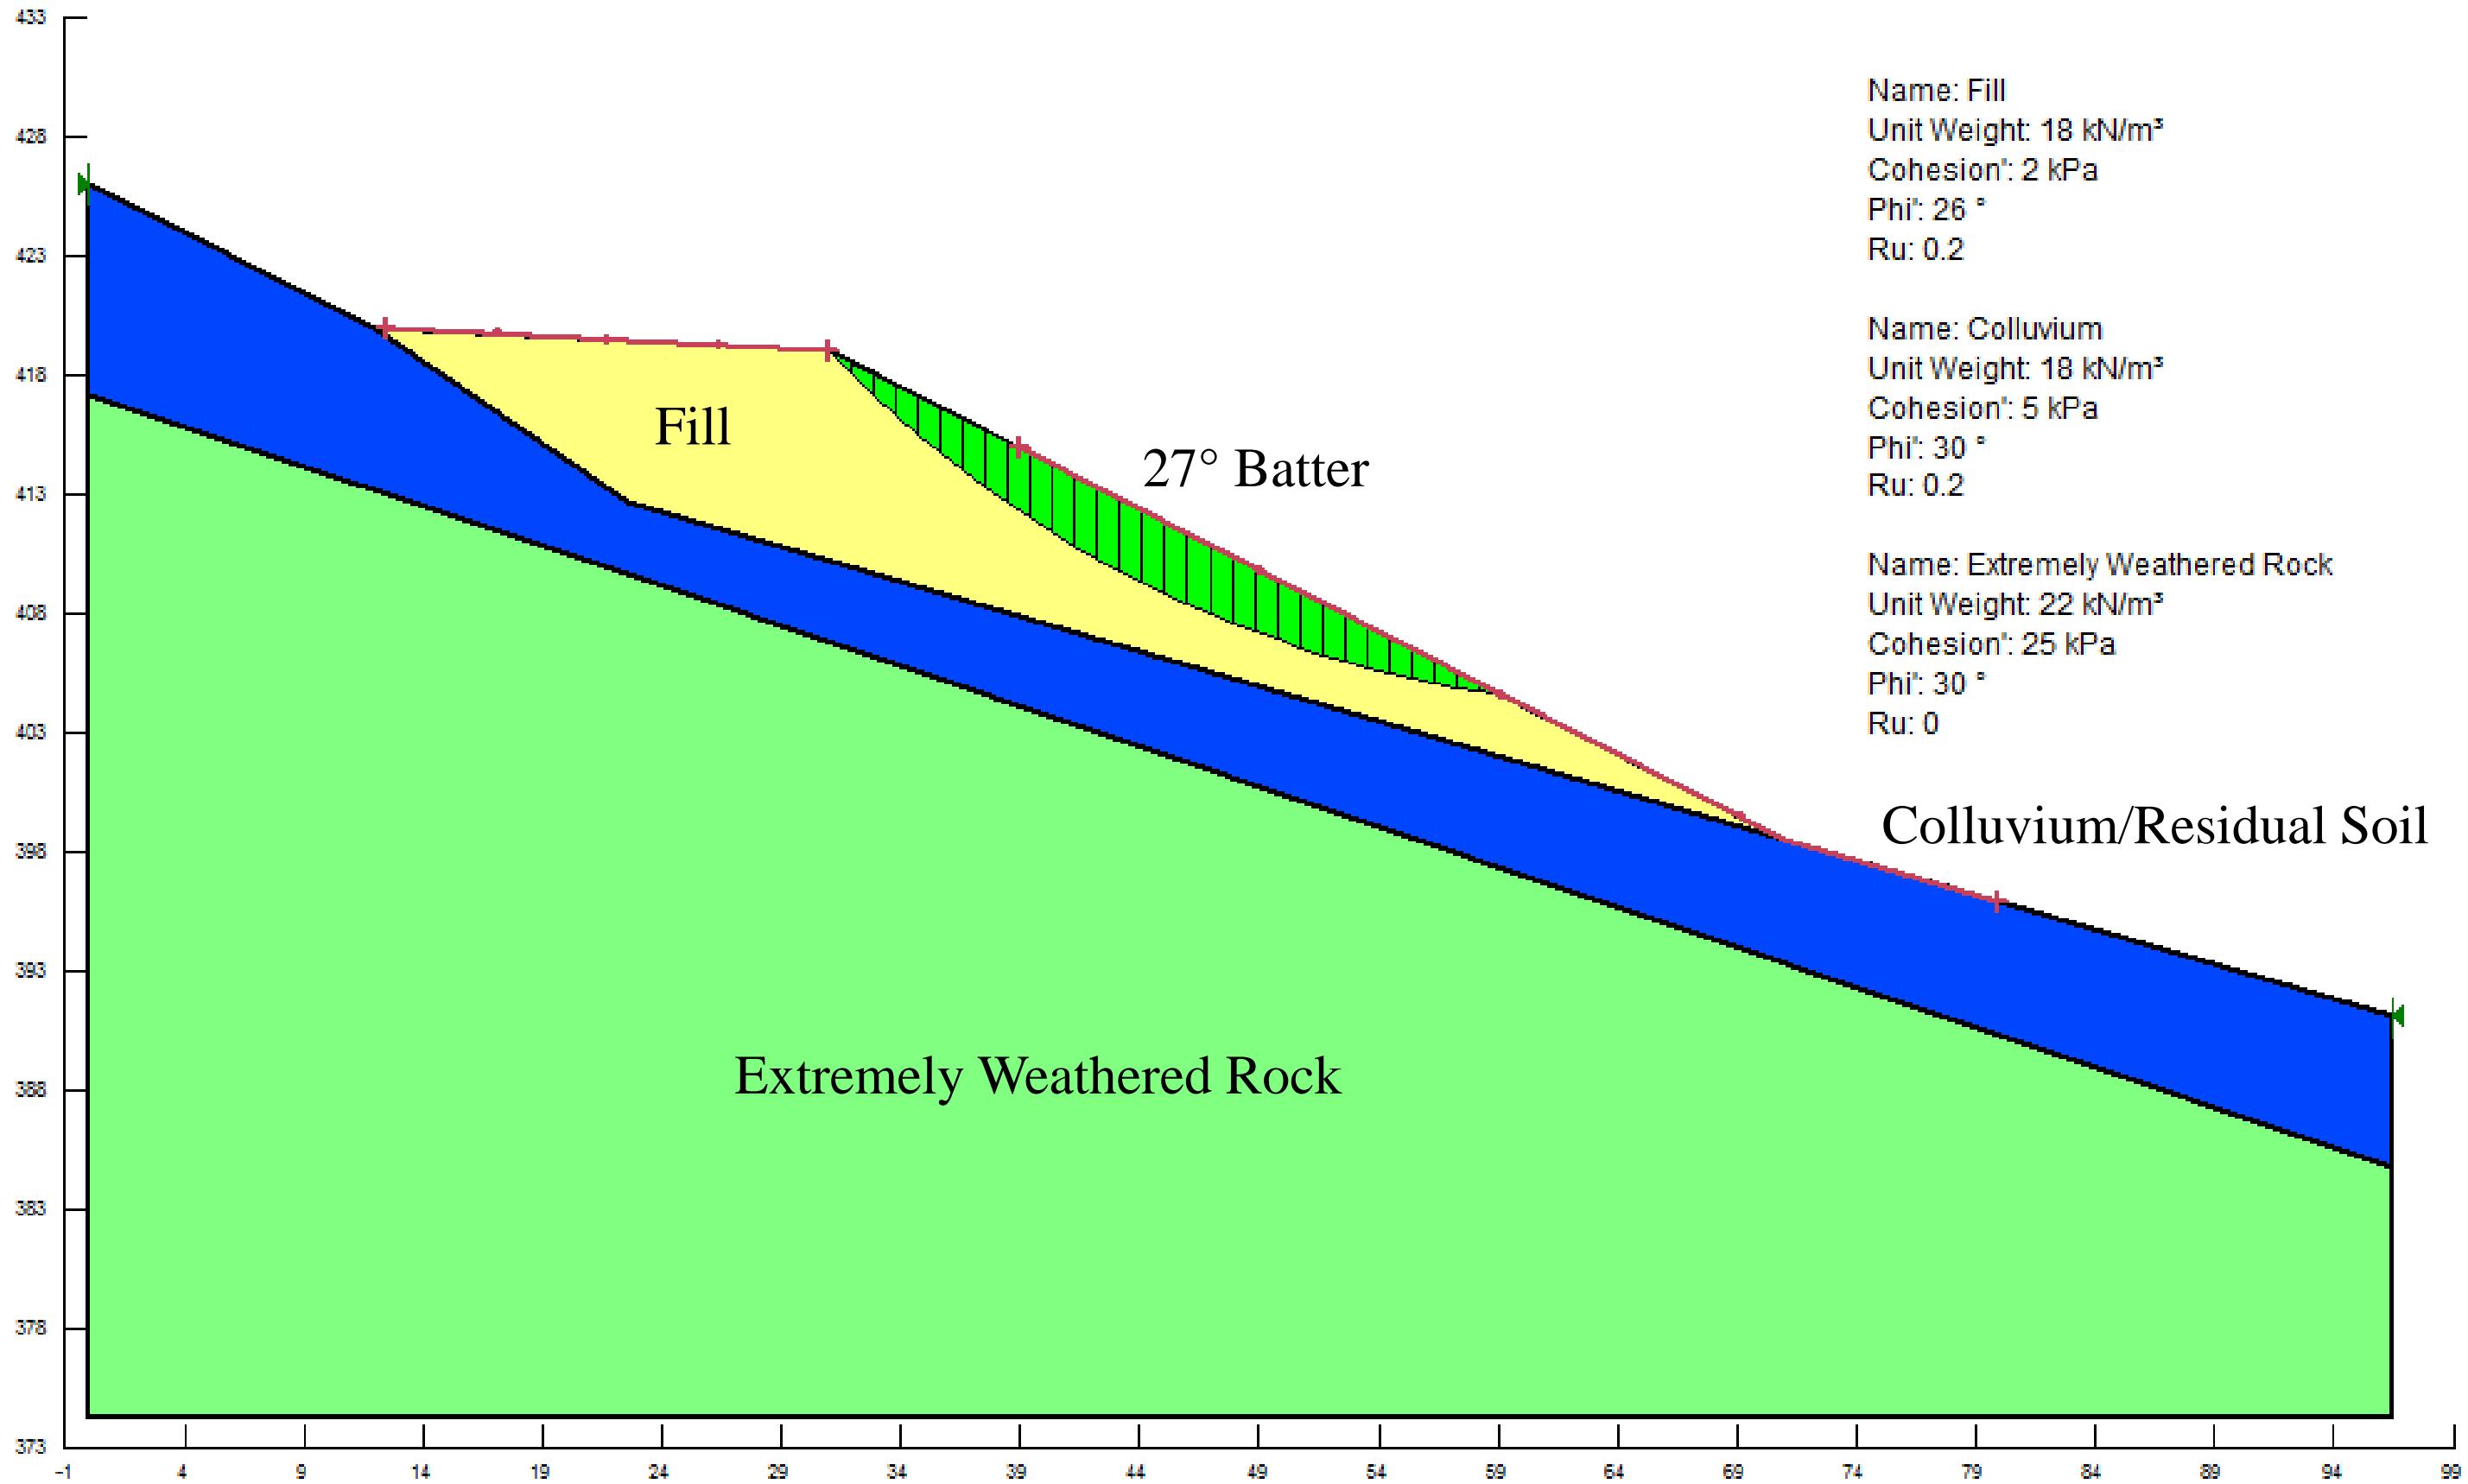
0.901 (Factor of Safety)

The back analysis results indicate that the slope was likely to be marginally stable in dry conditions with a Factor of Safety (FoS) of 1.1 obtained. In wet conditions, with an R_u of 0.2 in the embankment fill and underlying colluvium and residual soil, a FoS of less than unity was obtained (0.9). This critical failure surface is located within the embankment fill and the results support the hypothesis that slope failure was probably triggered by the infiltration of surface water into the embankment fill combined with poor drainage.

Name: Fill
 Unit Weight: 18 kN/m³
 Cohesion: 2 kPa
 Phi: 26 °
 Ru: 0.2

Name: Colluvium
 Unit Weight: 18 kN/m³
 Cohesion: 5 kPa
 Phi: 30 °
 Ru: 0.2
