**ATTACHMENT 5 – WorleyParsons Review of the West Moreton Reference Tariff
Capital and Maintenance Costs – Redacted**

West Moreton Reference Tariff Submission Review

WEST MORETON REFERENCE TARIFF SUBMISSION REVIEW

PROJECT 301001-01731 - AU1

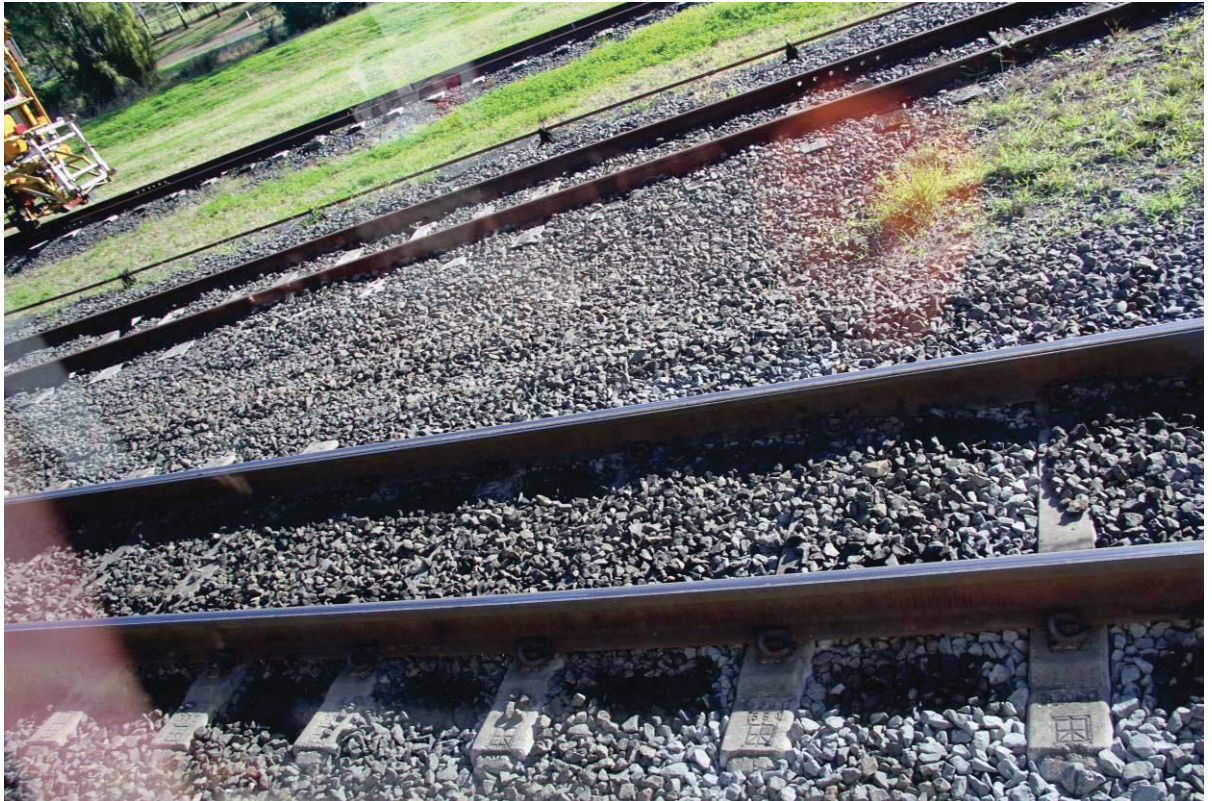
Figure 22 - Typical 50 kg rail on concrete sleepers

Some deterioration was noted in timber sleepers; however sleepers were generally in fair condition for the level of service required.
