Dams and Weirs Capital Works Program

27 May 2014
42627348/01/01

Prepared for:
Seqwater

Prepared by URS Australia Pty Ltd

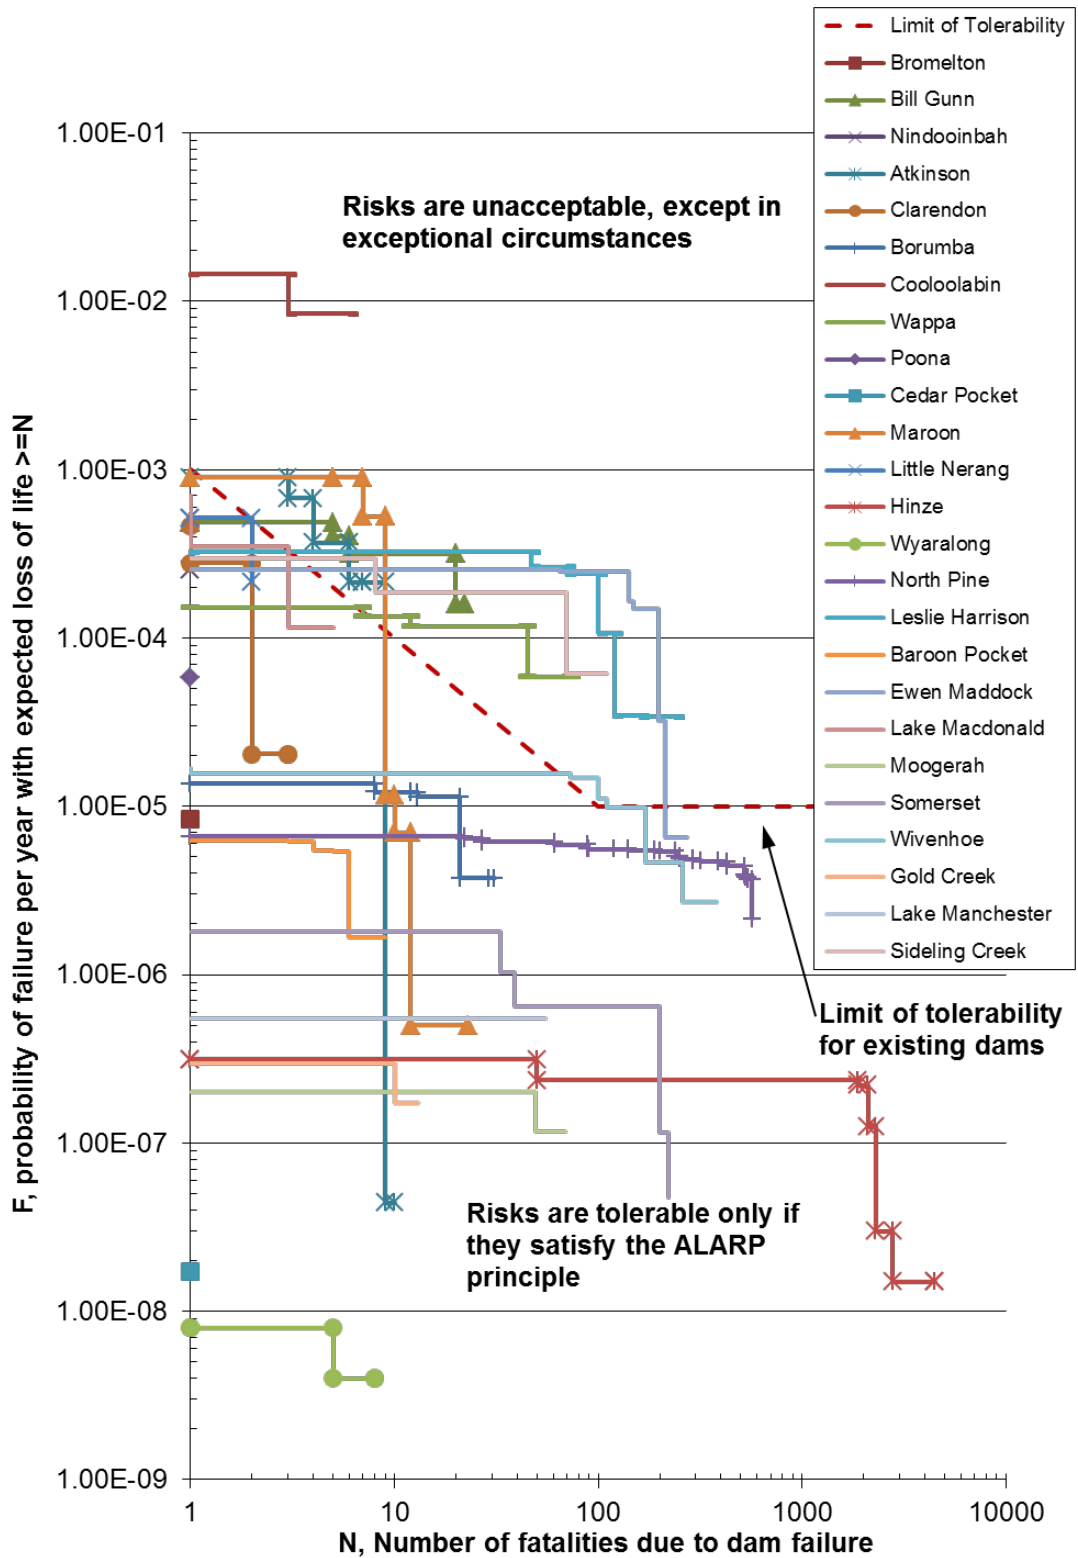
Figure 2-1 Seqwater Existing Portfolio of Dams F-N Curve

A key outcome of the risk assessment was that a number of dams in the portfolio exceed the ANCOLD and DEWS defined limit of tolerability for societal risk, as shown in Figure 2-1, and the ANCOLD defined limit for individual risk, as shown in Figure 2-2, and therefore are considered to pose an unacceptable level of risk based on the current assessment. Further discussion on the ANCOLD guidelines is presented in Section 2.2 below.

- Changes to the ANCOLD limit of tolerability for existing dams. The current limit of tolerability line, as shown in Figure 2-1, extends from F-N ordinates of 1 fatality (N) and probability (F) of 1E-03, diagonally to ordinates 100 fatalities and 1E-05, then it truncates and extends horizontally along the 1E-05 probability. There is the potential for the horizontal portion of the line to be removed and the diagonal line extended. This extension would cause North Pine Dam to plot above the ANCOLD limit of tolerability.

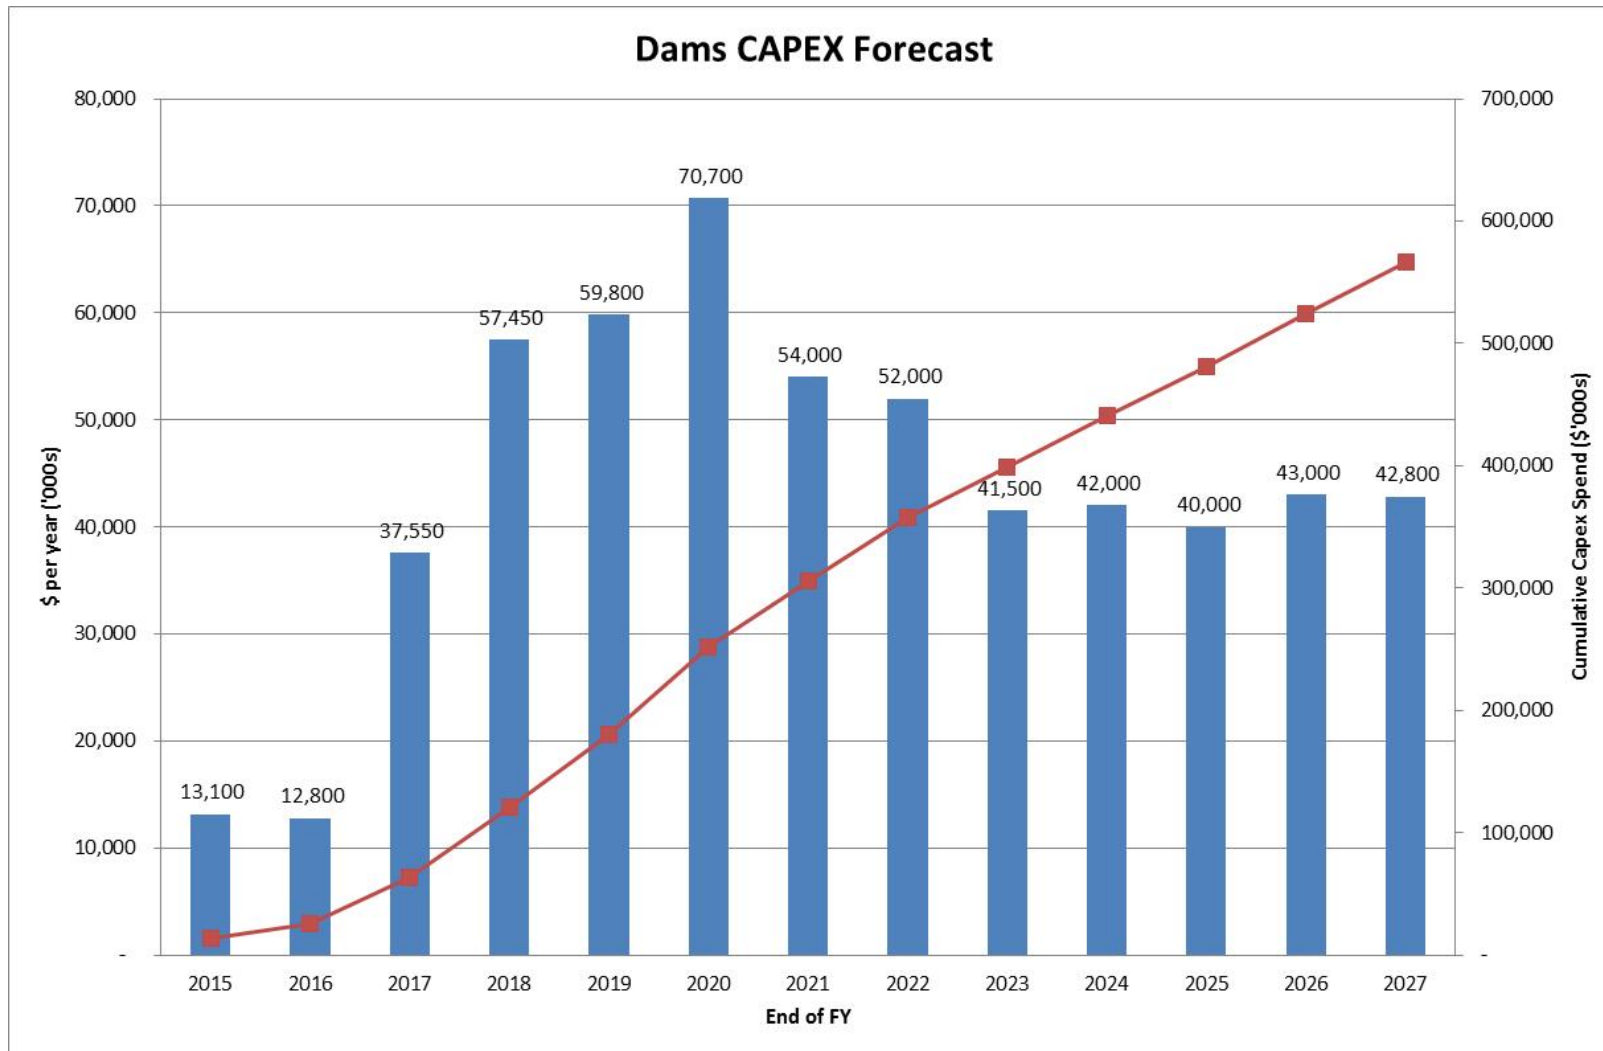
Figure 7-1 Expenditure profile for Water Storage Assets over 13 years

Total forecast capital expenditure on Dam Safety Capital Works Program is of the order of \$570M over 13 years, across 56 projects. There are 24 projects with forecast expenditure greater than \$2 million. The expenditure profile for this asset group is presented in Figure 7-1, over a prioritised timeline. All forecast expenditure is for the Compliance investment driver. The ten highest value projects, which account for nearly 90% of the \$570M capital expenditure, are summarised in Table 7-1.
