Critical Assets Due Diligence Review  
(R2A Pty Ltd)

# **GLADSTONE AREA WATER BOARD**

## **Critical Assets Due Diligence Review**

February 2009

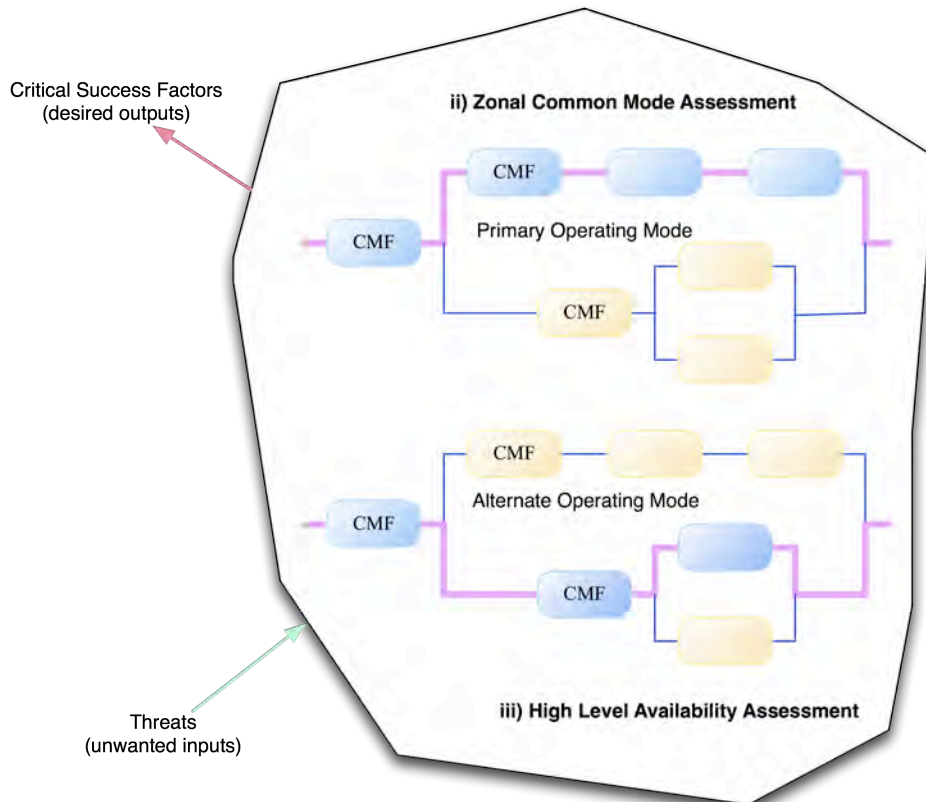
The methodology adopted for the review is a **risk based availability modelling technique** that uses both **top down and bottom up approaches** as described in detail in Chapter 22 of the R2A text and is summarised below. The review involves three (3) tasks and is represented by the following diagram.

##### Context of the Three Assessments

- i. Functional boundary analysis. This is a high-level context (boundary) vulnerability analysis establishing the risk context for the review. It examines the credible boundary threats to the critical success factors of GAWB. In this study, the critical success factors were defined as the requirements (quantity and availability) of the bulk water customers.

- ii. Zonal vulnerability assessment. This process identifies the critical common mode and common cause failures such as issues associated with fires/explosions, pipe failures and such. This is usually done on a geographic and incident history basis.
