## SunWater Price Regulation

### REVIEW OF SELECTED ANNUITY VALUES FOR REFURBISHMENT AND REPLACEMENT ITEMS

- 2 - Final
- 6 October 2011

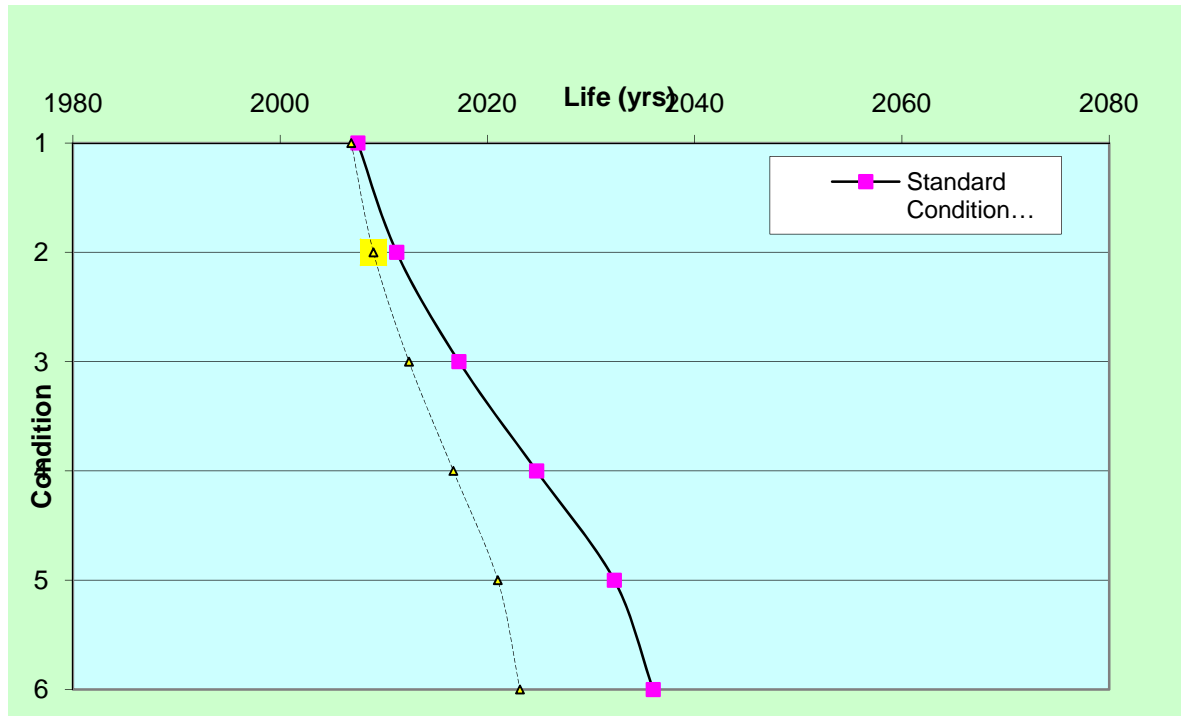
■ **Figure 3 Graphical output of the planning tool**

In this case, the planning tool predicts that the replacement date for the asset should be brought forward from the standard life based replacement date for that asset type of 2040 to 2021 taking into account the risk rating of a particular asset and the fact that the condition assessment indicates that the asset score (yellow square) has deteriorated more rapidly than the standard decay curve would predict.

Extracts of the tool are shown in Figure 2 and Figure 3 below for an asset installed in 2009 with a 35 year asset life, a Medium risk score, a condition score of 2 based on a 2009 assessment:
