Queensland Competition
Authority
FINAL

**AURIZON NETWORK
REVIEW OF BALLAST
UNDERCUTTING
SCOPE AND COSTS**

20 NOVEMBER 2015

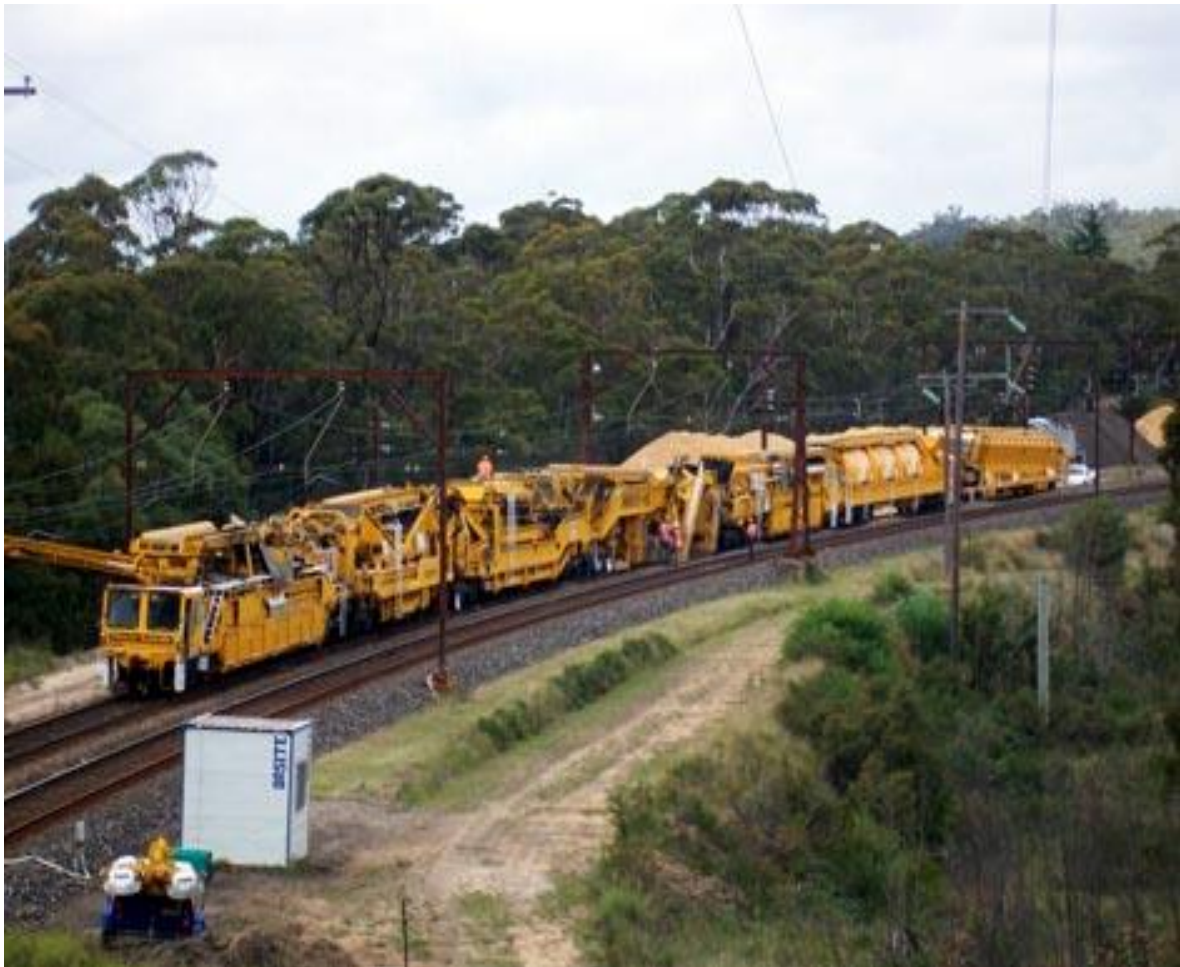
Ballast can be replaced manually or mechanically through a variety of methods. However, the most common method of ballast replacement in railways is through the use of an Automated Ballast Cleaning machine, which is the main equipment used in the maintenance task of ballast undercutting (and/or ballast cleaning). On the CQCN, main line undercutting work is predominantly undertaken using the rail mounted RM900 high output ballast cleaner (see below). By contrast, undercutting at turnouts, in mainline locations where additional ballast cleaning is required and the RM900 is not available, and mainline undercutting that exceeds the capacity of the Automated Ballast Cleaning machine, is undertaken using an excavator undercutter.

Figure 2 RM-900 mainline ballast undercutting machine

Due to the narrow construction width of the bridges within the CQCN, it is not possible to undertake ballast undercutting using the RM900 machine or an on-track undercutter. Instead, ballast on bridge decks is replaced using one of two alternative methods. The track is cut at either end of the bridge and then:

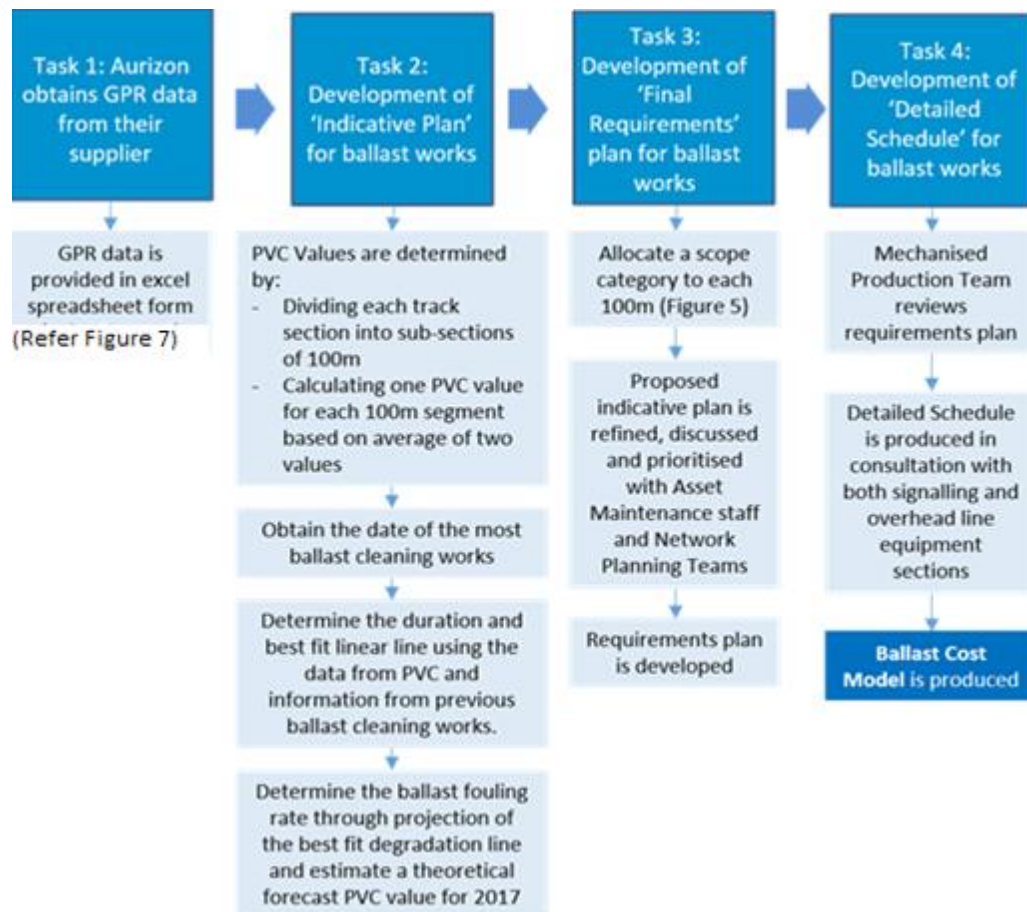
The Review Team understands there are four key tasks involved in developing the mainline ballast undercutting scope and a schedule of works. These are summarised in Figure 6 and detailed in full in Appendix 1.

Figure 6 Aurizon Network's process for developing ballast undercutting scope and schedule of works

In conclusion as the Review Team did not have access to the NSAP model and as the majority of the UT4 undercutting forecast has been calculated using GPR data and the tasks summarised in Figure 6, the following discusses the methodology as outlined in Figure 6.

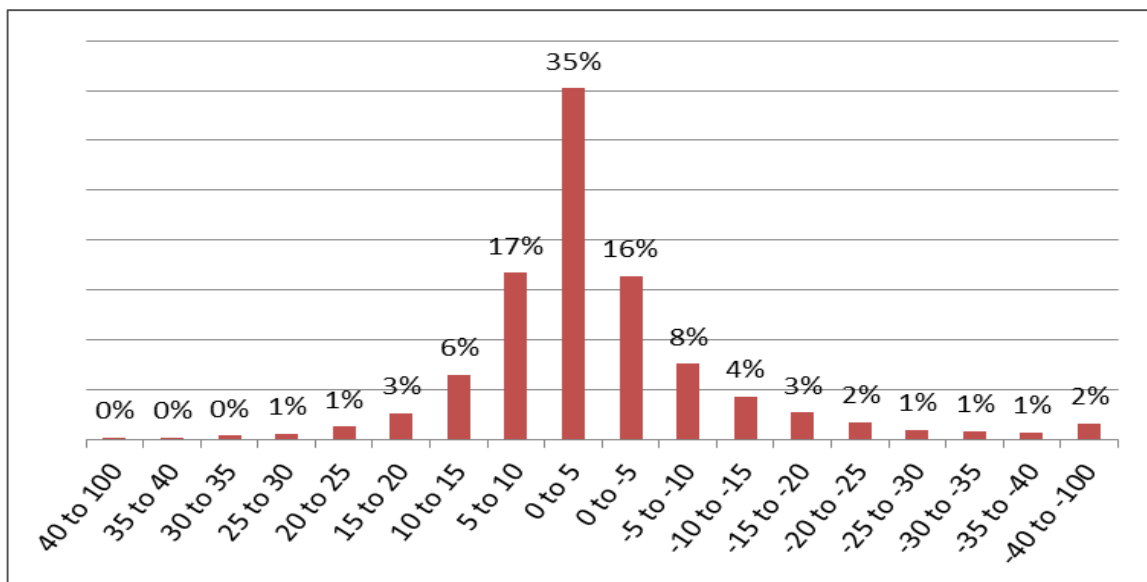
- 333.8km (3338 sections of 100m track) or 37 per cent of the total number of 100m lengths has a PVC value that has fallen from 2012 to 2014; and
- 115.3km (1153 sections of 100m track) or 13 per cent had a PVC value fall by greater than 10 percentage PVC points (Figure 11).

Figure 11 Change in PVC from 2012 to 2014 no ballast undercutting works after 2012 (n=10,105, all rail systems)

The results from Figure 11 demonstrate the importance of taking into account all reparation and other maintenance works which may any impact on the resultant projection of ballast degradation. It is apparent that these works potentially have a significant effect on the GPR result and subsequently may skew the resultant projection for the development of the ballast undercutting scope.

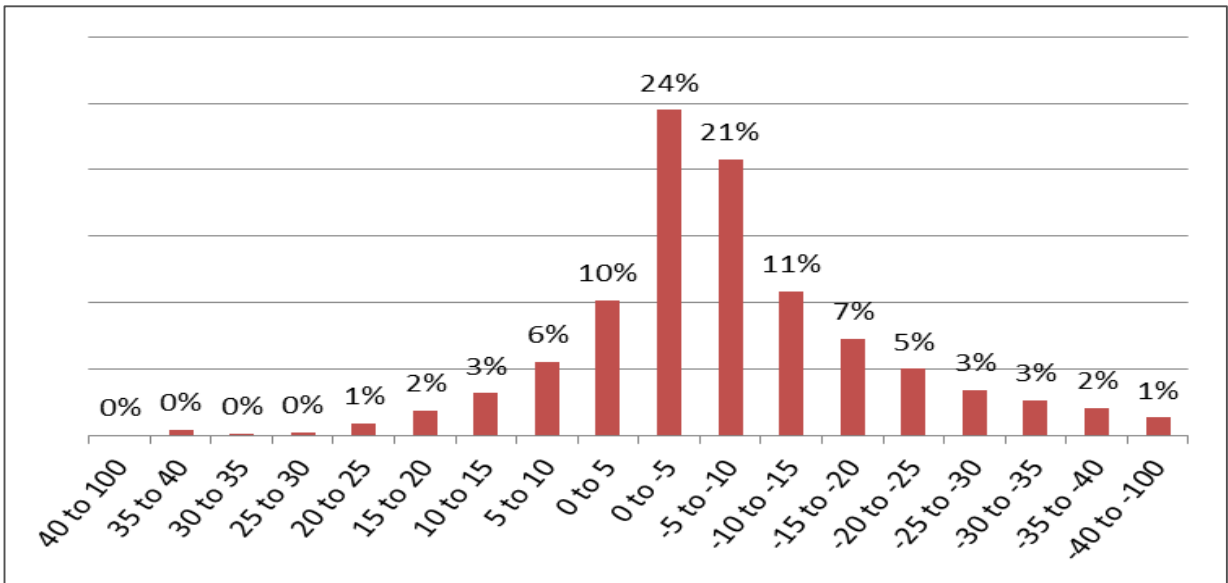
For those segments of track that have had works undertaken since 2012, The Review Team found that approximately 257km of track (28 per cent of the total number of 100m lengths) had a PVC value that has increased from 2012 to 2014 (Figure 13). This is an unexpected result as if works have been undertaken on a segment of track it seems counter-intuitive that there would be a subsequent increase in the PVC value.

Figure 13 Change in PVC from 2012 – 2014; with ballast undercutting works between 2012 and 2014 (n=1866, all rail systems)

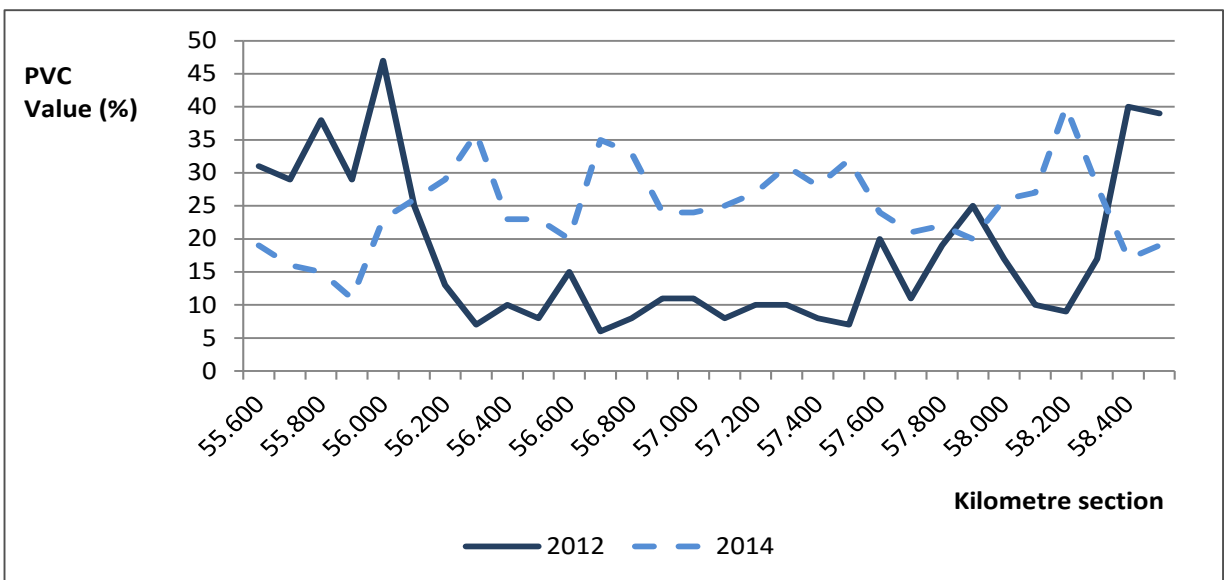
An example of this issue is illustrated in Figure 14 for a 3km section of Goonyella track. This shows that, from the data provided for review for ballast undercutting works, there are a number of 100m segments where the PVC values are, and in some cases significantly, greater in 2014 than in 2012 and yet work was undertaken on these segments between 2012 and 2014.

Figure 14 Comparison of PVC values for 2012 and 2014 with ballast undercutting works after 2012 for a section Goonyella track (n=30)

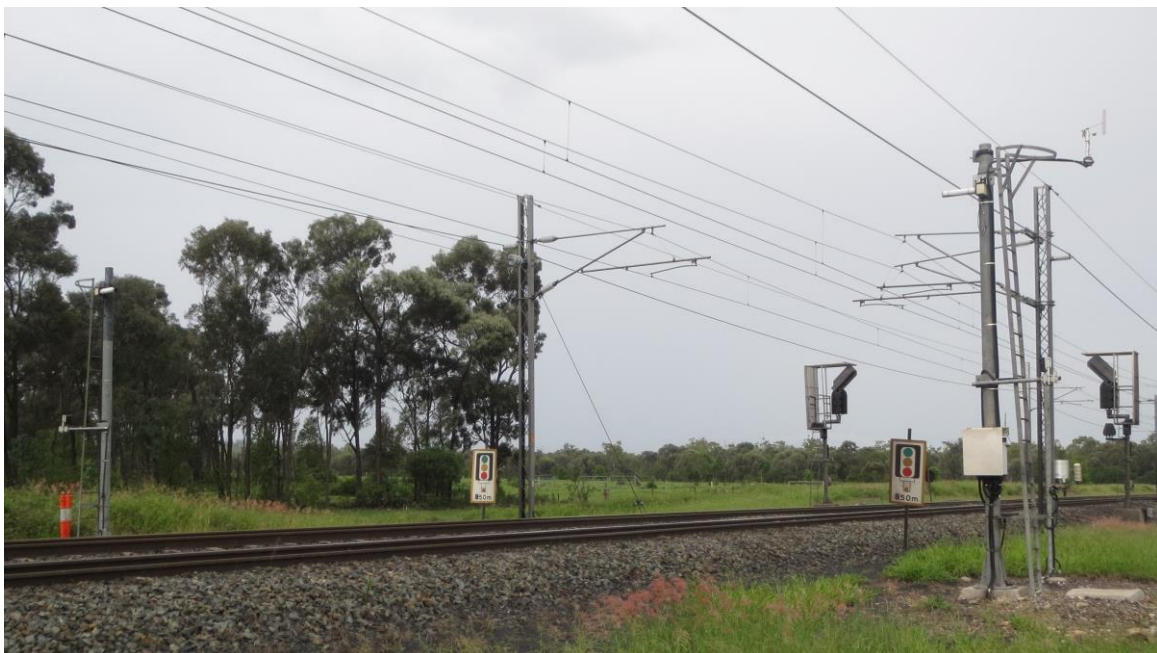
In addition Aurizon Network has installed, at key locations on the system, equipment which sends a beam across the top of wagons travelling at main line speeds. The intensity of the retuned beam is a measure of the quantity of coal dust in the air immediately above each passing wagon, with procedures being in place to reduce emissions from trains where the dust levels exceed acceptable limits. Shown below is the coal dust detection equipment installed at Mindi on the Goonyella system (Figure 15).

Figure 15 Coal dust detection equipment at Mindi on the Goonyella system

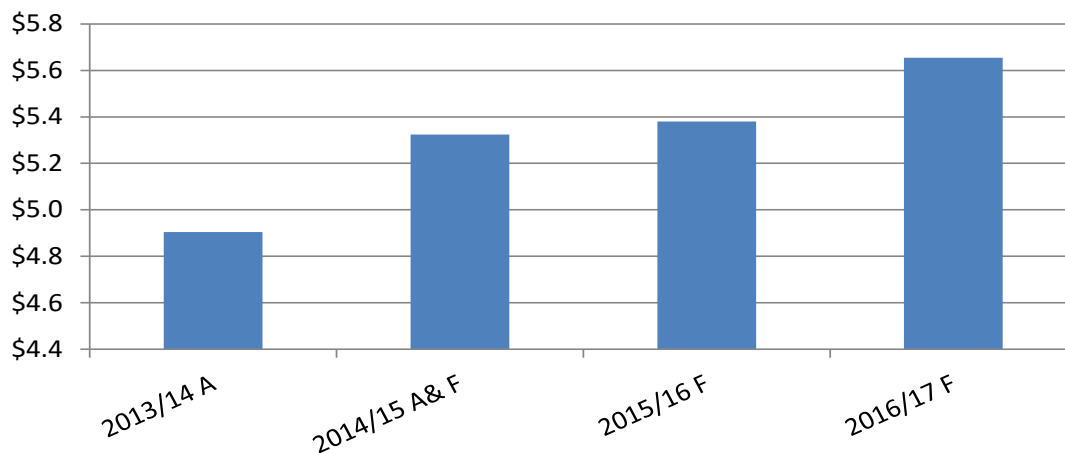
In terms of specific turnout ballast undercutting costs, our analysis revealed that the increase in turnout costs from FY14 to FY17 (Figure 19) is consistent with the change in kilometres of turnout track kilometres as the cost per kilometre is relatively stable over this period once we exclude internal charges.

Figure 19 Summary of turnout costs

Internal charges as specified in the UT4 ballast cost model (which is based on GPR data rather than the volumetric analysis undertaken previously) average over 40% of the total turnout ballast cost. However, beneficially, from (Figure 19), it can be seen that the absolute and proportional internal cost has decreased over the period FY15 to FY17 when compared to FY14 as a result of the change in methodology.

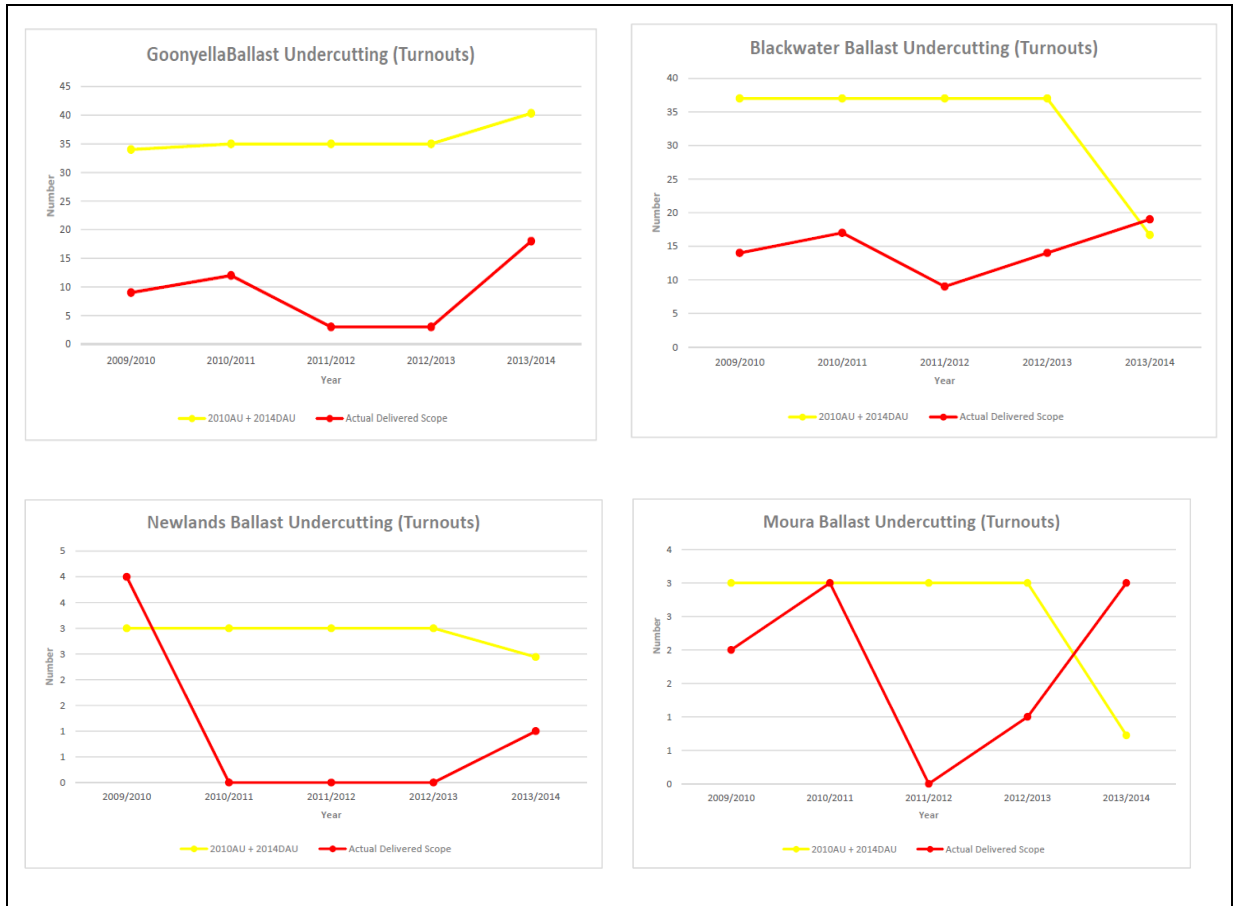
Team consider the continual shortfall on delivery of turnout undercutting delivered by Aurizon Network to be a concern (refer Figure 20).

Figure 20 Summary of Aurizon Network undercutting program versus actual

This highlights that significant works were undelivered in relation to turnout undercutting over the UT3 period. As customers would have already paid for this work and as it is reasonable to assume that this undelivered scope has now been included in the proposed UT4 scope, one questions whether the forecast cost reflects “double-counting” in relation to the fact that potentially a percentage of the turnout undercutting costs reflected in the UT4 forecast have been allocated already in previous years scope.

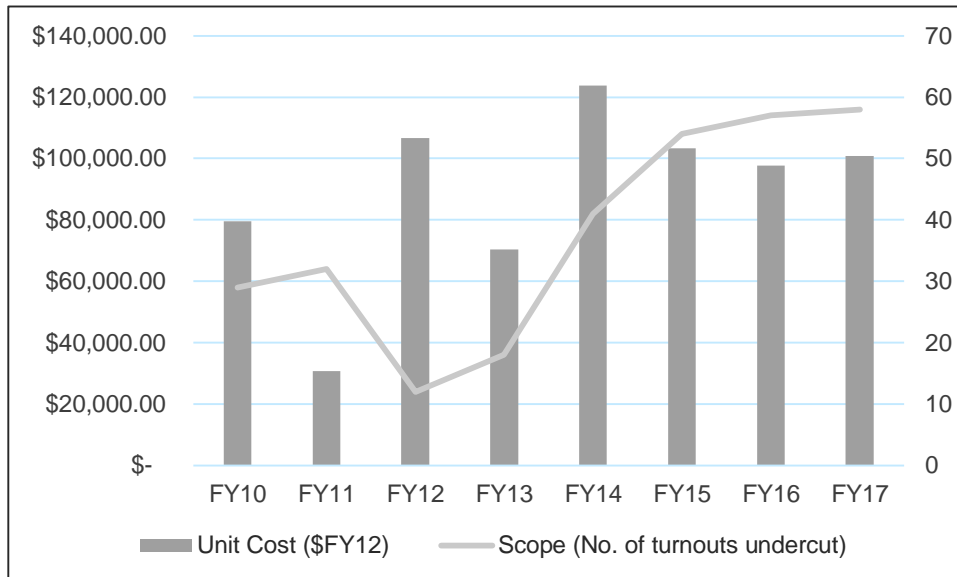
Figure 23 Turnouts - historic unit cost compared with scope

Figure 24 below shows unit costs for turnouts over the period from FY10 - FY17. This graph shows the unit cost to be more stable than that for mainline works, although the annual scope fluctuates considerably over the review period.
